**Sheldon Park Changing
Sheds and Toilets
PRK 0370 BLDG 003 EQ2
Detailed Engineering Evaluation
Quantitative Assessment Report**

Sheldon Park Changing Sheds and Toilets

Quantitative Assessment Report

672-710 Main North Road, Belfast

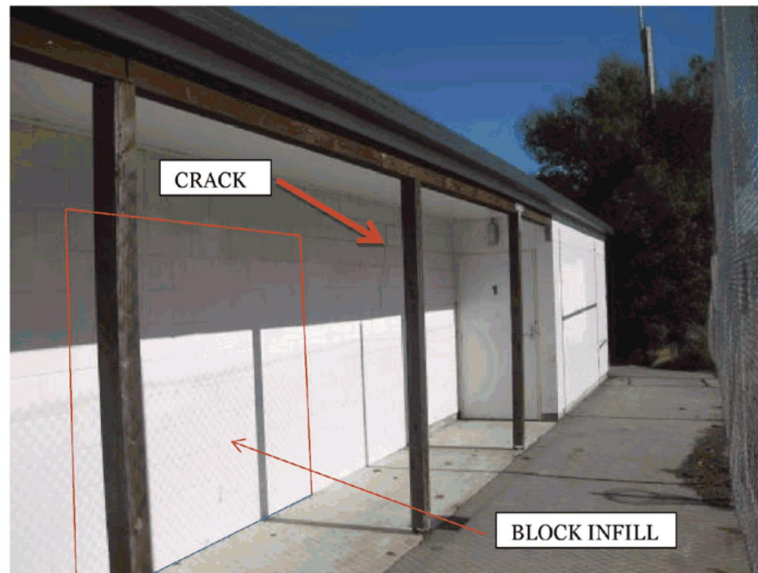
Photo 5: Front wall

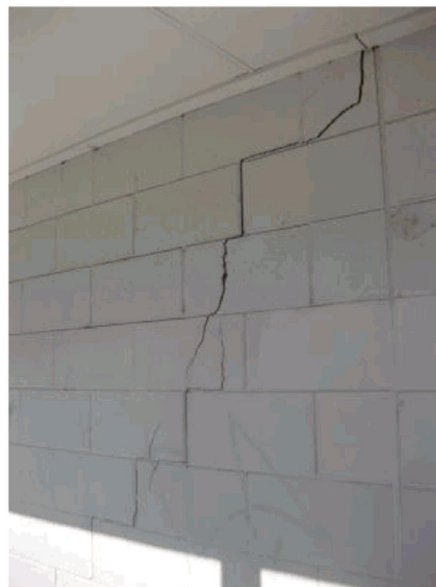
There are moderate wall cracks and opening up of the wall joints in both the front and rear external walls at the joints created by the extensions to the building. The opening of the joint is wider at the top indicating that differential foundation settlement has occurred at the ends of the building.

Photo 6: Crack in the front wall

- (a) Remedial repair work to cracked wall and open wall joints.
- (b) Strengthening works be undertaken to increase the seismic capacity of the building to at least 67%NBS.

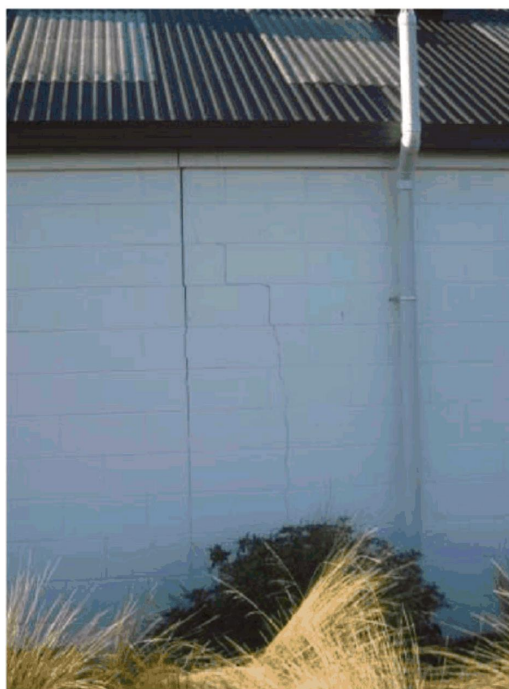
Photo 7: Crack in the rear wall

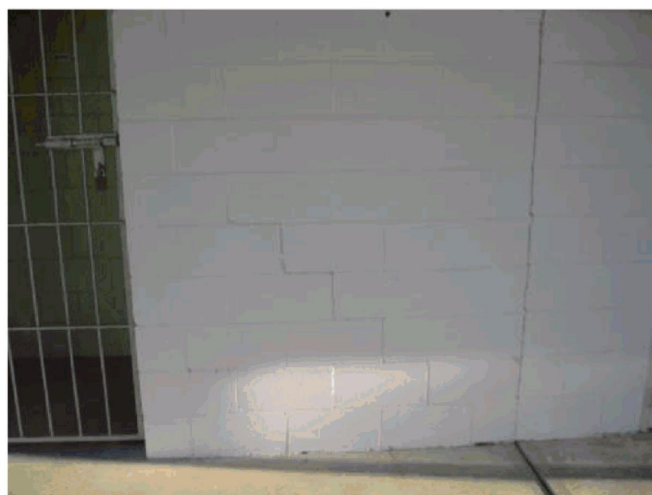
The masonry walls and foundations of the extensions are likely connected to the original building with steel dowels. Building rotation due to foundation settlement and bonding of the dowels is the likely cause of the cracking adjacent these joints. The cracking and opening of the joint has not significantly affected the wall strength and only minor repairs are required.

Photo 8: Diagonal crack in the front wall

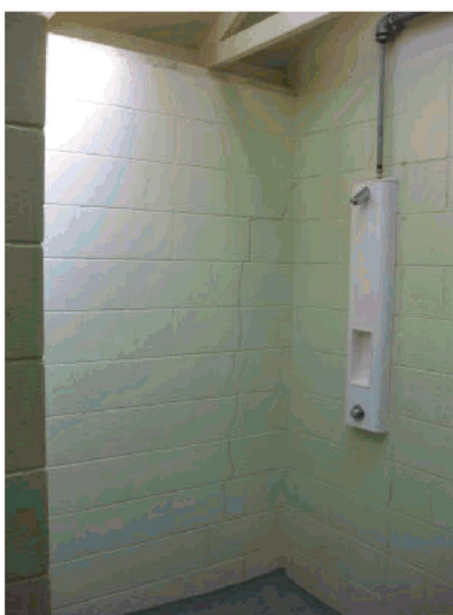
Photo 10: Diagonal crack in the back side wall from inside

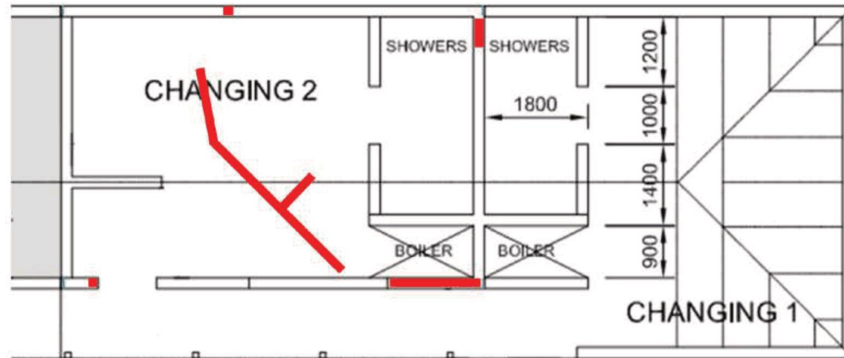
Location of prominent cracks in changing room 1 and 2.

The above figures displays locations of known cracks that require repair in red and locations for new sealant application in blue. Please note that this may not include all cracks throughout the structure and others should be identified by the contractor before work commences as outlined in provided specifications.

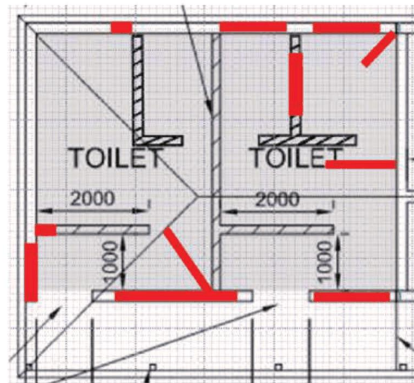
Location of prominent cracks in male and female toilets.
