## HMNZS STEADFAST – LANDSCAPE HISTORY & CONSERVATION REPORT

PREPARED FOR CHRISTCHURCH CITY COUNCIL

JANUARY 2022

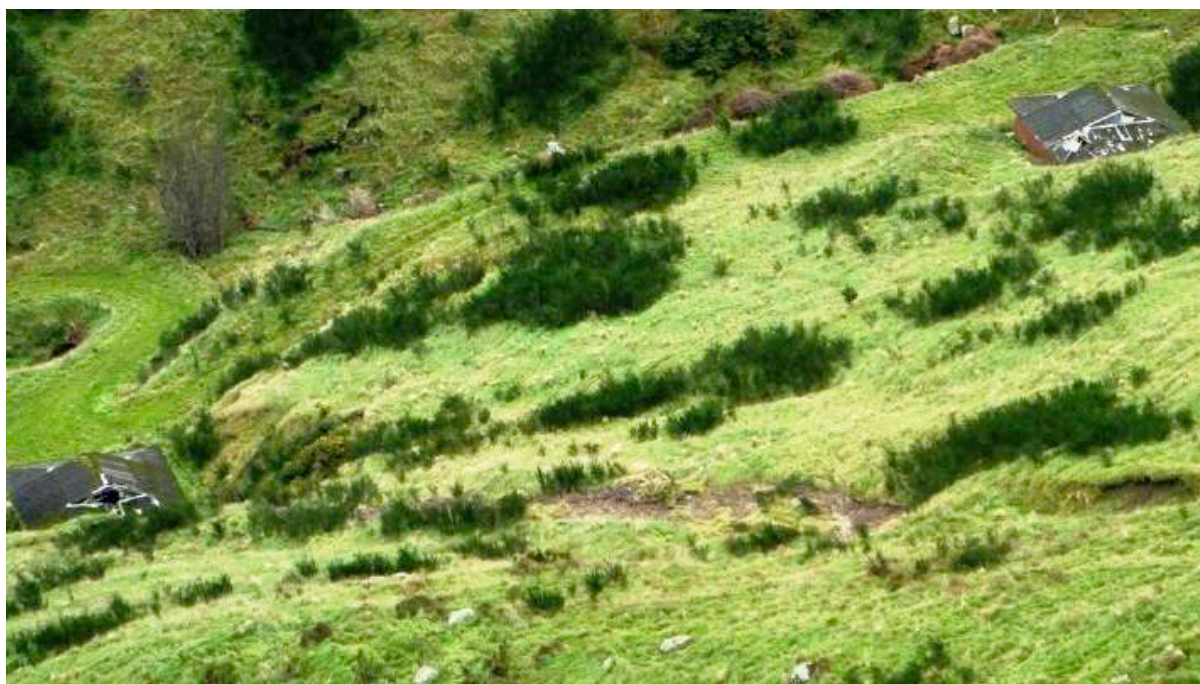
*Figure 56: Rockfall damage to the ammunition stores. Fallen boulders can be seen on the slopes in the foreground and in the valley floor in the background.*

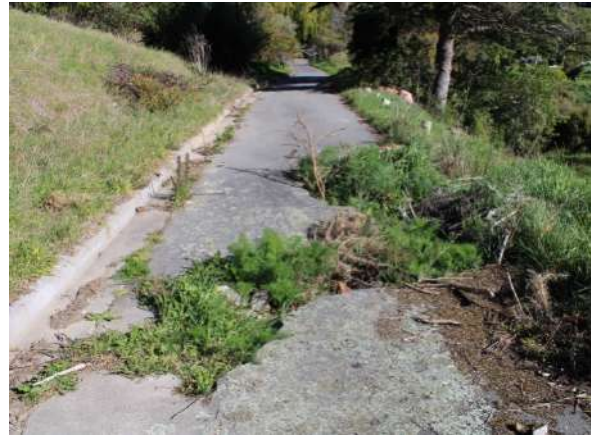
Figure 115: The subdivision road sealing is cracked, broken and overgrown with gorse, grass and weeds.

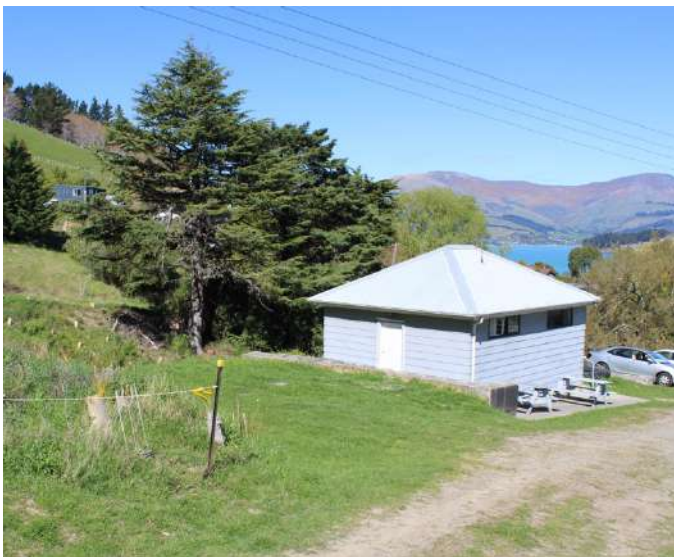
Figure 116: Car park area adjacent to the stream bank was filled some years ago without compaction and is now sinking.

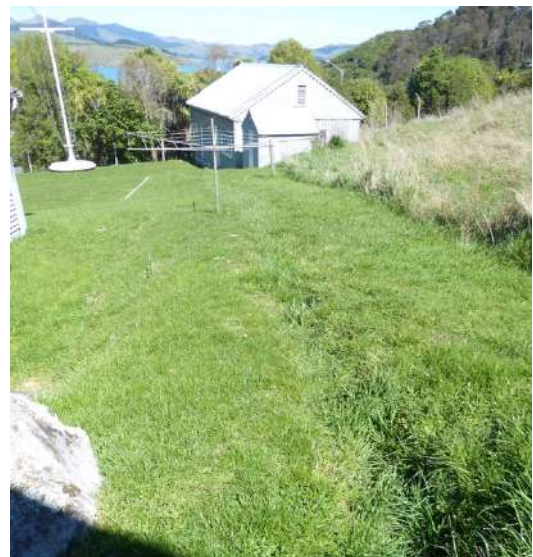
Figure 117: Drainage channels are a trip hazard.

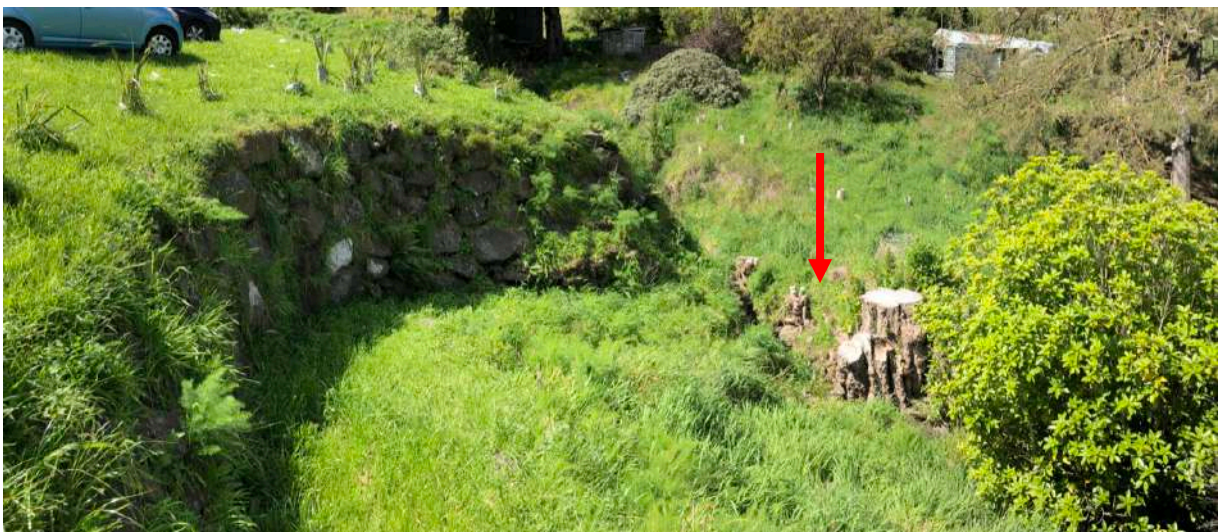
Figure 118: Pedestrian bridge has been removed.

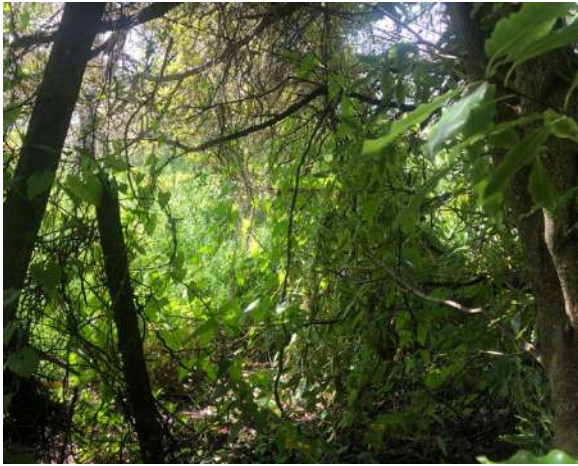
*Figure 119: Damage to Governors Bay Road/front boundary fence. The fence wire appears to have been cut leaving a large hole.*

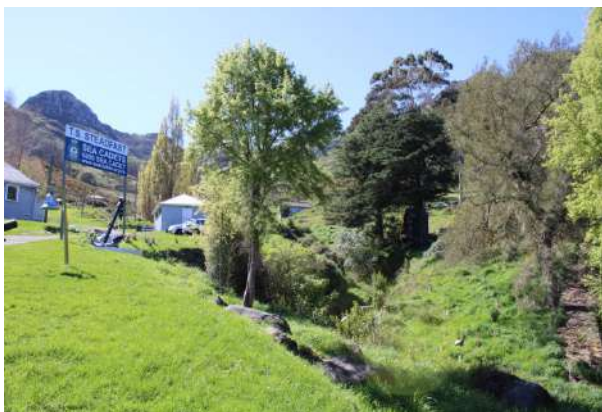
*Figure 127: Original stone terracing, rock garden, steps and pathway are difficult to distinguish in the long grass. Rubbish and large dead branches were also found in this area.*

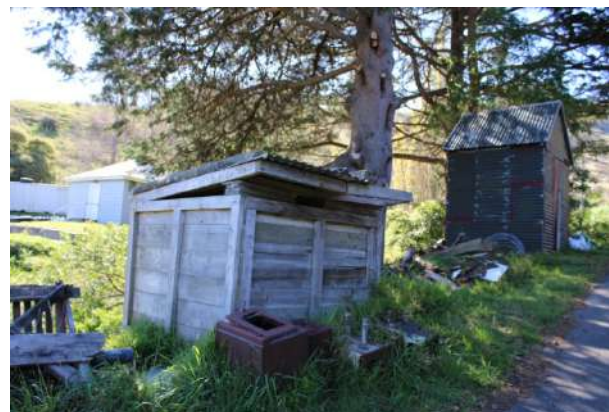
*Figure 128: An informal native plant nursery west of the road contains a dilapidated shed with boxes and rubbish strewn along the stream bank.*

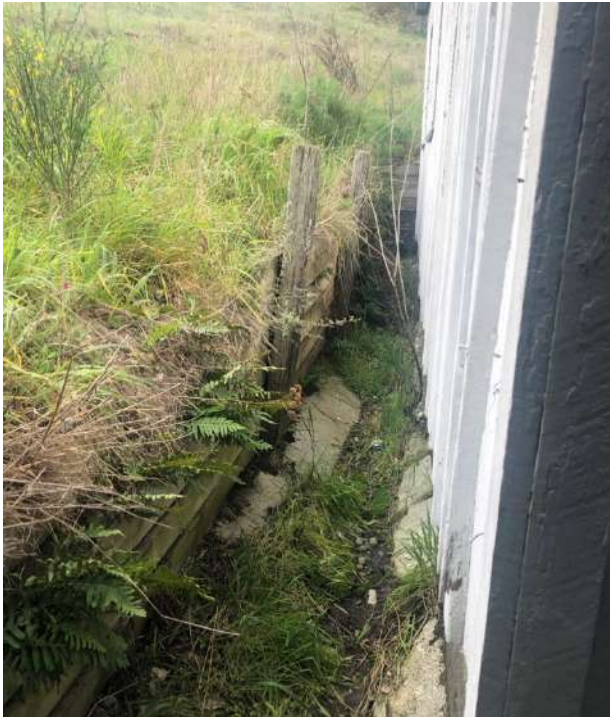
*Figure 135: Behind the Garage - deteriorating retaining wall.*

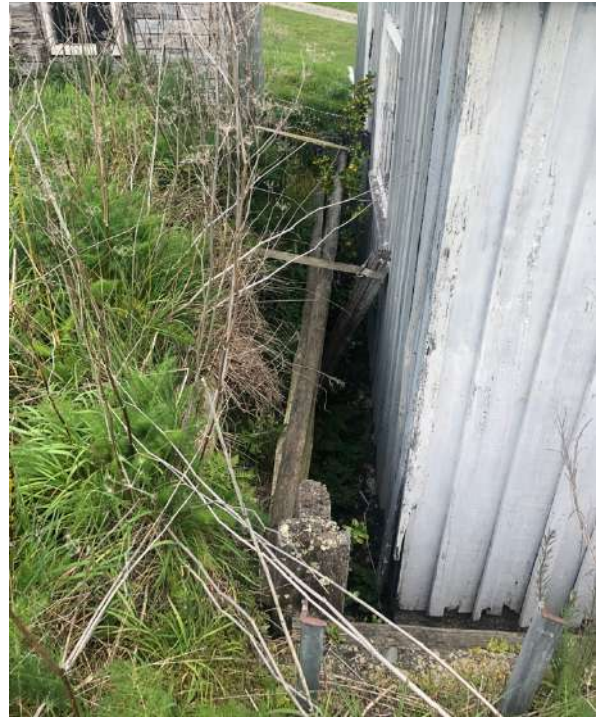
*Figure 136: Retaining wall between the Garage and Small Store is falling apart.*

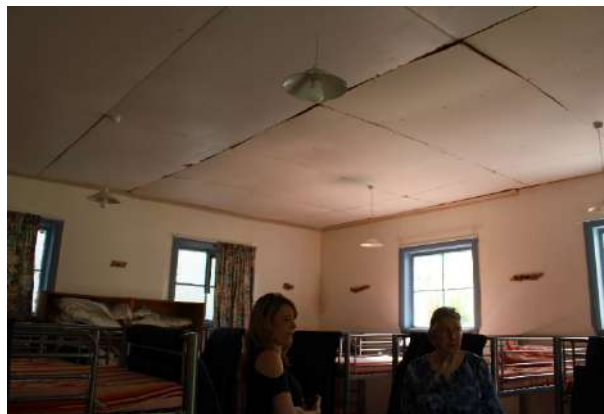
Figure 144: Suspended ceiling tiles failing.

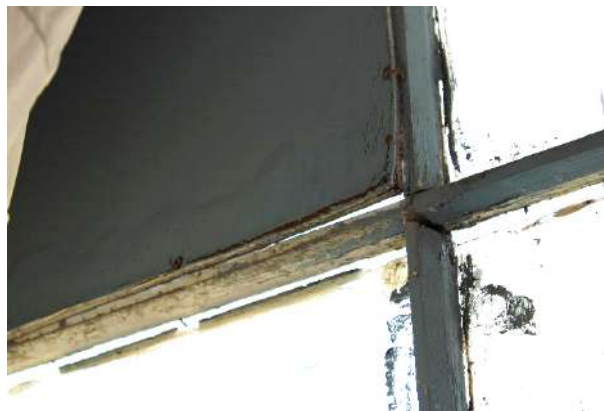
Figure 146: Window glazing bars failing and boarded over in some areas.

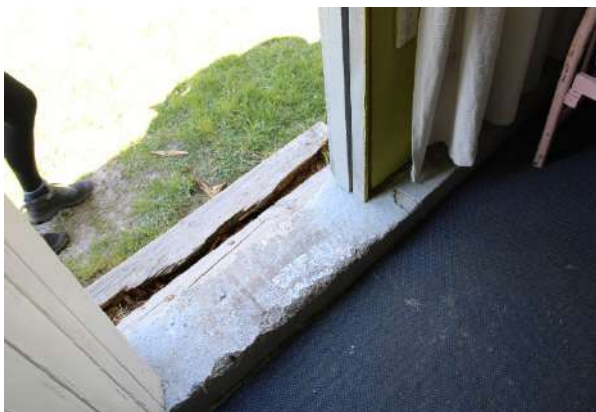
Figure 147: Entranceway with timber planks in the place of stairs.

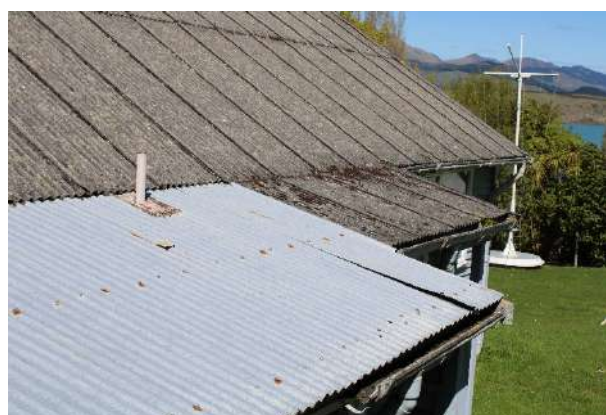
Figure 157: Severely deteriorated roof cladding.

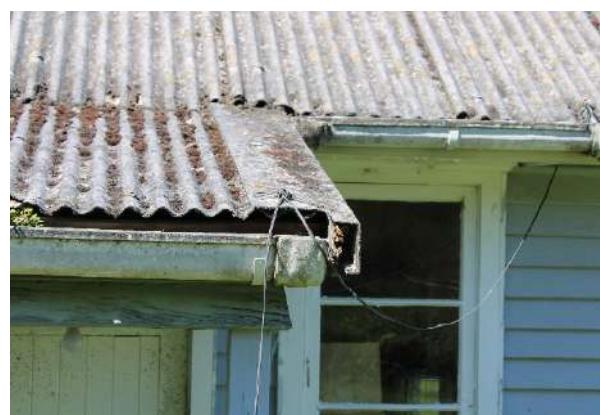
Figure 158: Severely deteriorated roof cladding.

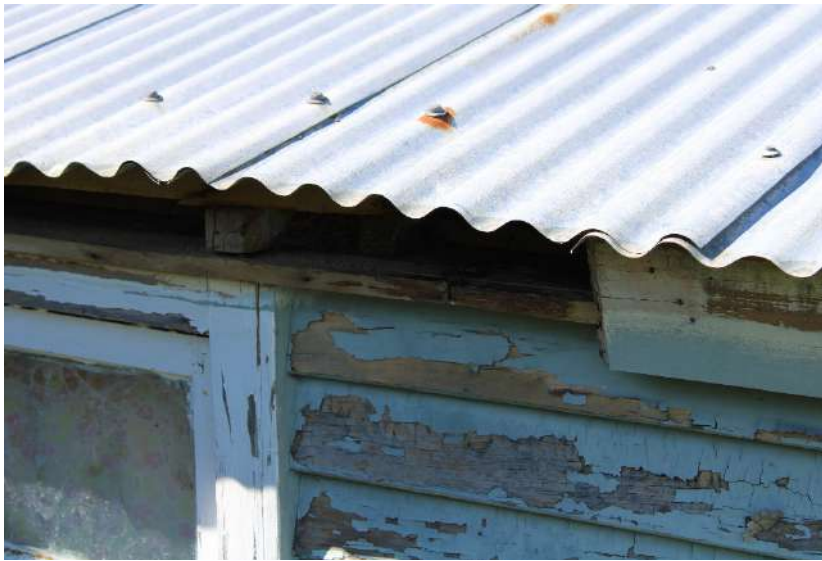
Figure 159: Paint flaking exposing timber underneath to elements.

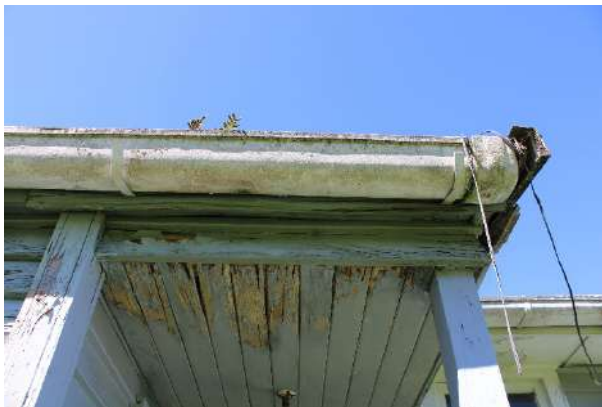
Figure 161: Rotten timber and failing guttering.

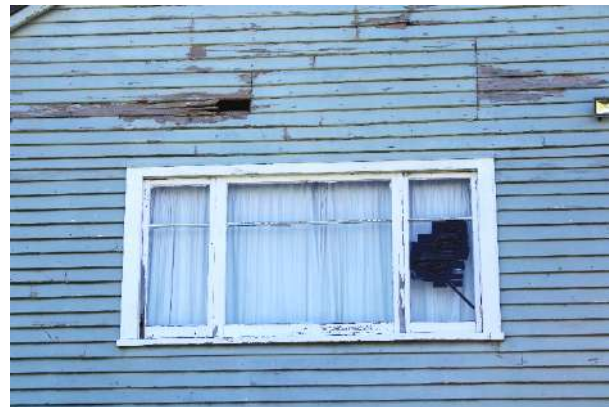
Figure 162: Missing timber allowing moisture to enter the building and broken window.

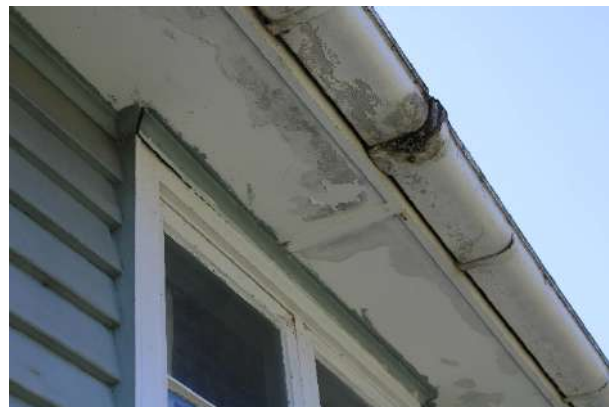
Figure 164: Failing guttering and subsequent water damage to soffit.

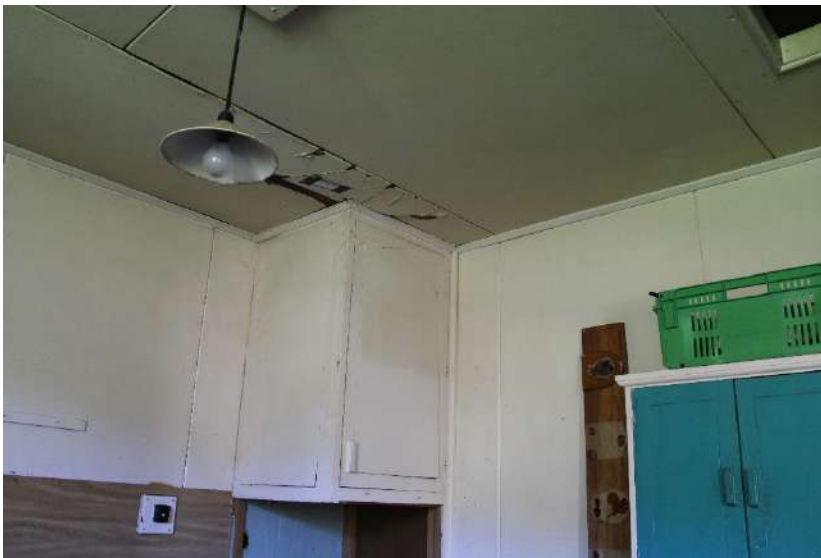
Figure 167: Kitchen space with failing ceiling linings.

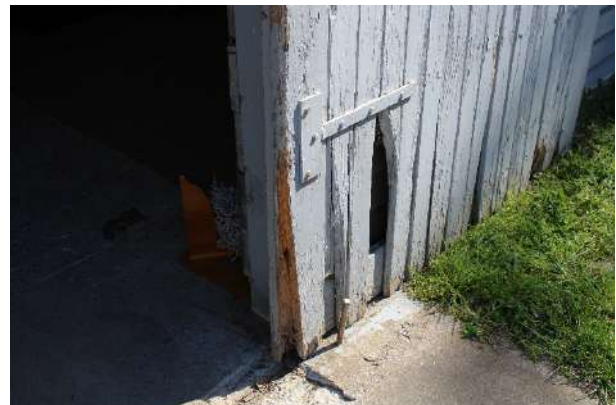
*Figure 171: Damage to Drill Hall sliding doors.*

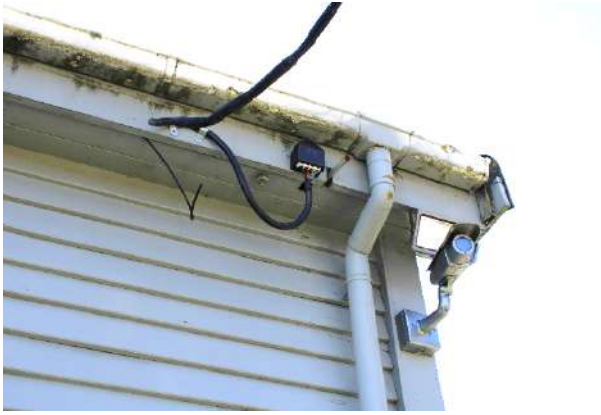
Figure 172: Microbiological growth to guttering.

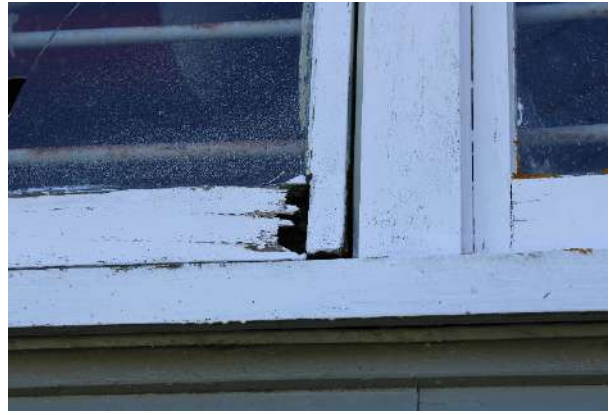
Figure 173: Damage to timber window frames.

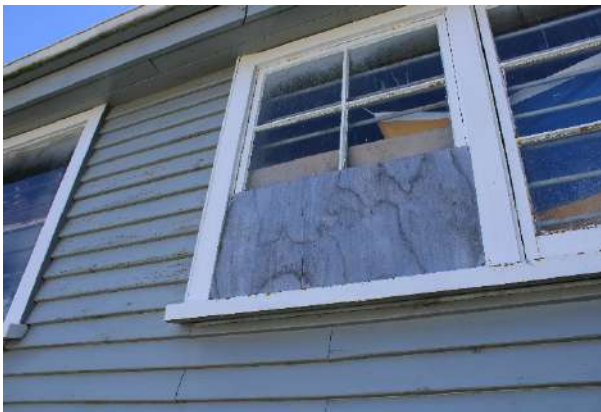
Figure 174: Damage to windows.

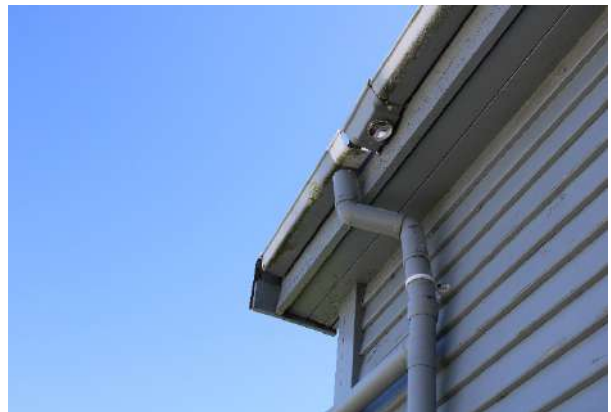
Figure 175: Failing guttering and downpipes.

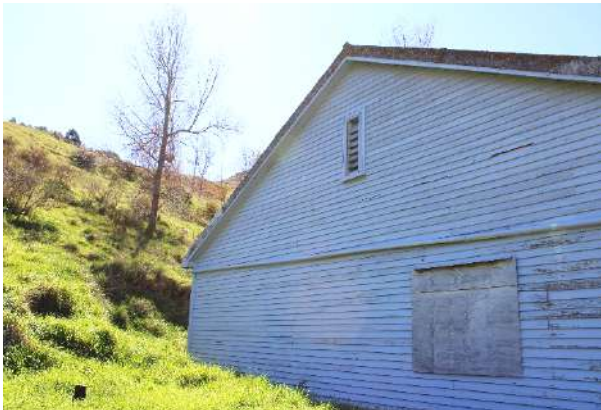
Figure 176: Severely damaged bargeboards, flaking paint exposing timber beneath, plywood covering hole in the building.

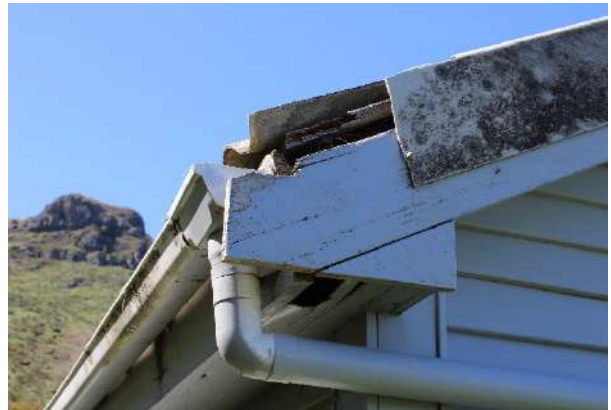
Figure 177: Damaged bargeboards and roof cladding, rotten timber below.

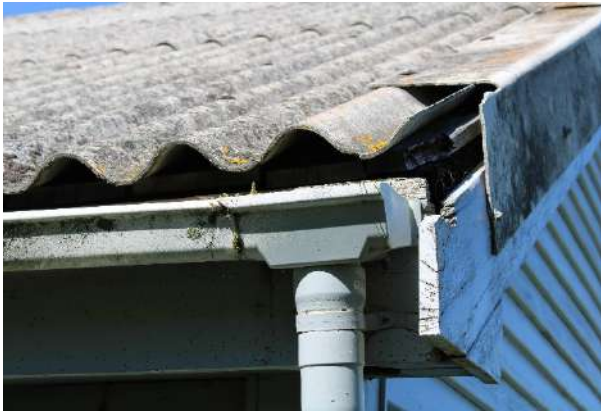
Figure 178: Severely deteriorated roof cladding.

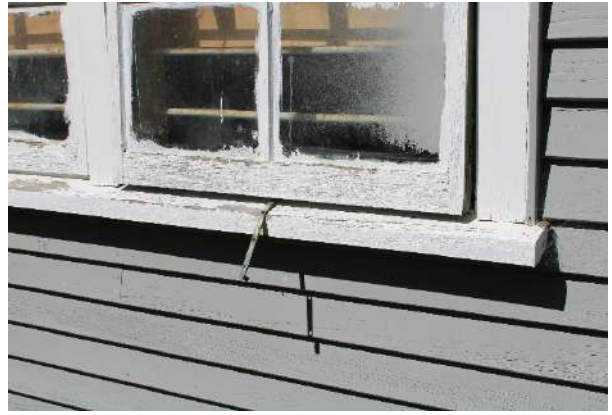
Figure 179: Damaged timber window frames.

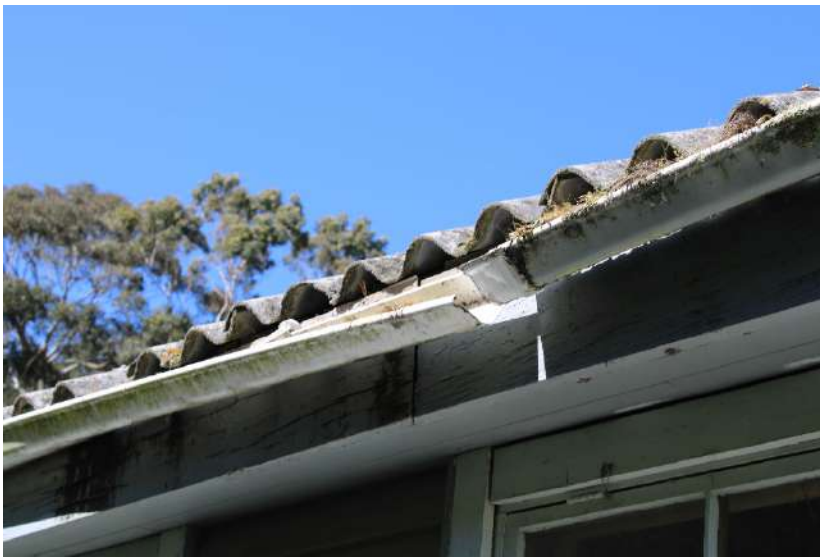
Figure 180: Failing guttering.

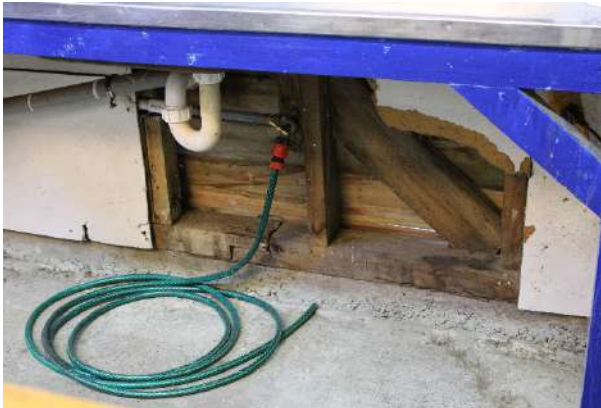
Figure 188: Exposed framing where internal linings have failed.

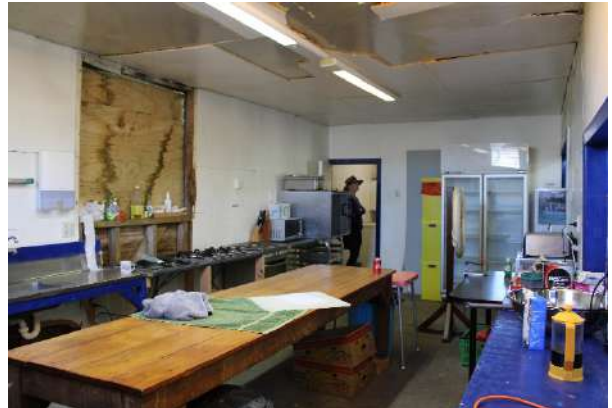
Figure 189: Kitchen with exposed concrete floor, failing ceiling linings, and external hole covered with plywood.

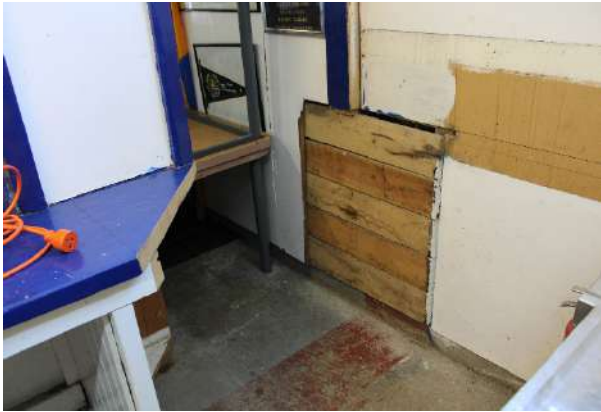
Figure 190: Covered hole in wall compromising weathertightness to building.

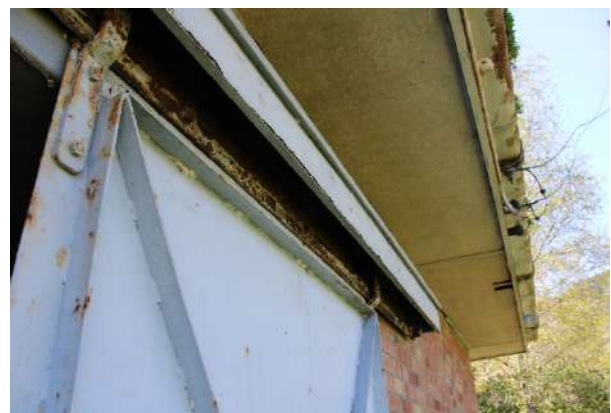
Figure 201: Corrosion to steel sliding doors.

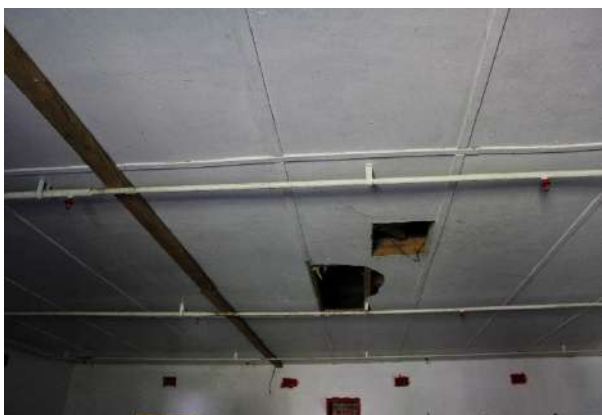
Figure 202: Failing internal linings.

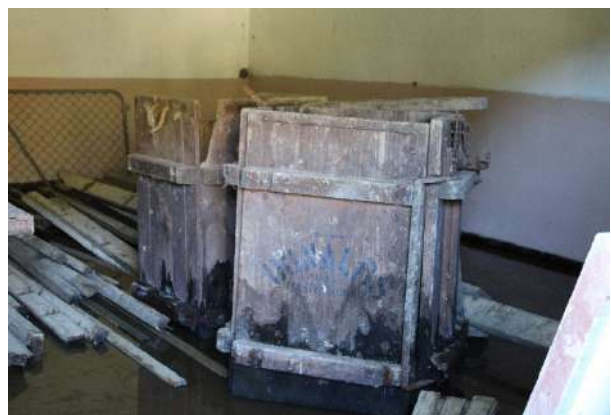
Figure 203: Internal flooding.

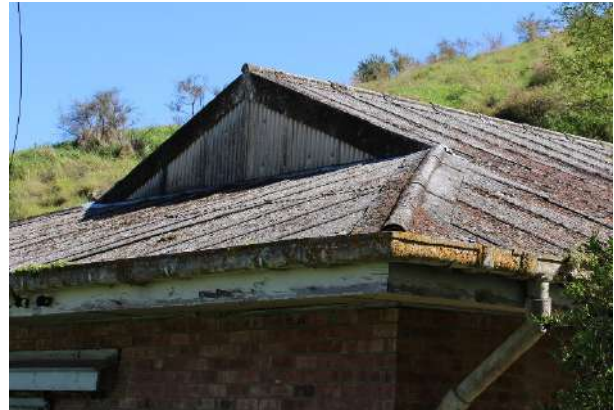
Figure 205: Severely deteriorated roof cladding and damage to guttering.

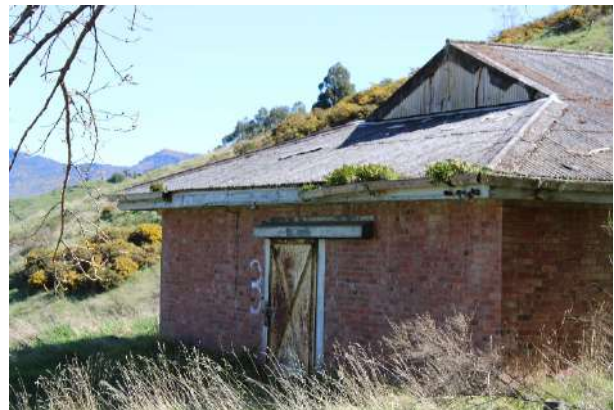
Figure 207: Biological growth to guttering.

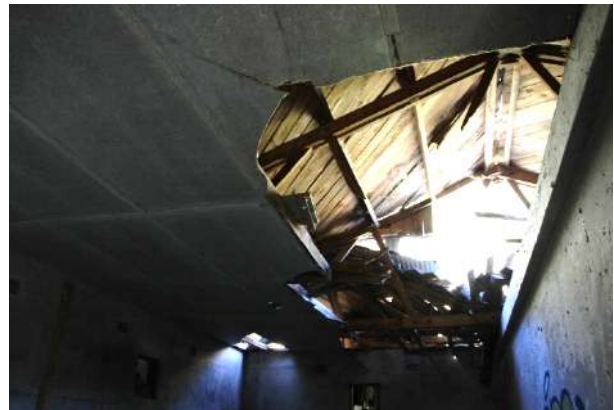
Figure 209: Roof penetration caused by rockslide.

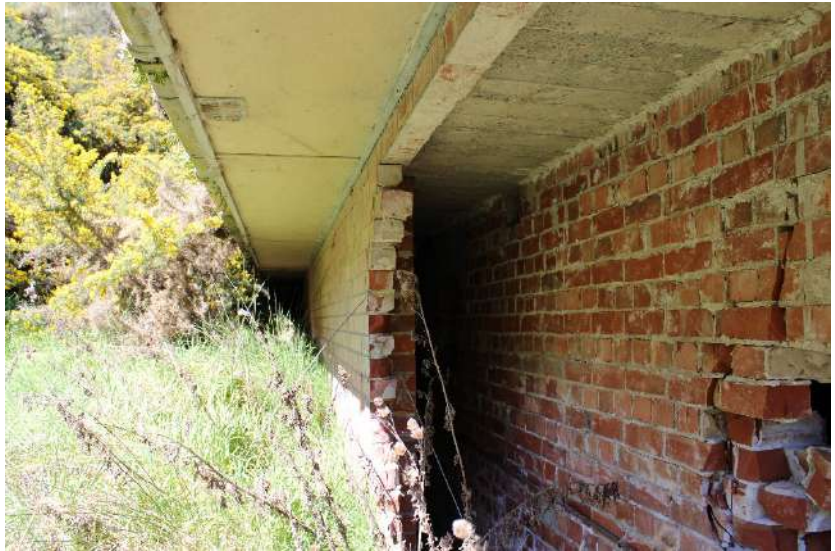
Figure 211: External damage to double layer brick wall caused by rockslide.

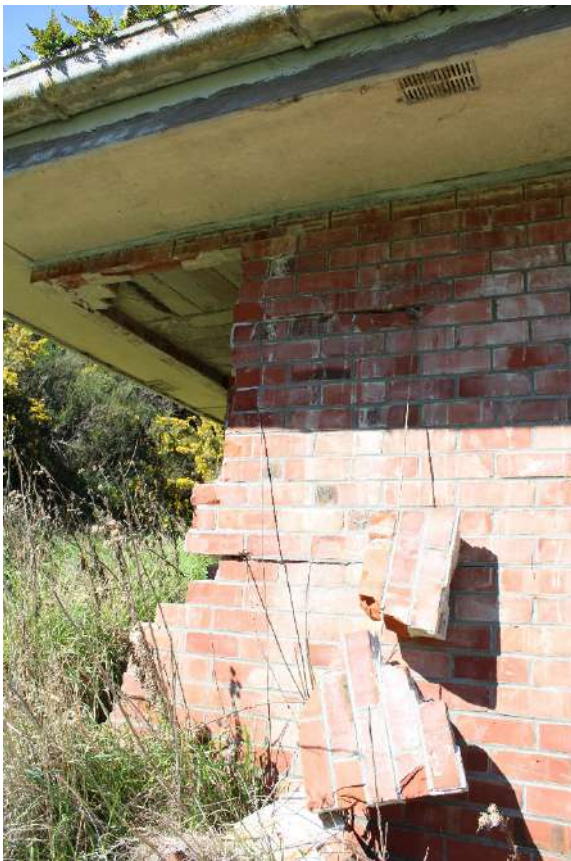
Figure 212: Damage to brick wall exterior.

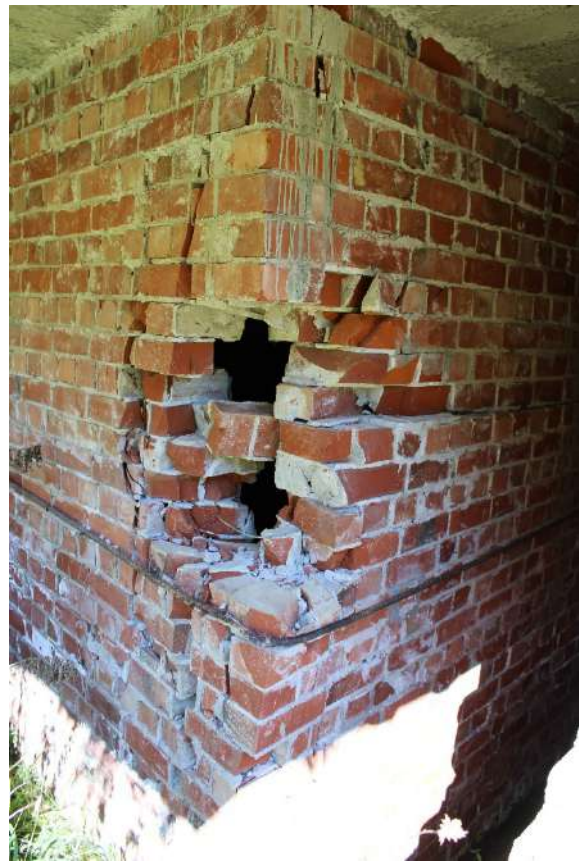
Figure 213: Damage to brick wall exterior.

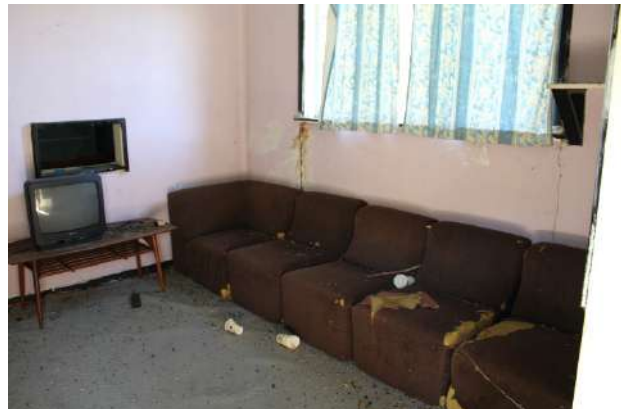
*Figure 227: Interior of laboratory building showing severe pigeon infestation and failing wall/floor/ceiling linings.*

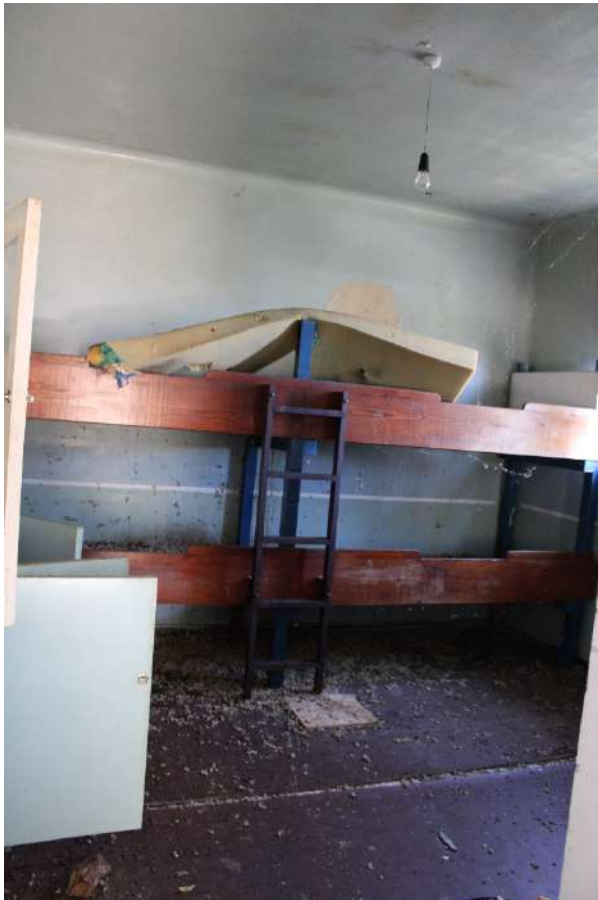
Figure 228: Pigeon infestation to interior.

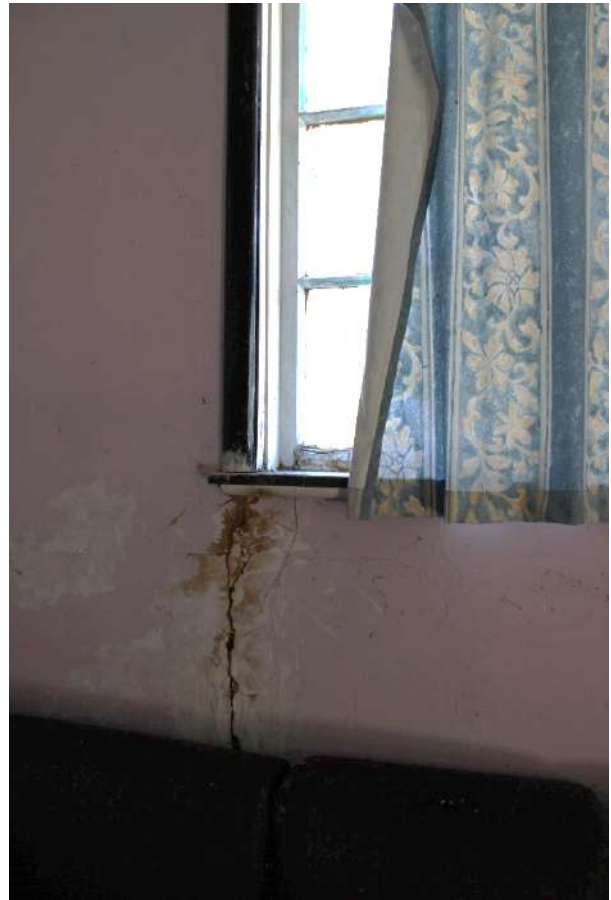
Figure 229: Severe wall cracking and window damage.
