**Christchurch City Council**  
**ATTACHMENTS - UNDER SEPARATE COVER**

<b>TABLE OF CONTENTS NGĀ IHIRANGI</b>	<b>PAGE</b>
<b>10. Yaldhurst Memorial Hall - Future Use Issues and Options</b>	
A. FCEL Engineering Report and Repair Concepts.....	3
B. OPUS / THC Structural Reports .....	33
C. Cost Estimate - WTP.....	67
D. YRRA EOI Information .....	85
E. Statement of Significance .....	110
F. Factors to Consider When Dealing Unilaterally .....	116

**ADDRESS:** 524 Pound Road, Yaldhurst  
Christchurch 7676

**TITLE:** Detailed Seismic Assessment (DSA)

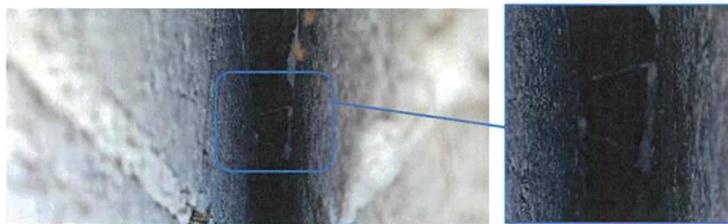
Figure 9 - Veneer ties observed intact during FCEL inspection

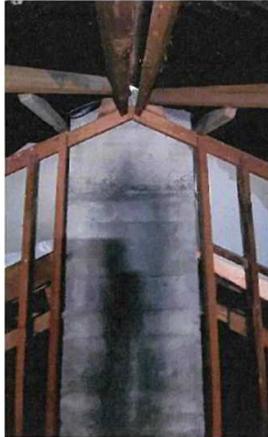
The chimney is formed using in situ reinforced concrete, the concrete forms the four sides of the chimney flue, with an opening to one side at the base of the flue which forms the fireplace. The chimney is supported on a reinforced concrete base. Given the central location of the chimney within the structure, it appears to be well supported from all sides by the surrounding structures, details on the drawing showed that cleats were intended to attach the chimney to the timber structure, however, these cleats were not observed on site, given the lack of ties and the difference in stiffness between the chimney and the framing it appears that the chimney is cantilevering about the base in both directions, although some load will be transferred via compression into the roof framing and bracing. This mechanism for support is considered an unreliable load path.

Figure 15 - As constructed chimney structure, tie back not observed.

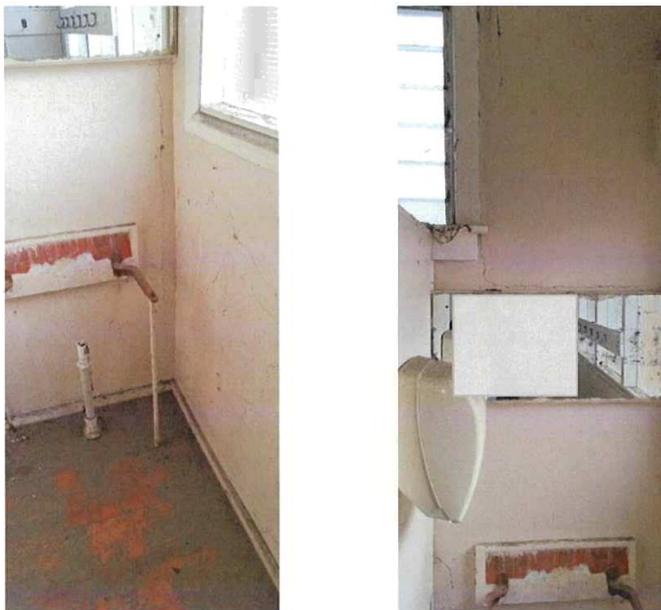
Cracking and movement at the interface of the perpendicular reinforced concrete framed walls. The cracking patterns are consistent with seismic loading and as can be seen in the annotated photo in Figure 17, the load path of the mid height beam of the end wall applies large levels of loading at a location that does not align with the rigid infill panels nor the reinforced concrete bounding frame of the side walls.

Figure 16 - Damage to walls in Male WC

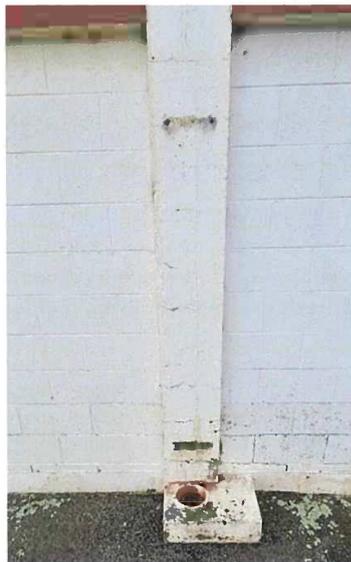
Minor flexural cracking to the reinforced concrete columns at the base was observed, this is consistent with the damage that would be expected due to earthquake loading.

Figure 18 - Flexural cracking to concrete cantilevered posts

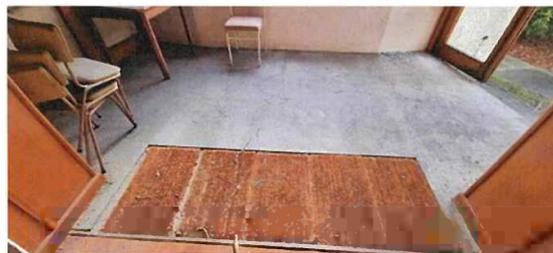
Cracking was observed to the concrete slab at the entry foyer. This is considered likely to be shrinkage cracking given the location of the cracking and appears unrelated to seismic movements.

*Figure 20 - Cracking to entry lobby slab*

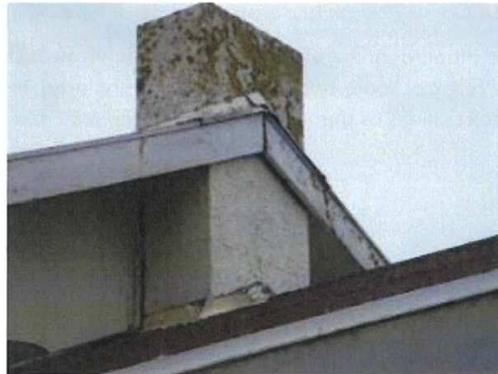
Chimney damage could not be observed during the FCEL inspection, however, it was observed by Opus in 2012 and appears to show significant damage to the chimney. As this was not observed internally by FCEL, this damage appears to be to the render and due to movements of the surrounding roofing. This has since been covered to prevent roof leaks.

Figure 21 - Chimney damage from 2012 (Extracted from the Opus Report)

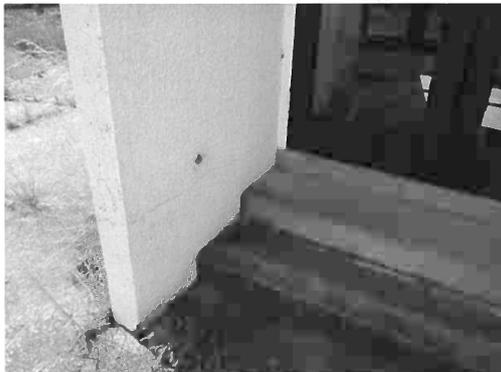
11. Wing wall at Entrance (North/West Elevation) - Horizontal cracking

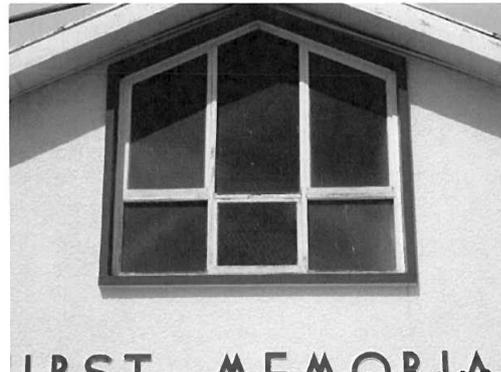
12. North Elevation – Vertical Cracks either side columns of concrete frame

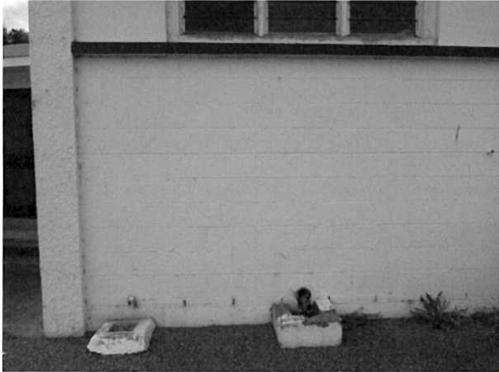
13. West Elevation – Stepped Cracks in blockwork

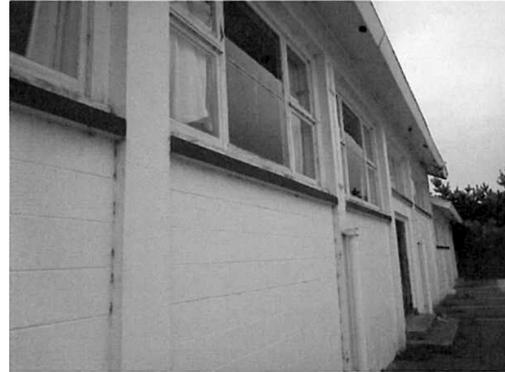
14. West Elevation – separation cracks between columns and masonry panels

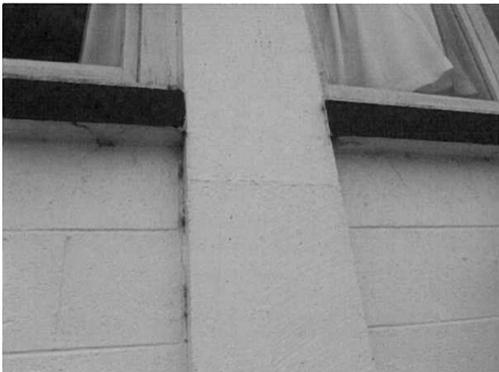
15. West Elevation – Horizontal cracks to columns at construction joint locations below windows

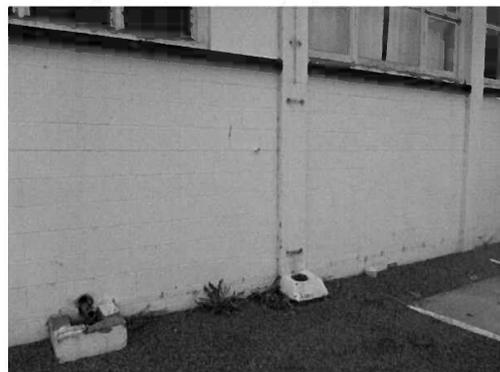
16. West Elevation – stepped cracks in masonry panels

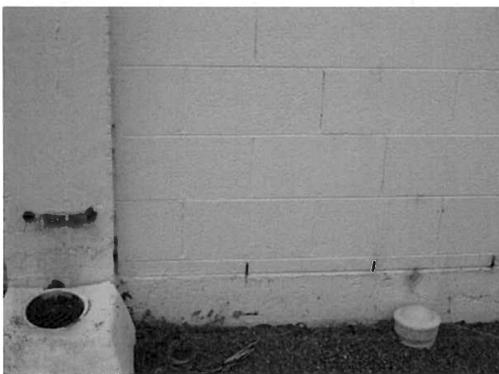
17. West Elevation - Stepped cracking in masonry wall panel

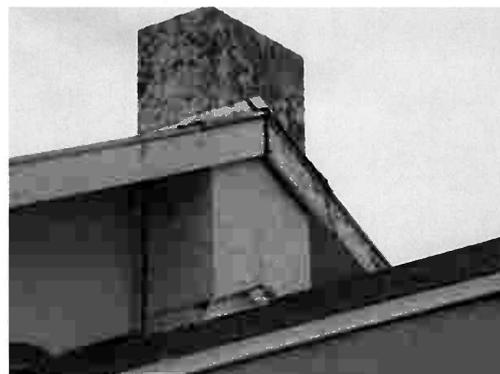
18. Chimney damage

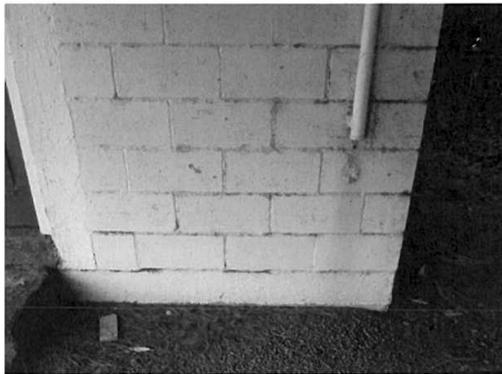
19. West Elevation – south corner – stepped crack in masonry

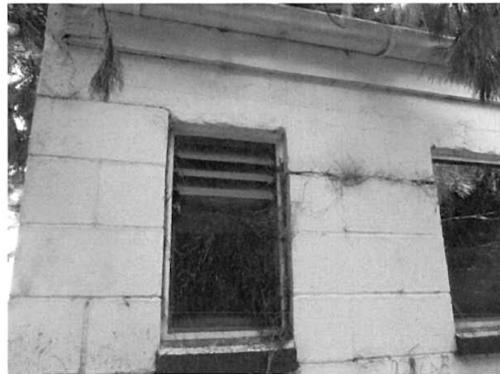
20. South Elevation – Horizontal cracks in masonry at lintel height
