**Christchurch City Council**  
**ATTACHMENTS - UNDER SEPARATE COVER**

<b>TABLE OF CONTENTS NGĀ IHIRANGI</b>	<b>PAGE</b>
<b>10. Yaldhurst Memorial Hall - Future Use Issues and Options</b>	
A. FCEL Engineering Report and Repair Concepts.....	3
B. OPUS / THC Structural Reports .....	33
C. Cost Estimate - WTP.....	67
D. YRRA EOI Information .....	85
E. Statement of Significance .....	110
F. Factors to Consider When Dealing Unilaterally .....	116

**ADDRESS:** 524 Pound Road, Yaldhurst  
Christchurch 7676

**TITLE:** Detailed Seismic Assessment (DSA)

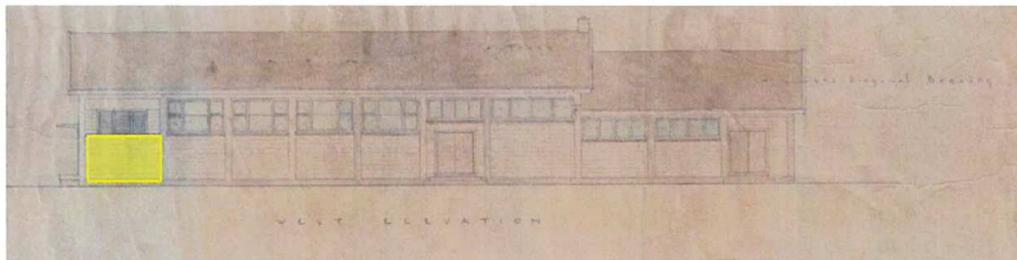
Figure 3 - Original west elevation (typical URM panel highlighted in yellow)

In the longitudinal direction the lateral load resisting system is provided by the reinforced concrete frame with the infill URM panels. Where high level windows are present, the longitudinal load is required to transfer in bending through the short columns between the top of the URM and the roof as shown in Figure 3 and Figure 4.

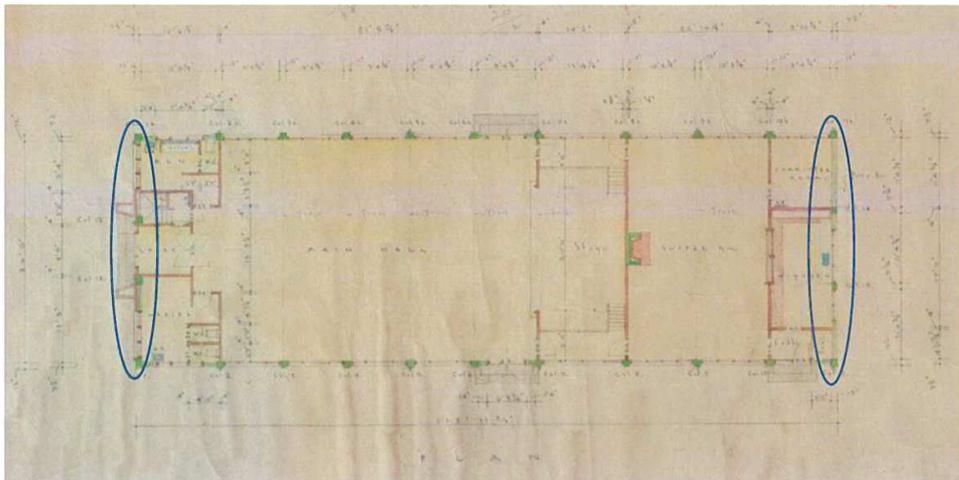
*Figure 5 - Floor plan with end walls circled*

The concrete and URM end walls are braced in the longitudinal direction using a combination of cantilevered footings (similar to that of the side walls in the transverse direction) for out of plane loads and load spanning horizontally into the side walls via the reinforced concrete bond beams at the head of the wall panels.

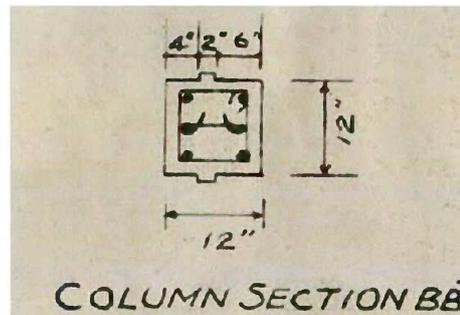
Figure 10 - Corbel detail on cantilevered columns

using a corbel detail as shown in Figure 10 and below. These details mechanically secure the masonry to the bounding frame and allow "arching" of the URM to begin as noted in section C7.6 of the MBIE Guidance. The reinforced concrete windowsill beams are not considered to provide any contribution to the panel or this arching action.

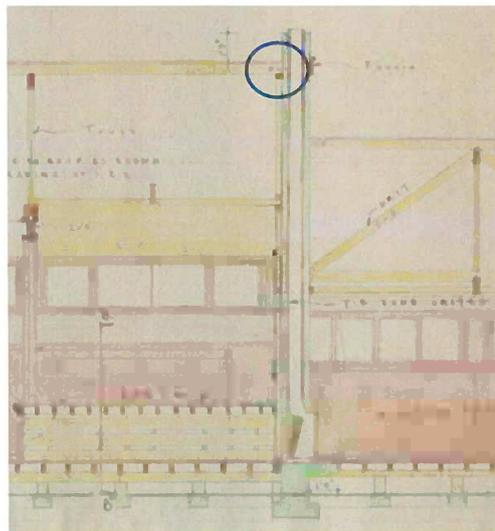
Figure 14 - Original detail of the chimney structure, proposed tie back circled

The chimney is formed using in situ reinforced concrete, the concrete forms the four sides of the chimney flue, with an opening to one side at the base of the flue which forms the fireplace. The chimney is supported on a reinforced concrete base. Given the central location of the chimney within the structure, it appears to be well supported from all sides by the surrounding structures, details on the drawing showed that cleats were intended to attach the chimney to the timber structure, however, these cleats were not observed on site, given the lack of ties and the difference in stiffness between the chimney and the framing it appears that the chimney is cantilevering about the base in both directions, although some load will be transferred via compression into the roof framing and bracing. This mechanism for support is considered an unreliable load path.

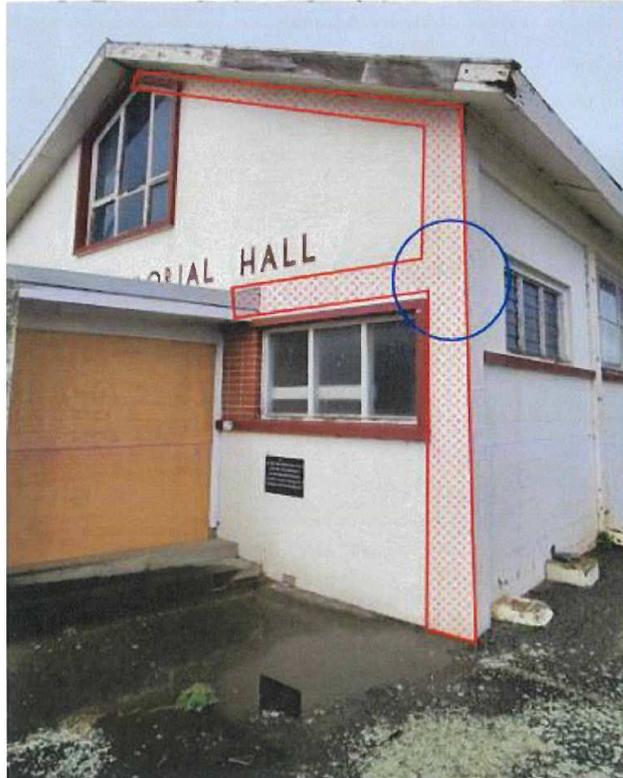
Figure 17 - End wall with bounding frame overmarked

Cracking and movement at the interface of the perpendicular reinforced concrete framed walls. The cracking patterns are consistent with seismic loading and as can be seen in the annotated photo in Figure 17, the load path of the mid height beam of the end wall applies large levels of loading at a location that does not align with the rigid infill panels nor the reinforced concrete bounding frame of the side walls.
