Waihoru
Spreydon-Cashmere-Heathcote Community Board
ATTACHMENTS - UNDER SEPARATE COVER

| TABLE OF CONTENTS NGĀ IHIRANGI | PAGE |
|---|---|
| C. South Library Memo for Concept Temporary Strengthening 67%NBS IL3 - Life Safety..... | 3 |

| Subject | Christchurch South Library - Temporary Strengthening 67%NBS |

Christchurch South Library – Proposed Concept Strengthening Scheme
67% NBS IL3 (Life Safety)

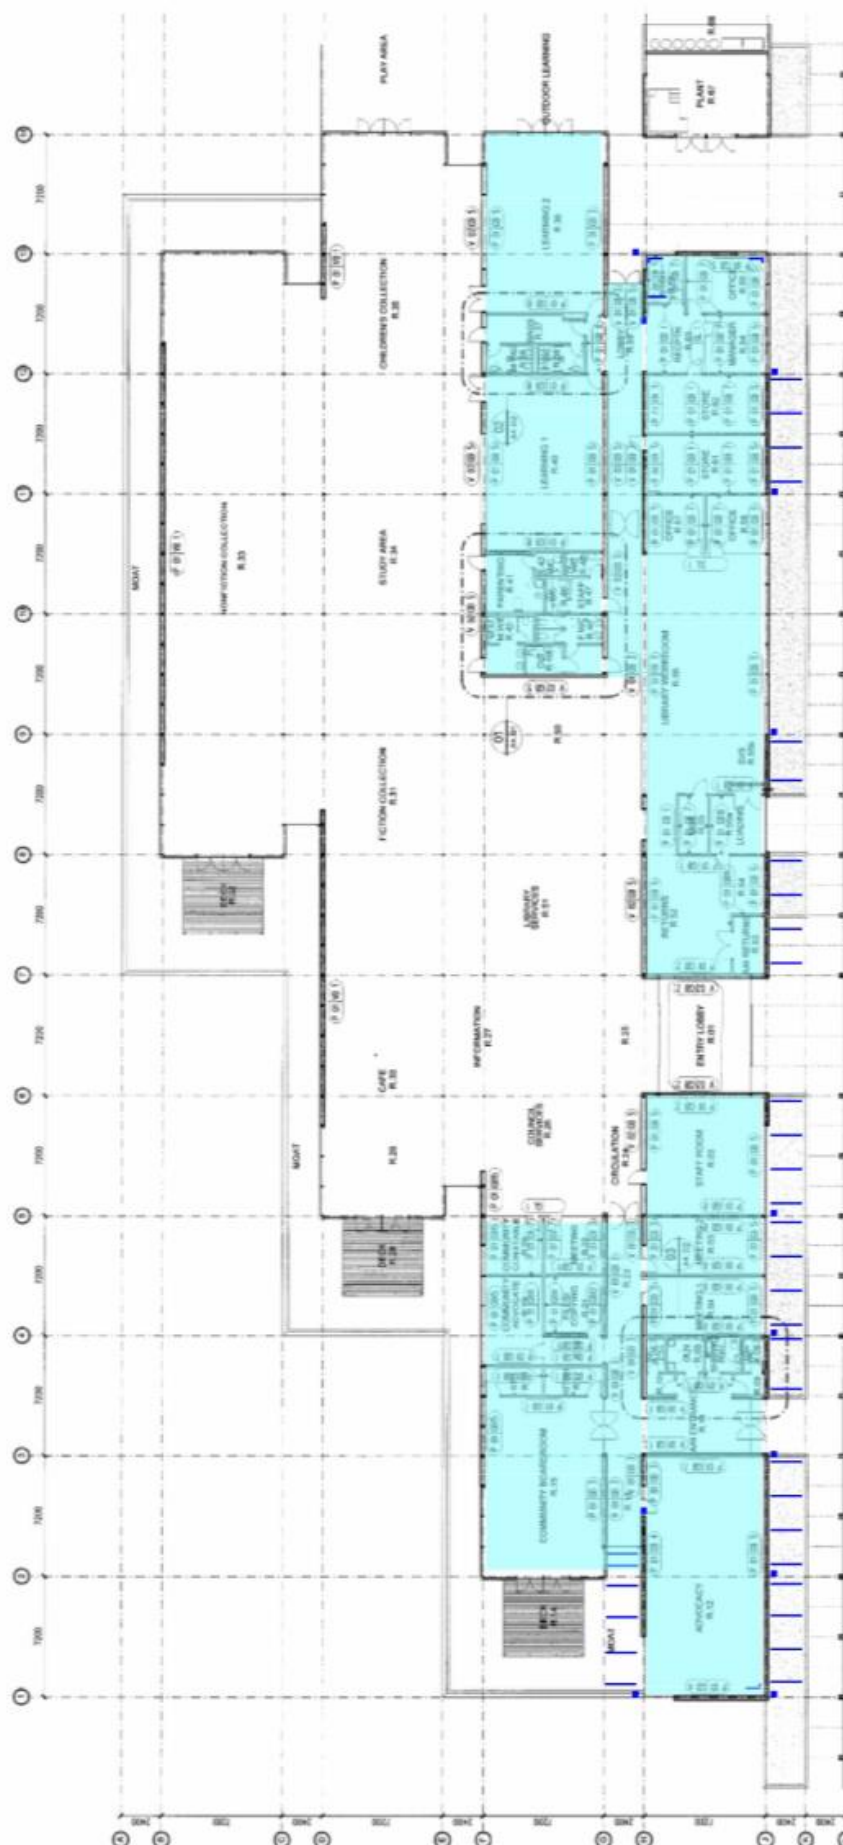
Christchurch South Library - Risk Zone Map **Current Status 34% NBS (IL3) with 2012 Temporary Strengthening**

The building is currently 34%NBS which is governed by parts of the building that were not previously strengthened when the temporary strengthening was implemented in 2012. The capacity is based on strength for life safety of occupants only and it is likely that damage to the building may occur at lower levels of seismic loading. The appended "Risk Zone Map" (refer Appendix 1) highlights areas of the building where elements of the structure currently achieve a capacity greater than 34%NBS in general due to the previous strengthening. The areas not highlighted are those where further strengthening would be required to achieve a higher building capacity.

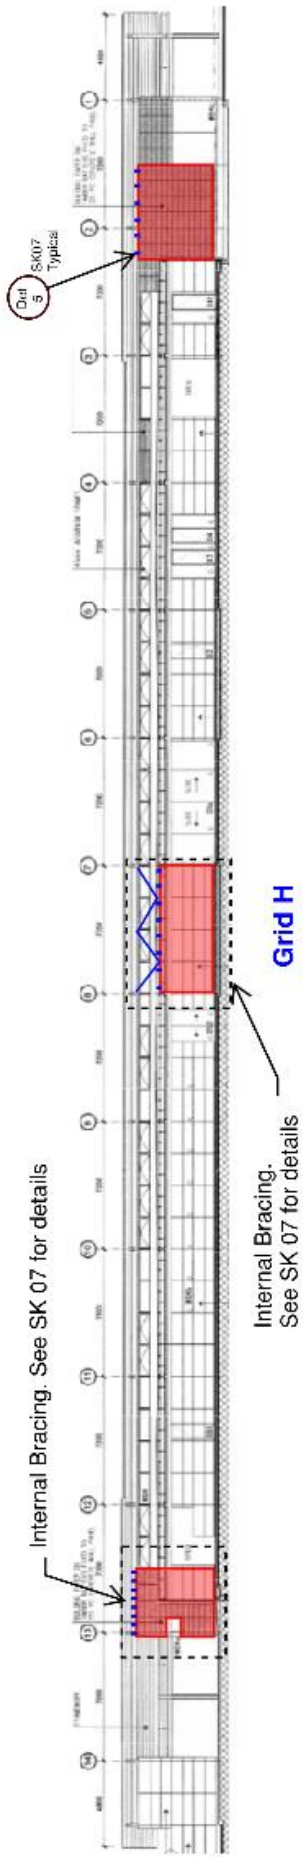
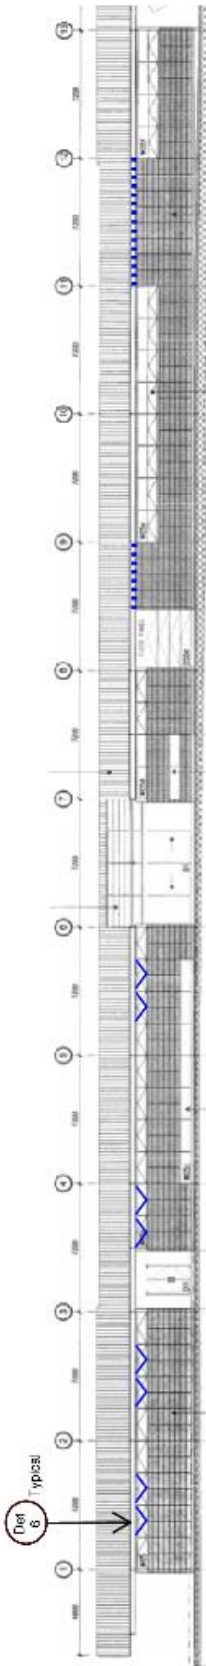
| DESCRIPTION: Proposed Concept Strengthening Scheme 67%NBS IL3 (Life Safety) | | START PAGE No. / REVISION BY: | | SK02 / REV 1 | |

Grid J - View from South

External bracing required as indicated on 6-DP536.00-SK01, SK02, SK03 and detailed on 6-DP536.00-SK07. Example architectural scope is outlined on drawing A-SK01 and Figure 1 on A-SK04.

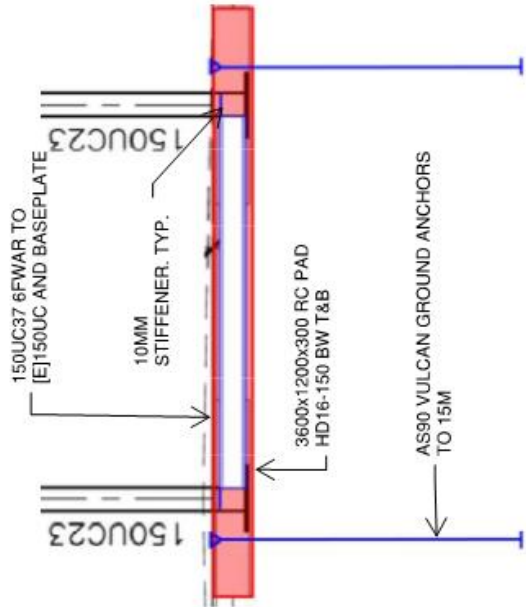
DETAIL 9
NTS

- PROPOSED METHOD OF CONSTRUCTION**
1. REMOVED EXISTING PAD FOUND & CUT BACK SLAB.
 2. INSTALL NEW 150UC37 BASE BEAM
 3. INSERT GROUND ANCHOR RODS
 4. CAST RC PAD
 5. COMPLETE INSTALLATION OF GROUND ANCHORS

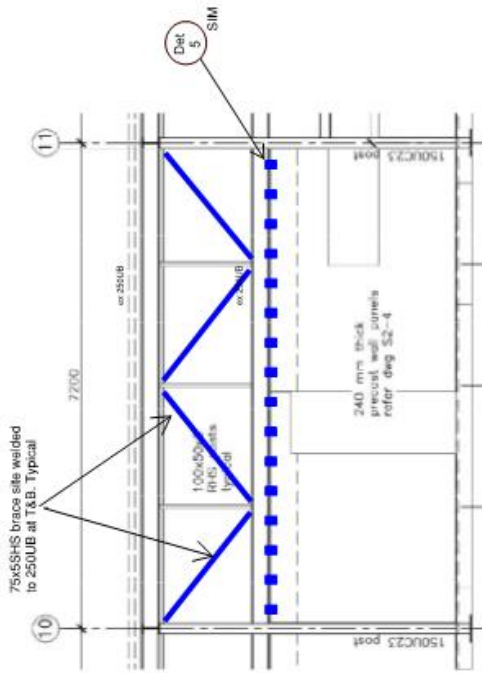
Internal Bracing Elevation (Grid F shown)

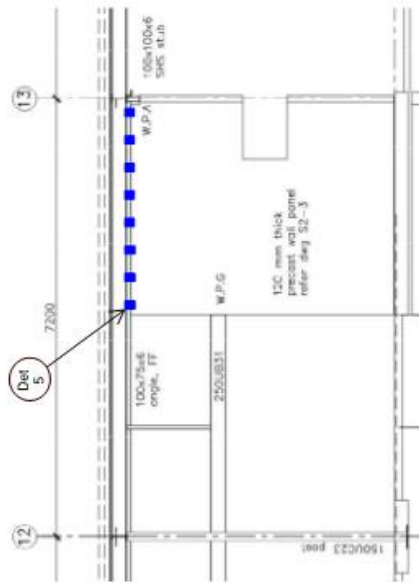
Internal Bracing Elevation (Grid H shown)

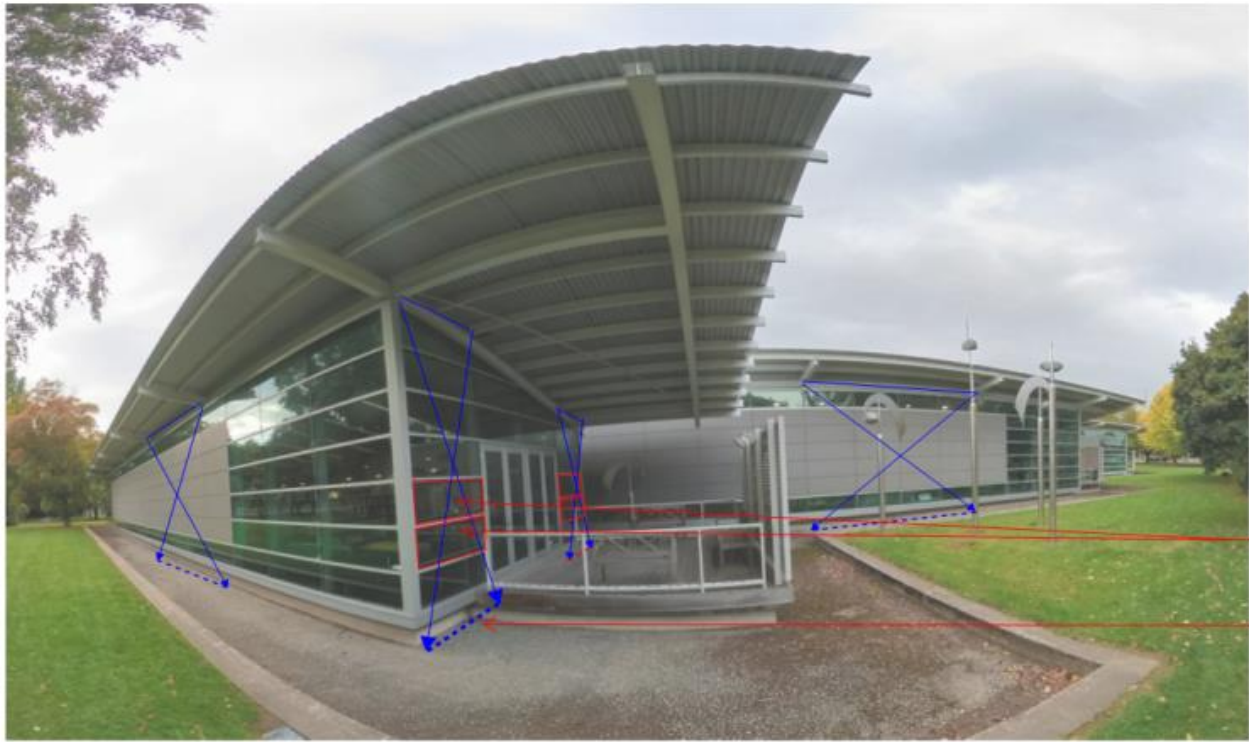
FIGURE 1

Operable glazing impeded by bracing in multiple locations.

Deck to be removed and reinstated for access to ground beam works. Extent of deck reduced by extent of bracing.

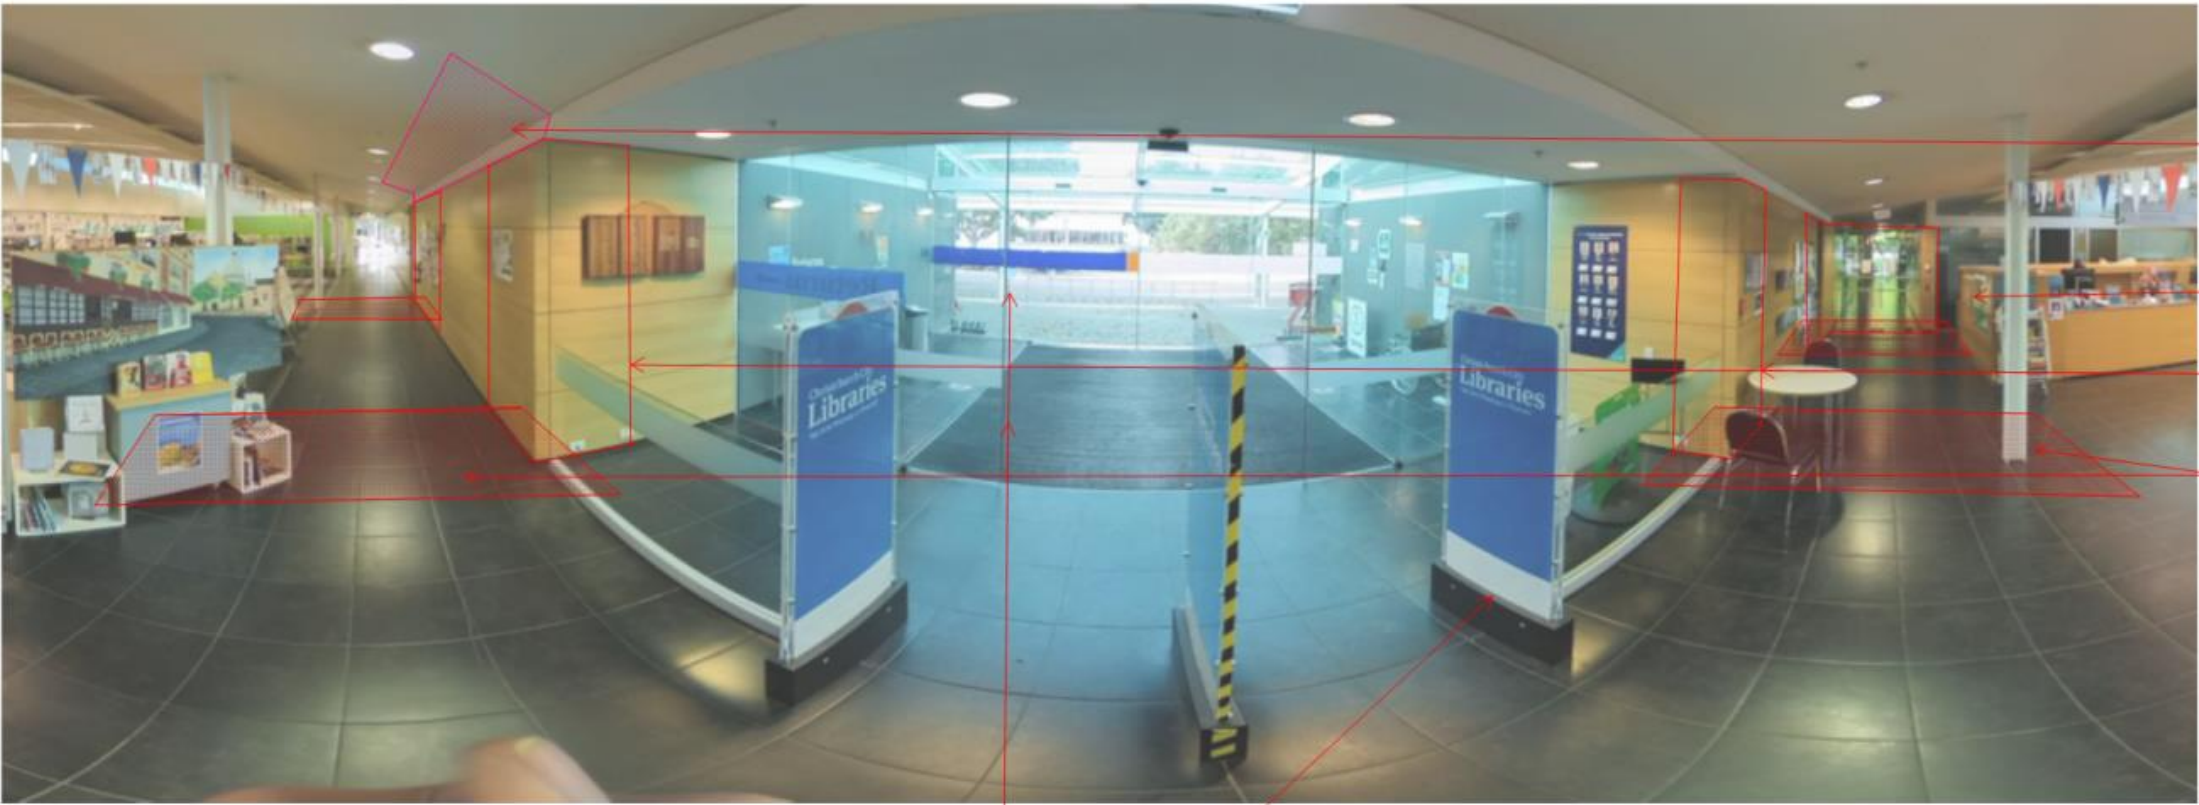
Ceiling area to be opened for internal bracing and replaced for internal bracing design installation.

Fixed joinery effected by strengthening works. Removed and instated if possible or replacement required.

Approximate minimum area of walls and wall finishes to be removed and replaced

Approximate minimum area of flooring, slab, insulation and waterproofing required to be removed and replaced with works.

Several walls will need to be demolished for access to the strengthening works as set out on A-SK02. This will include replacement of wall framing, finishes and fixtures including gib, timber wall panelling internal glazing and doors. Fixed furniture such as wall hung cupboards and fixed benching and desks will also need removing and reinstalling where possible or replacing where required.
