To	Lynne Armitage (CCC)
Copy	Soon Ong
From	Andrew Davidson
Office	Christchurch
Date	30 May 2023
File/Ref	6-DP536.00
Subject	Christchurch South Library - Temporary Strengthening 67%NBS

Christchurch South Library – Proposed Concept Strengthening Scheme
67% NBS IL3 (Life Safety)

Christchurch South Library – Temporary Strengthening 67% NBS Architectural Works

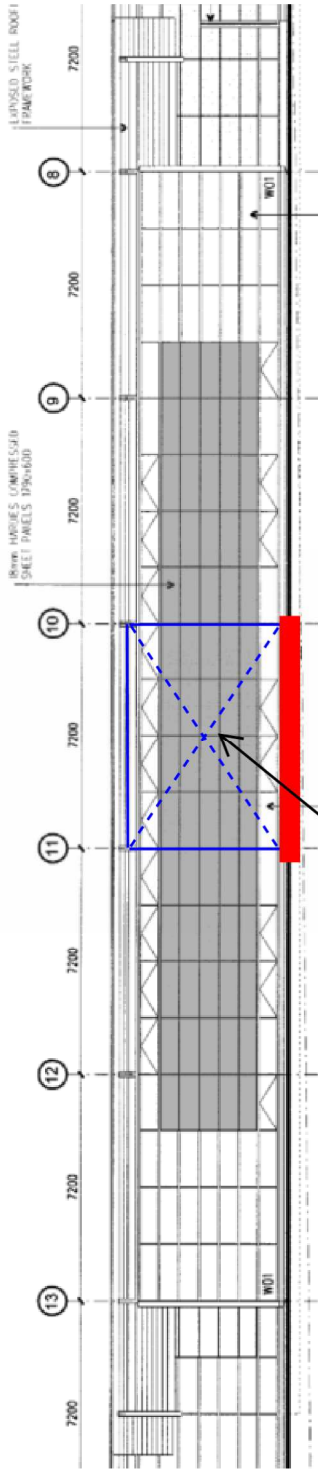
Grid A

External Bracing. See SK 07 for details

External Bracing.

External bracing required as indicated on 6-DP536.00-SK01, SK02, SK03 and detailed on 6-DP536.00-SK07. Example architectural scope is outlined on drawing A-SK01 and Figure 1 on A-SK04.

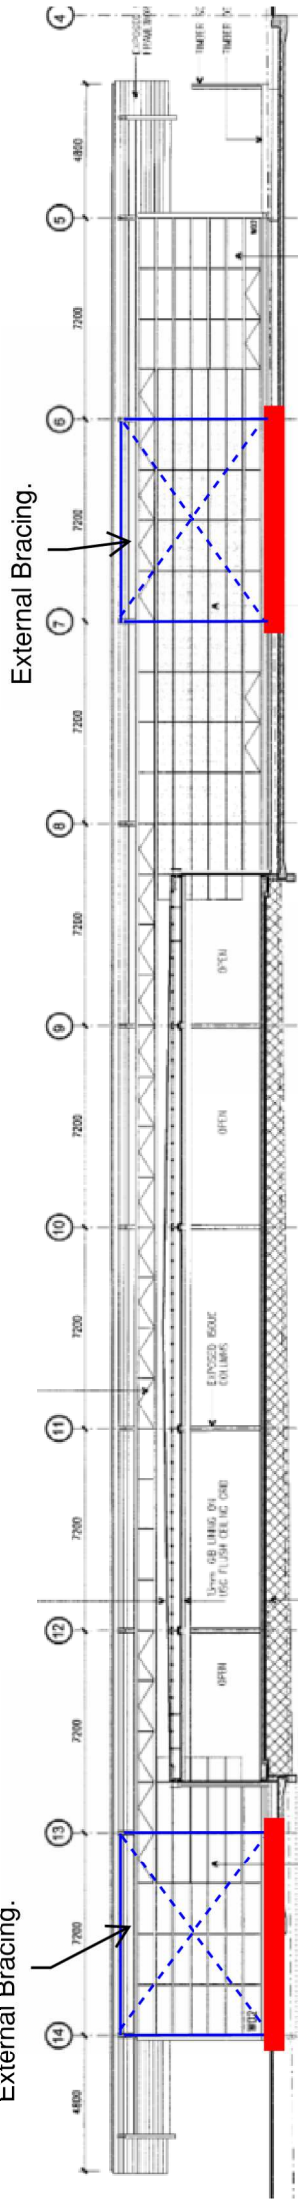
Grid D

External Bracing.

External Bracing

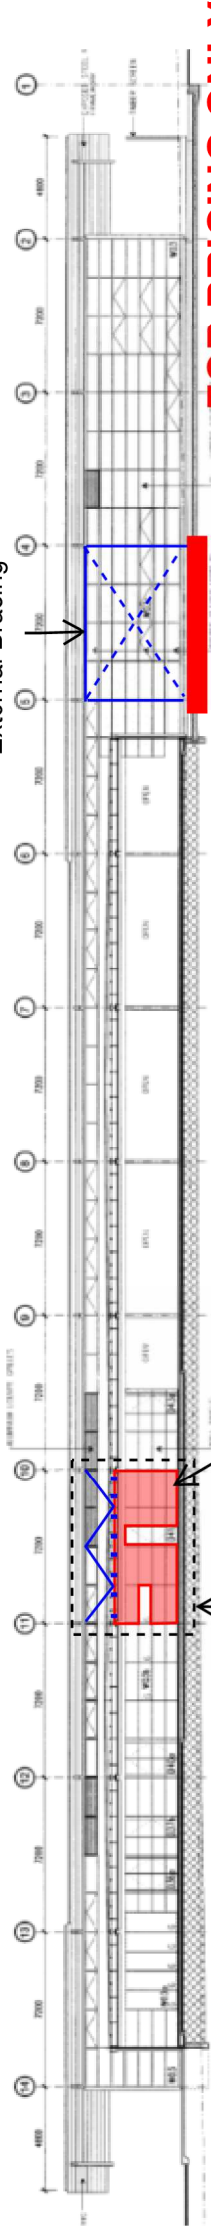
Grid F

Internal Bracing. See SK 07 for details

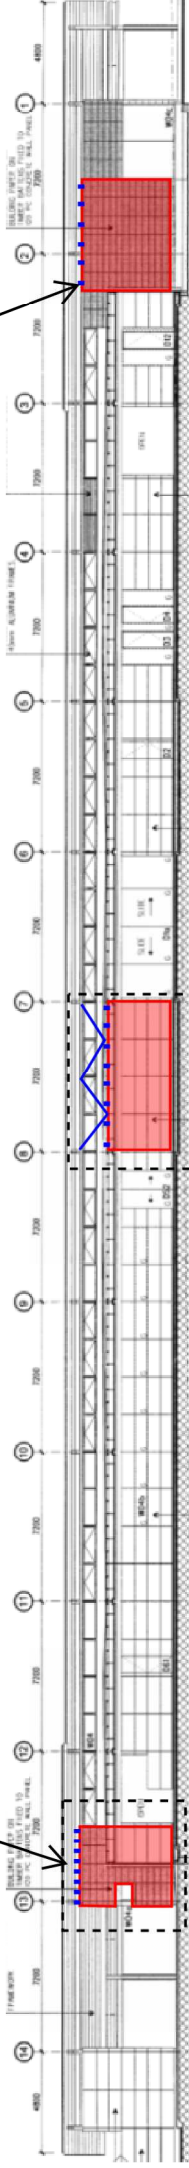
Grid H

Internal Bracing. See SK 07 for details

Internal Bracing.
See SK 07 for details

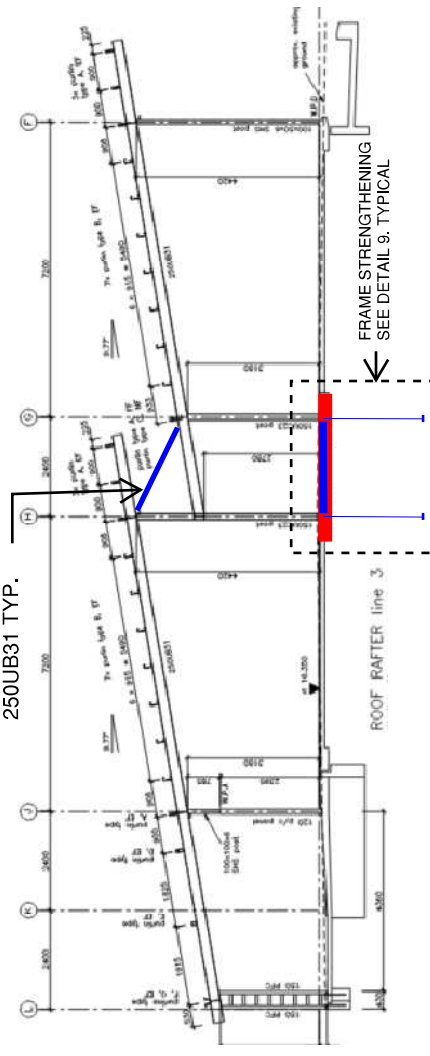
Grid 4

FRAME STRENGTHENING
SEE DETAIL 9. TYPICAL

There are 22 locations of corridor frame strengthening indicated on SK01 throughout the library. The works will be intrusive and require removal of the floor finishes surrounding the strengthening works including the tile and carpet finishes. Due to the extensive nature of areas required it is recommended that all floor finishes are replaced as part of the works to create consistency. We are led to believe there is electric under floor heating throughout the library which will also need repairing or an alternative method of heating may be worth exploring. Slab replacement works are required to install the ground beam required, this will involve replacement of the slab, under slab insulation and waterproofing.

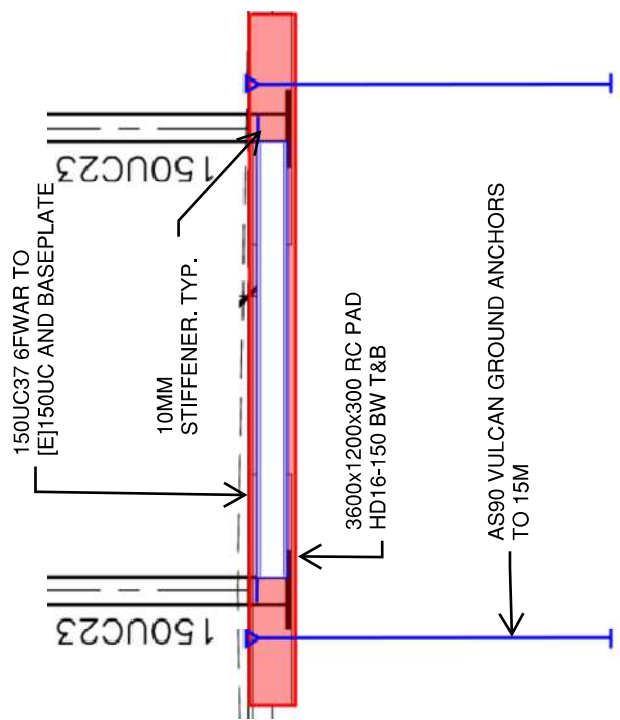
DETAIL 9
NTS

- PROPOSED METHOD OF CONSTRUCTION**
1. REMOVED EXISTING PAD FOUND & CUT BACK SLAB.
 2. INSTALL NEW 150UC37 BASE BEAM
 3. INSERT GROUND ANCHOR RODS
 4. CAST RC PAD
 5. COMPLETE INSTALLATION OF GROUND ANCHORS

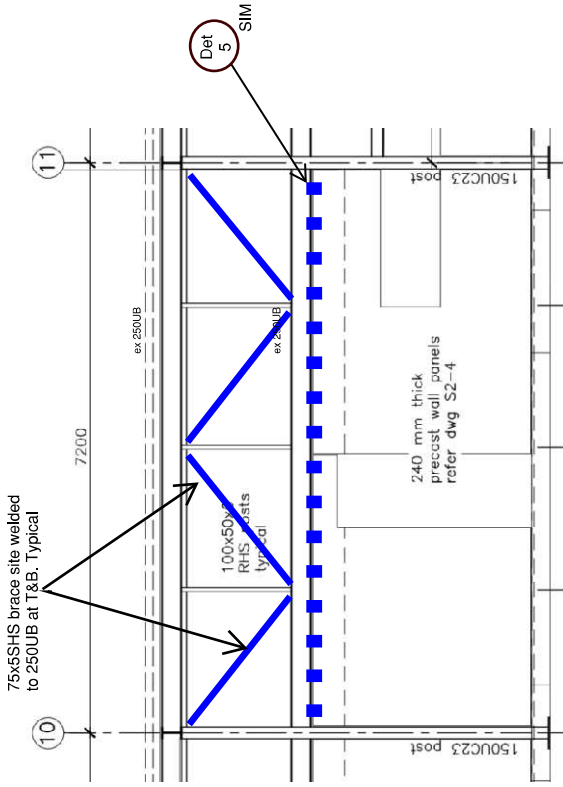
Internal Bracing Elevation (Grid F shown)

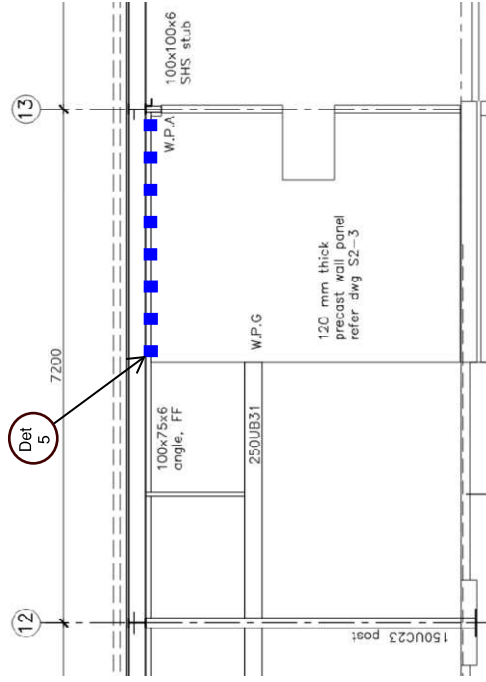
Internal Bracing Elevation (Grid H shown)

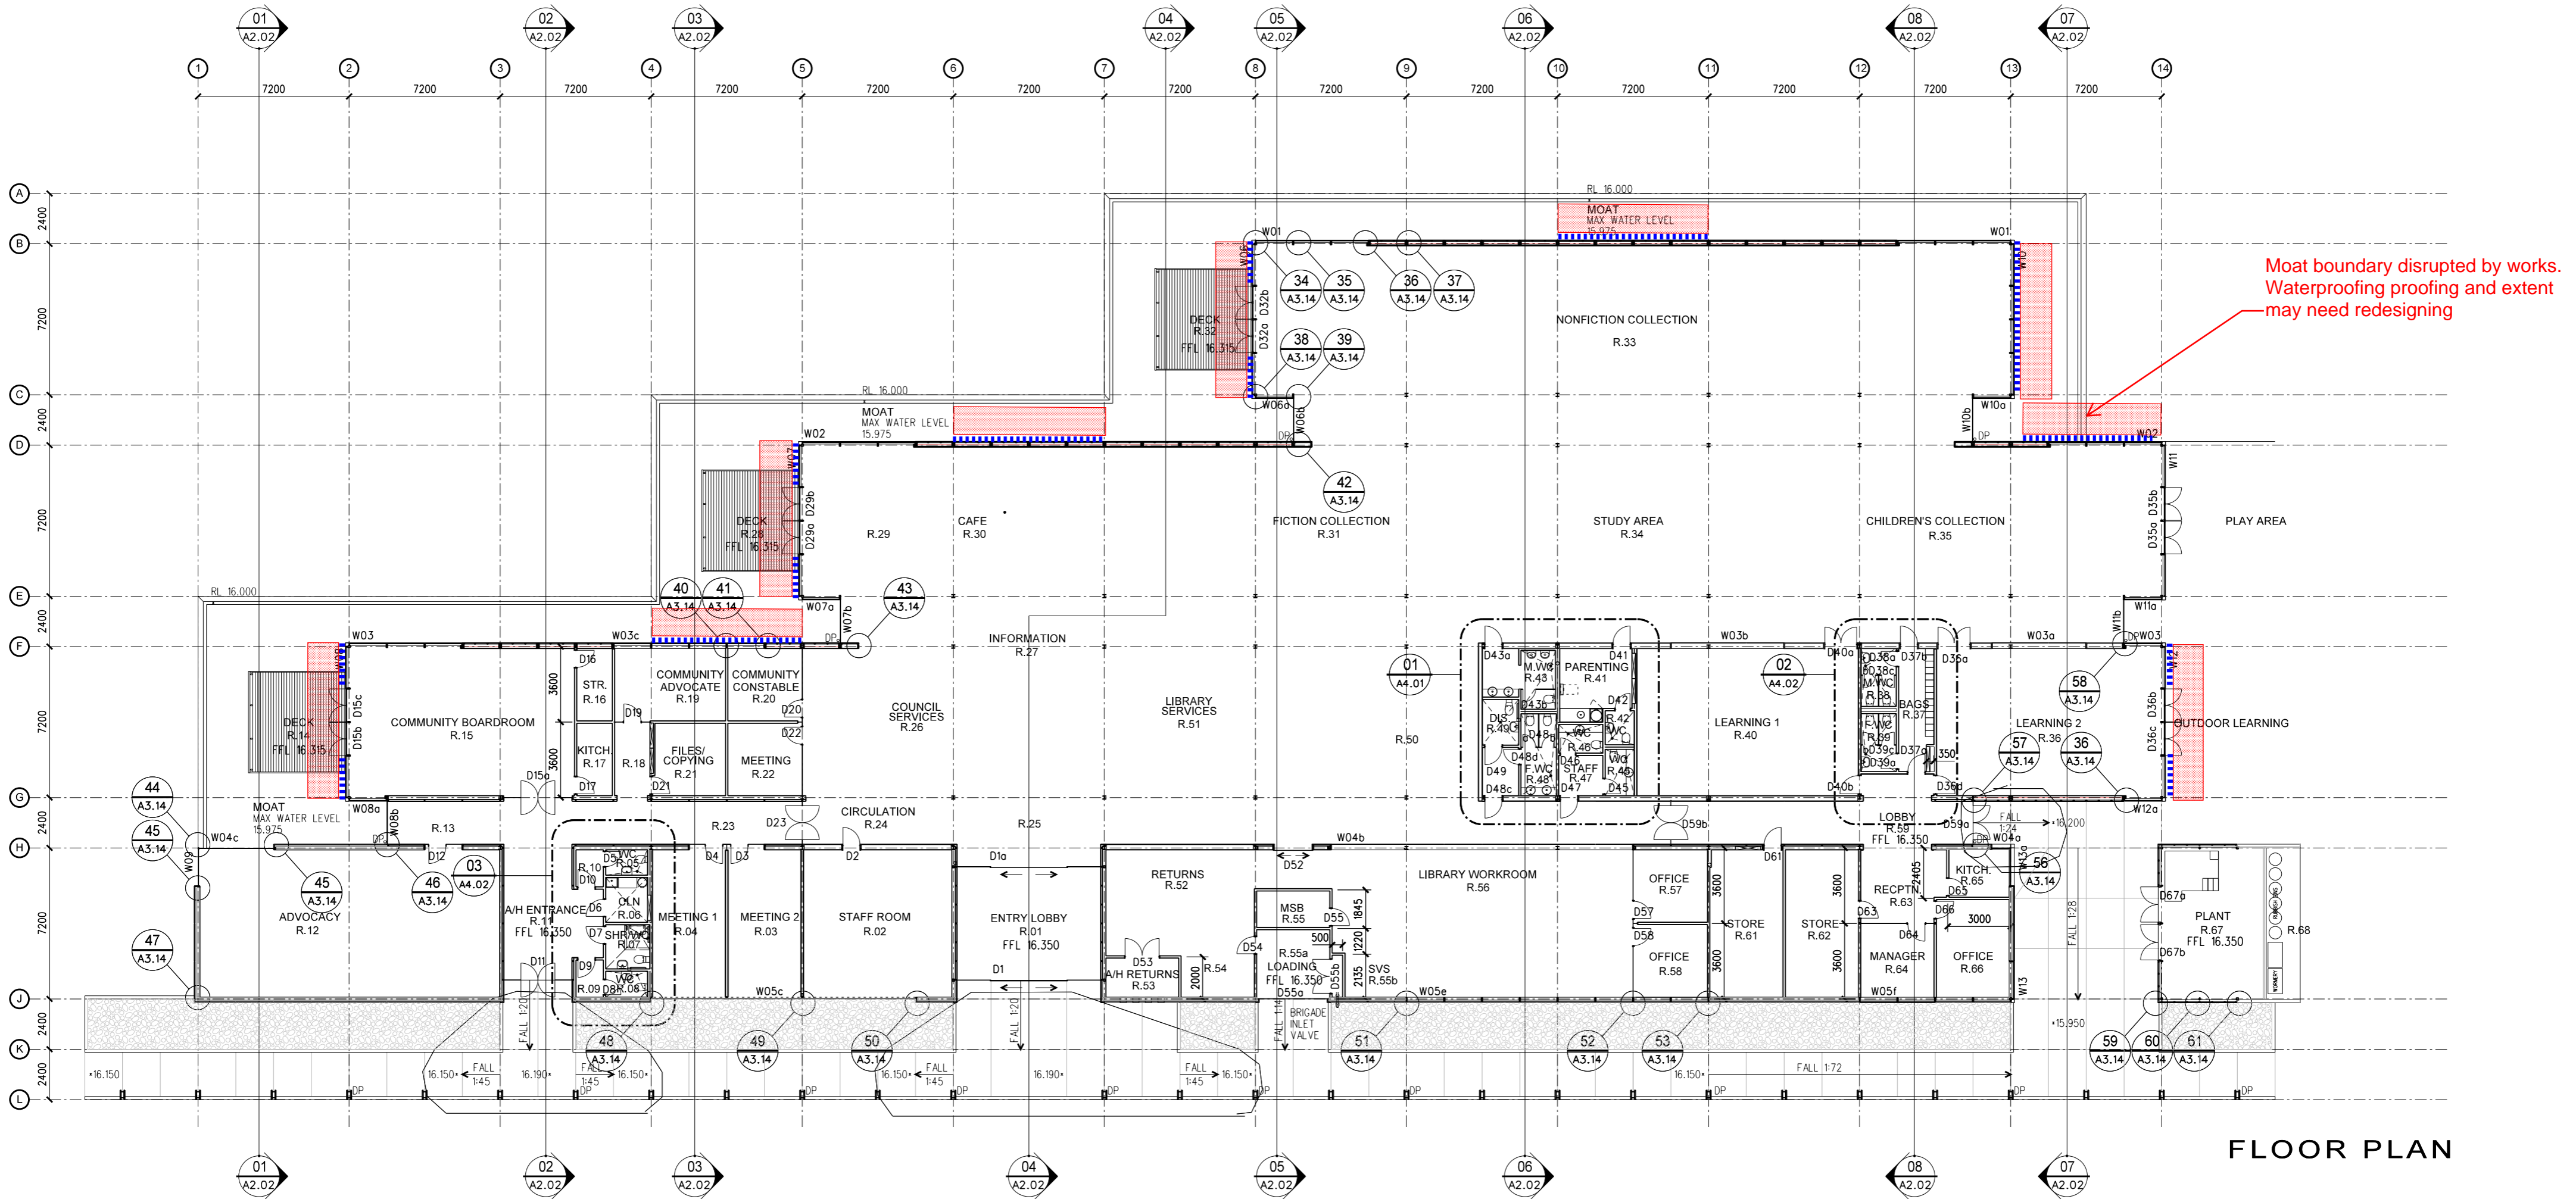
FLOOR PLAN

Summary
External works include replacement of external hard standing and decks with any associated waterproofing of moat design.

External Bracing Strengthening

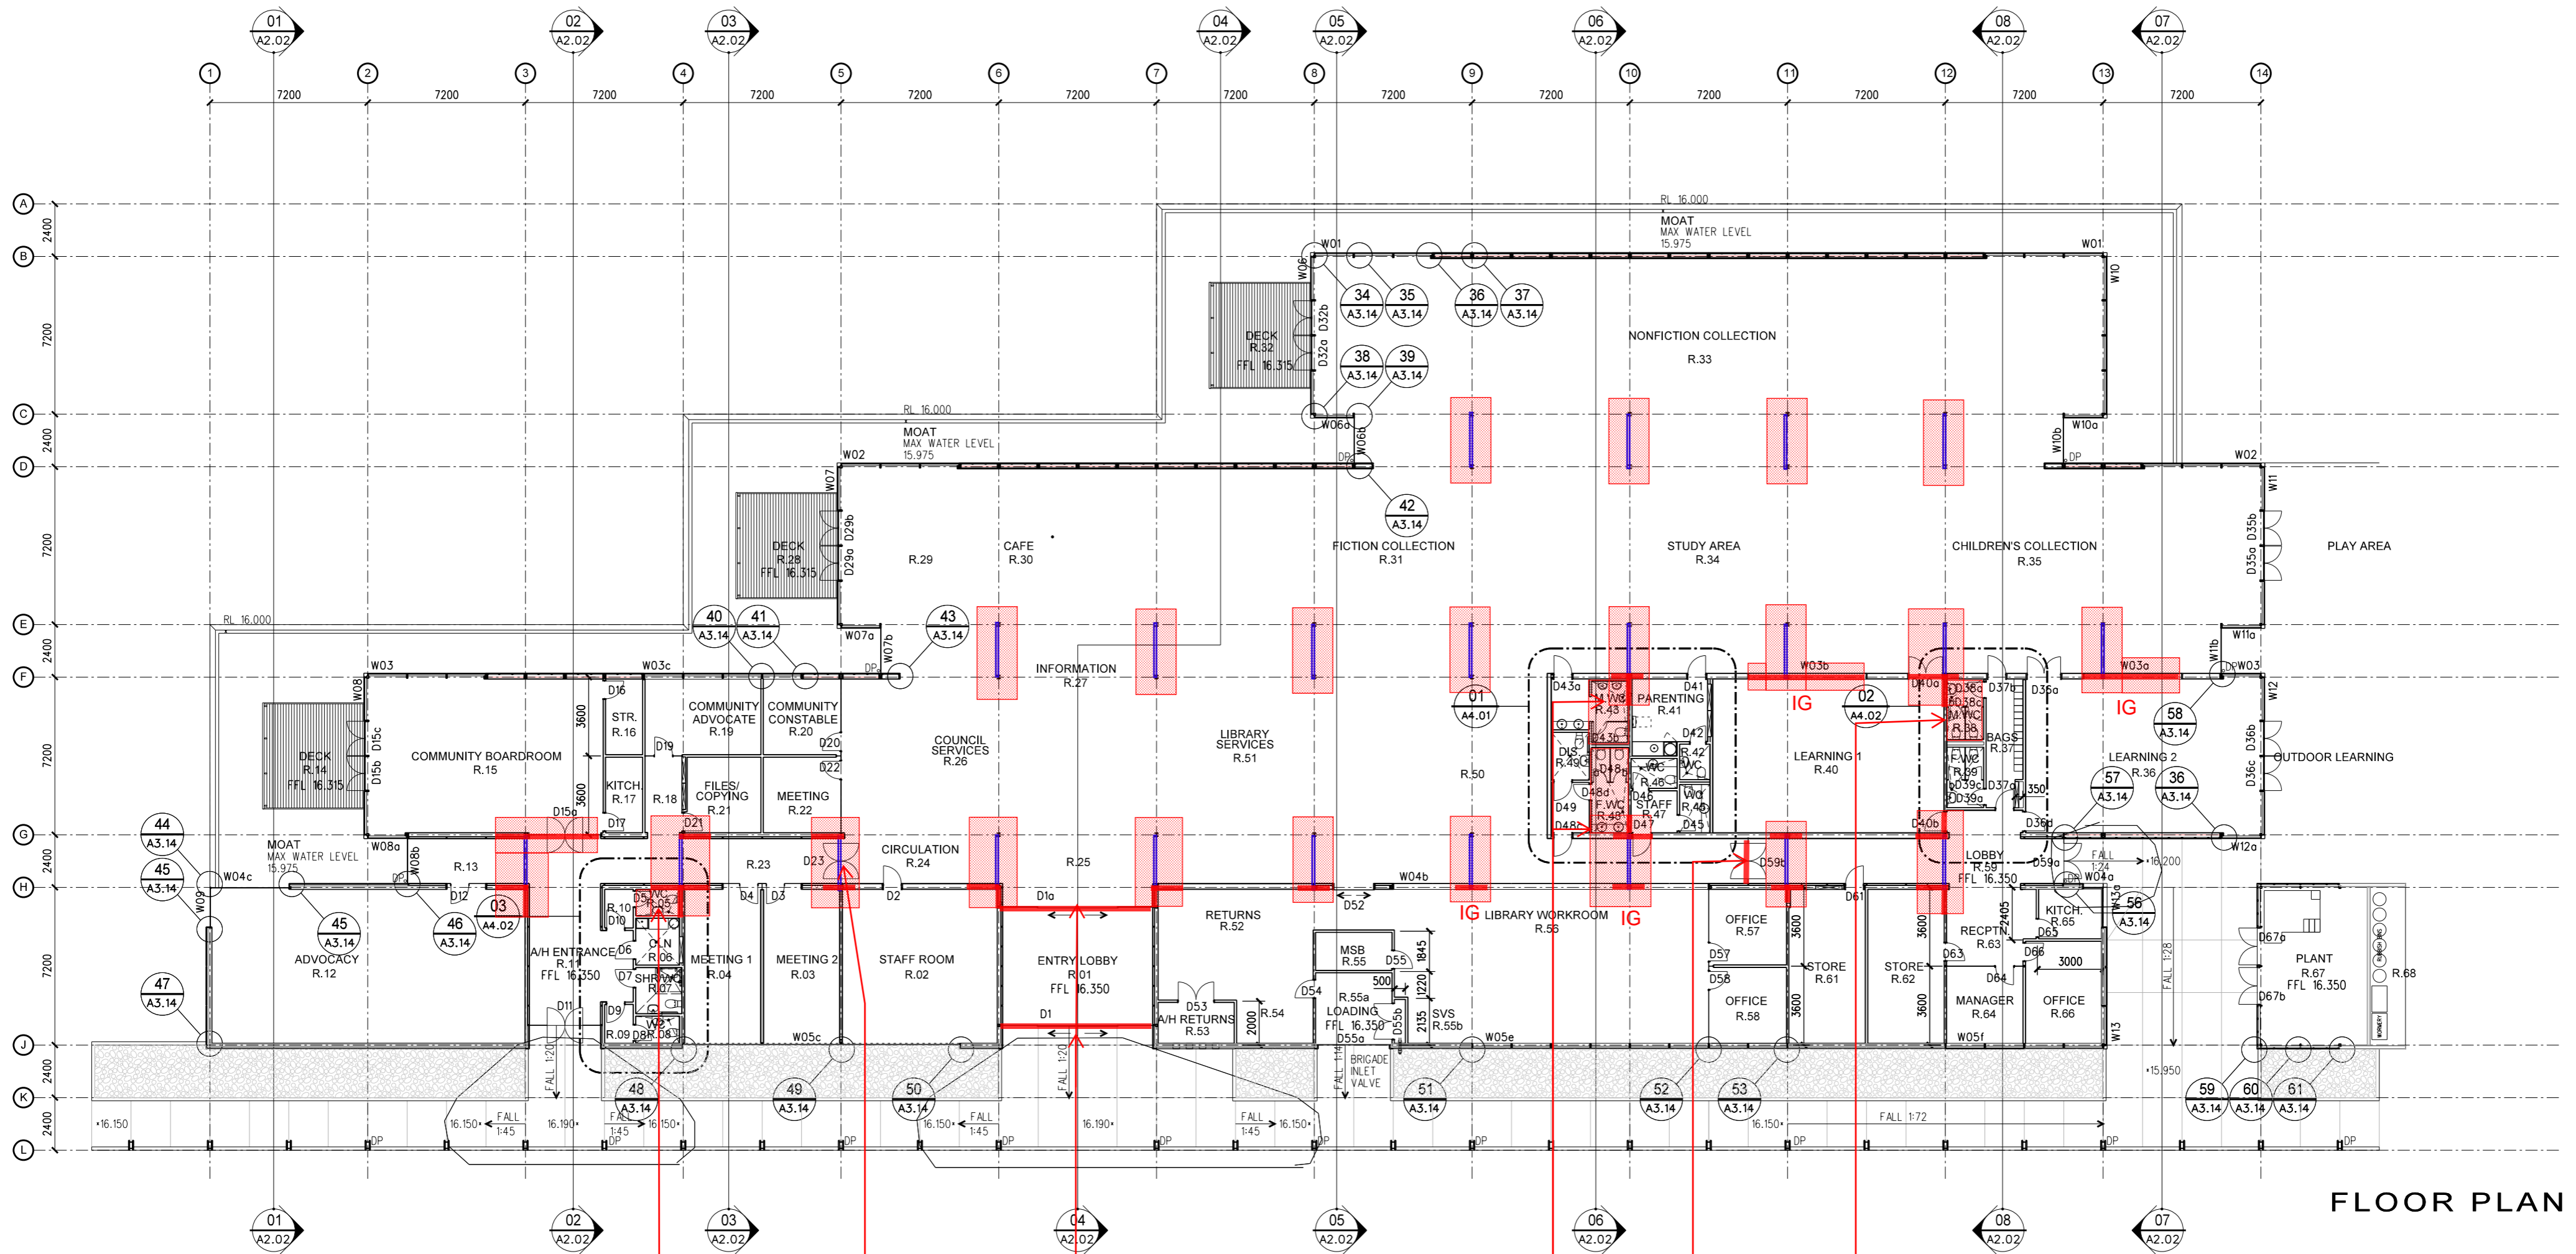
FLOOR PLAN

Works include demolition and replacement of areas of flooring (including tile and carpet floor finishes, slab, below slab insulation and waterproofing), internal walls (including framing, gib, timber panel finishes, internal glazing and associated fixtures and fittings; basins, toilets, drainage works and timber joinery) and roofing at bracing junctions.

WC affected by works

A number of WCs are affected by the works (R.05, R.38, R.43, R.48 and R.47) Floor wastes, basins, toilets and SVPs will need to be removed and replaced. Where spaces have floor wastes, floor finishes will need replacing and falls to drains recreating.

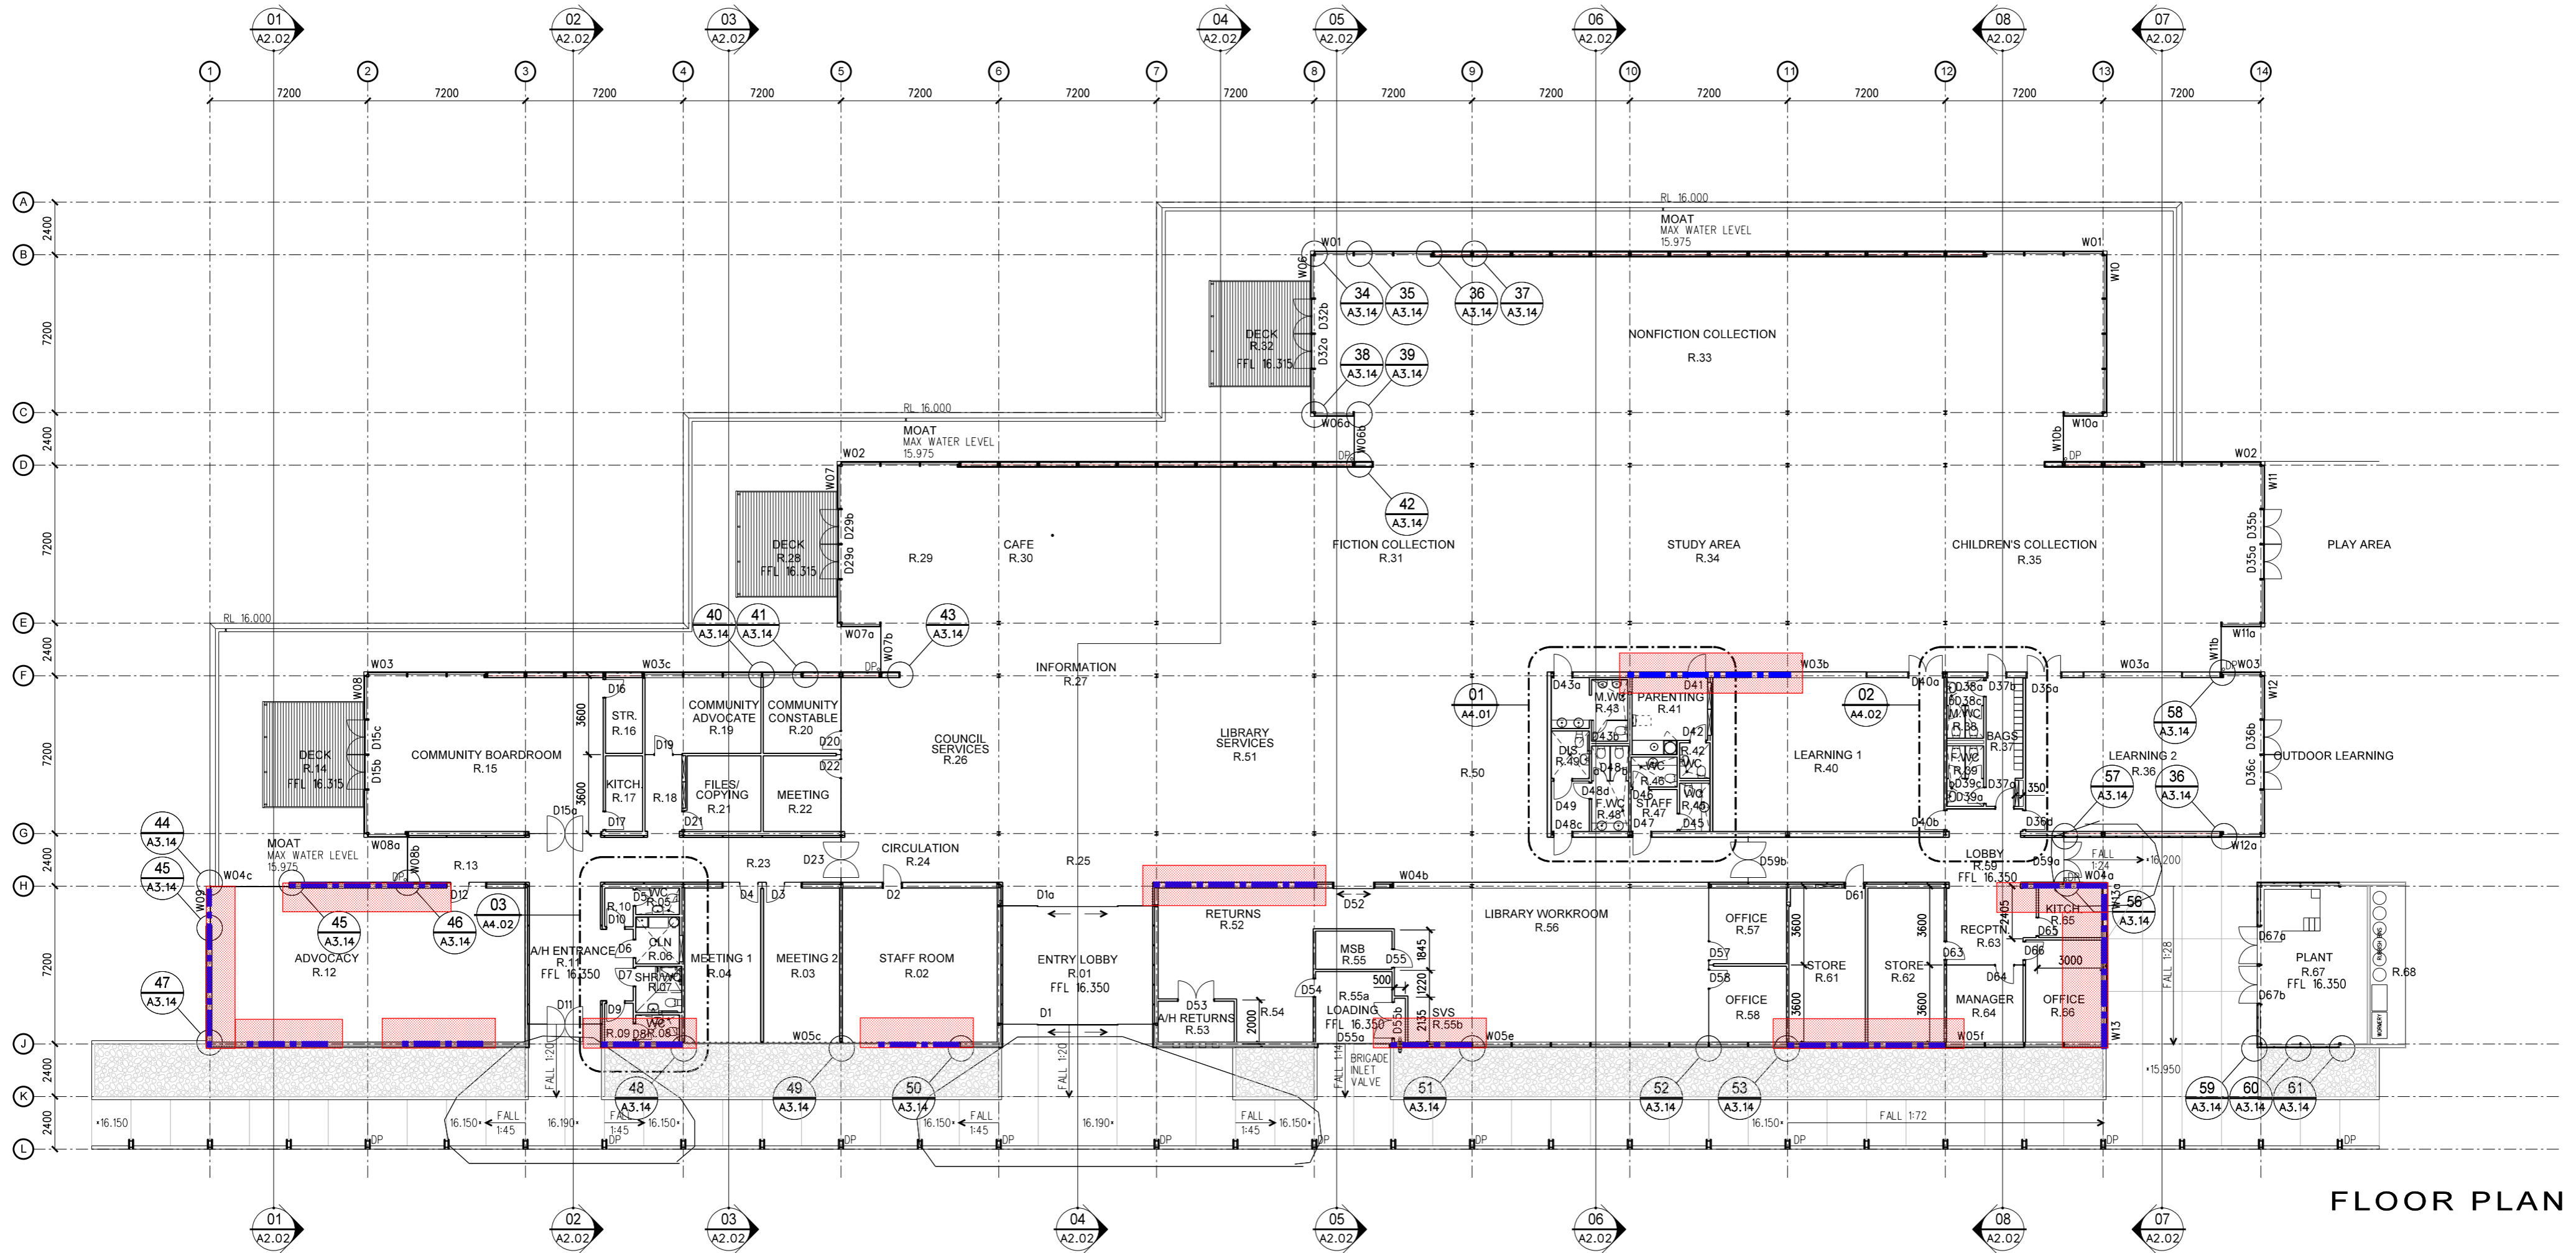
FLOOR PLAN

Summary
 Ceilings, internal and external walls will require repairing where internal bracing has been proposed. Additional works to mitigate increased thermal breaks may also be required.

Internal Bracing / Connection to PC Wall

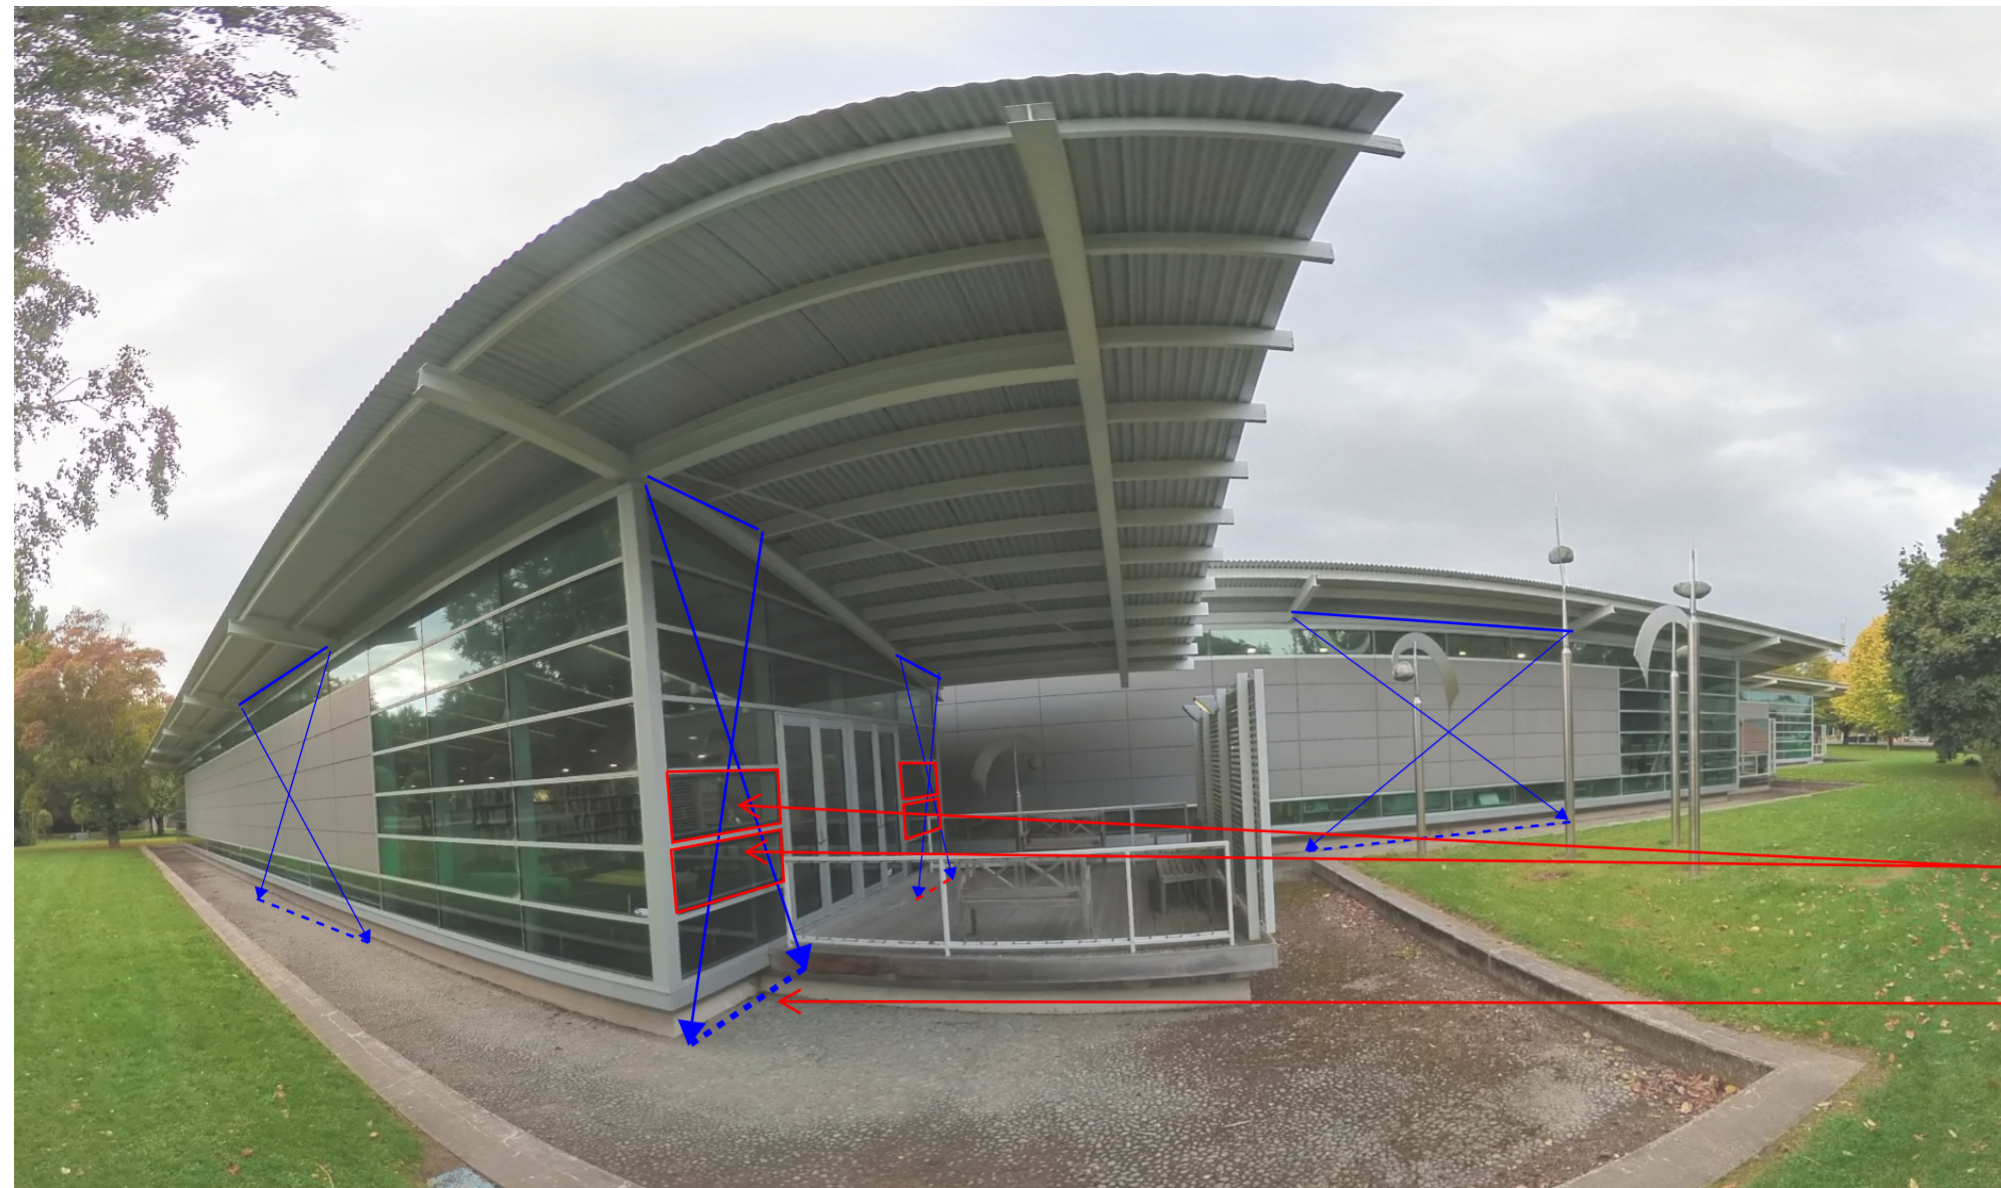
FIGURE 1

Operable glazing impeded by bracing in multiple locations.

Deck to be removed and reinstated for access to ground beam works. Extent of deck reduced by extent of bracing.

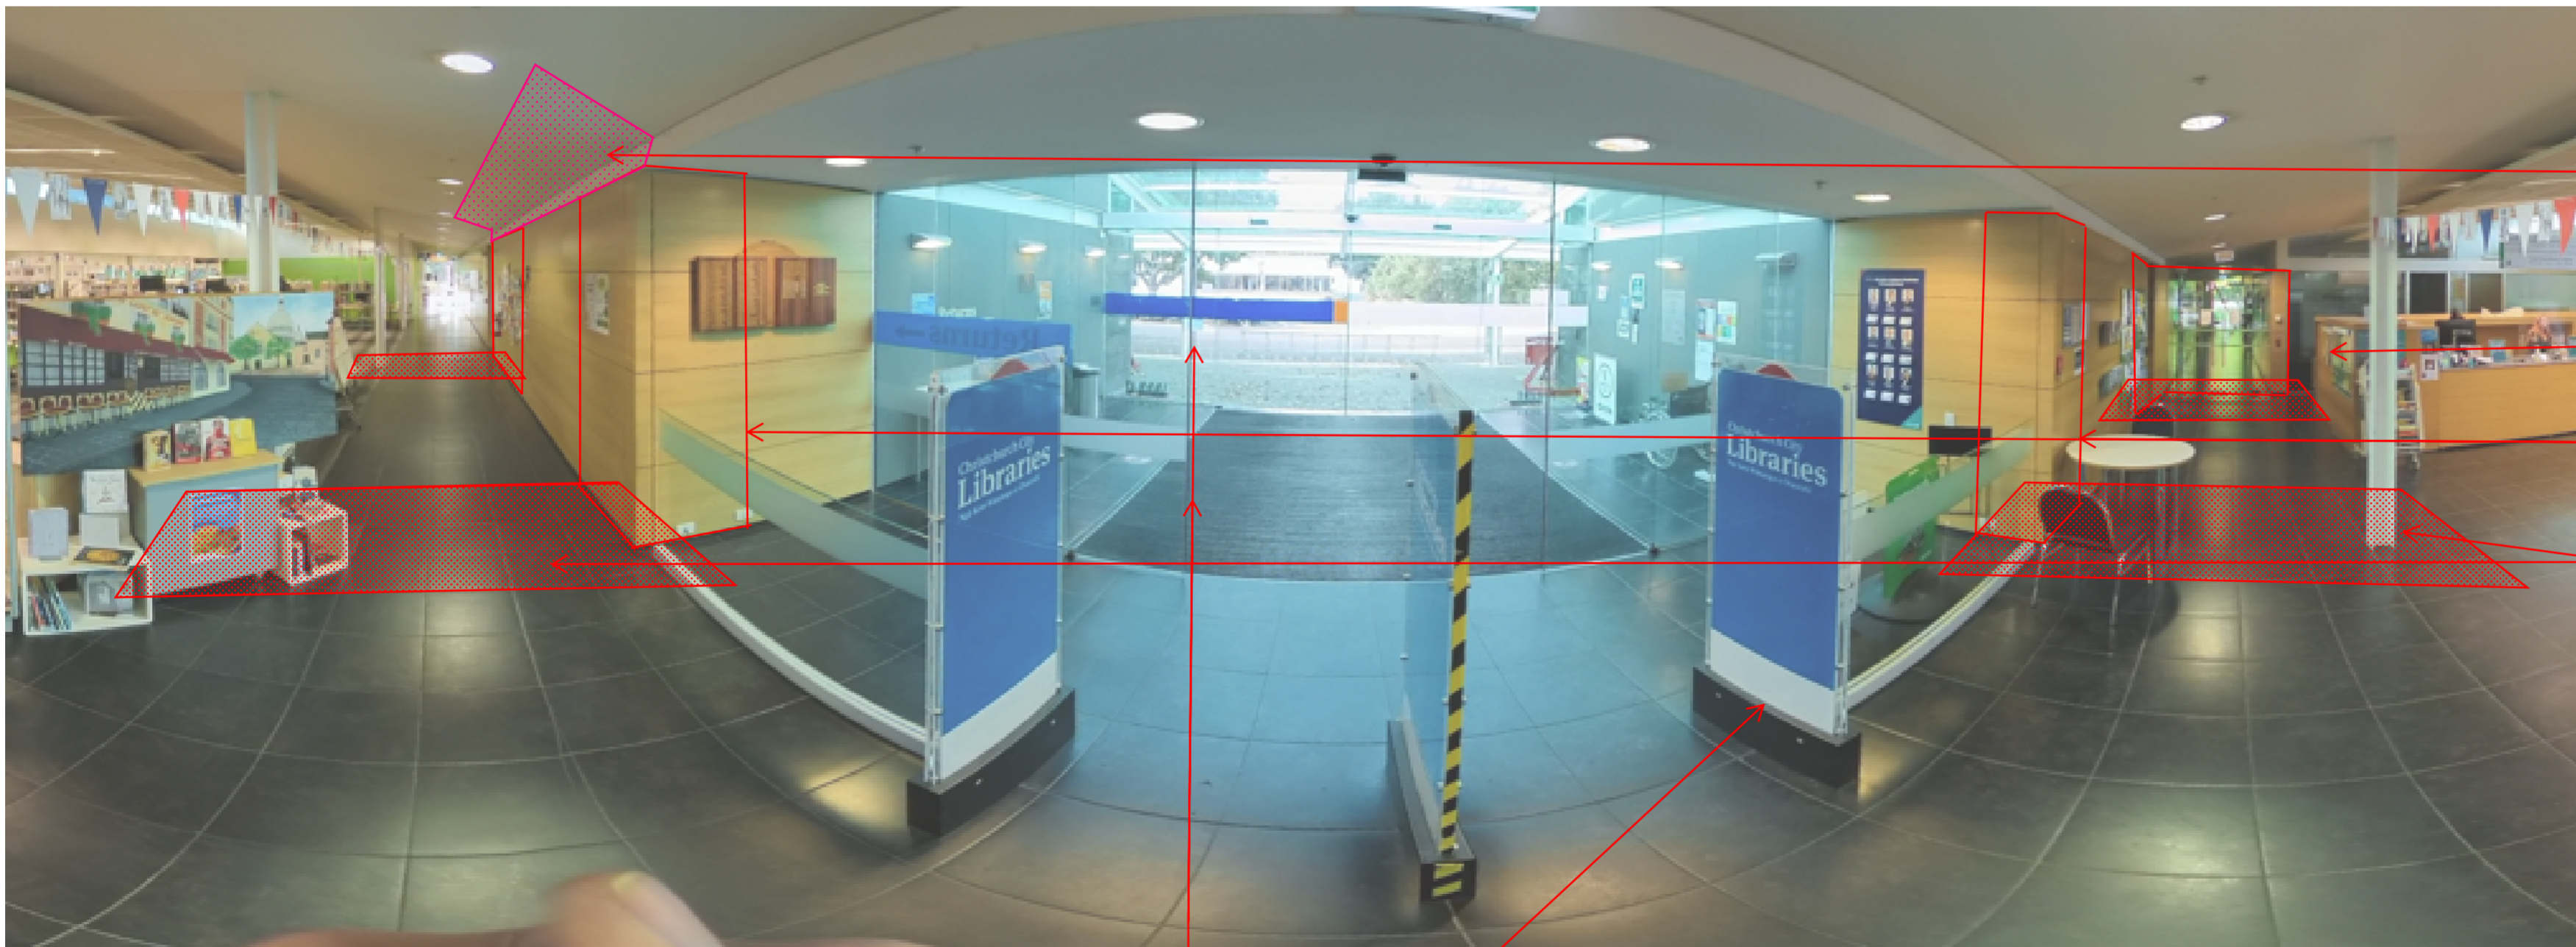
Ceiling area to be opened for internal bracing and replaced for internal bracing design installation.

Fixed joinery effected by strengthening works. Removed and instated if possible or replacement required.

Approximate minimum area of walls and wall finishes to be removed and replaced

Approximate minimum area of flooring, slab, insulation and waterproofing required to be removed and replaced with works.
