# Finance and Performance Committee AGENDA

Date:	Thursday 26 May 2022
Time:	9.30am
Venue:	Council Chambers, Civic Offices,
	53 Hereford Street, Christchurch

# South Christchurch Library / Te Kete Wānanga o Wai Mōkihi CONCEPT DESIGN STAGE - STRUCTURAL DRAWINGS Dec 2021

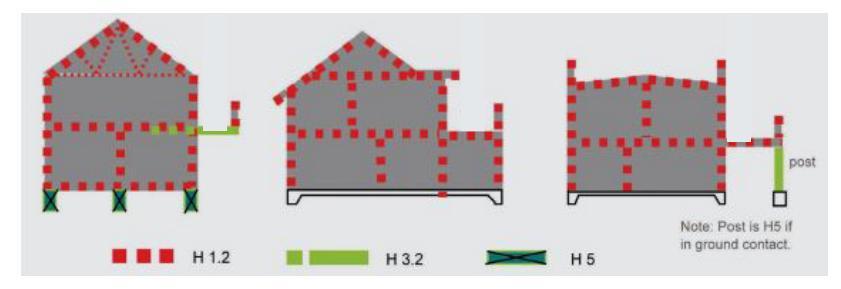
Figure 6. NZBC B2 Timber durability requirements

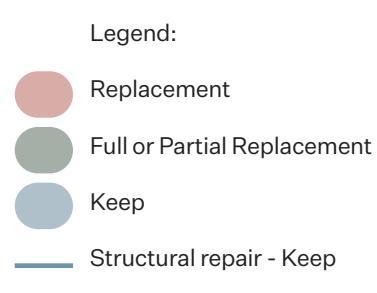
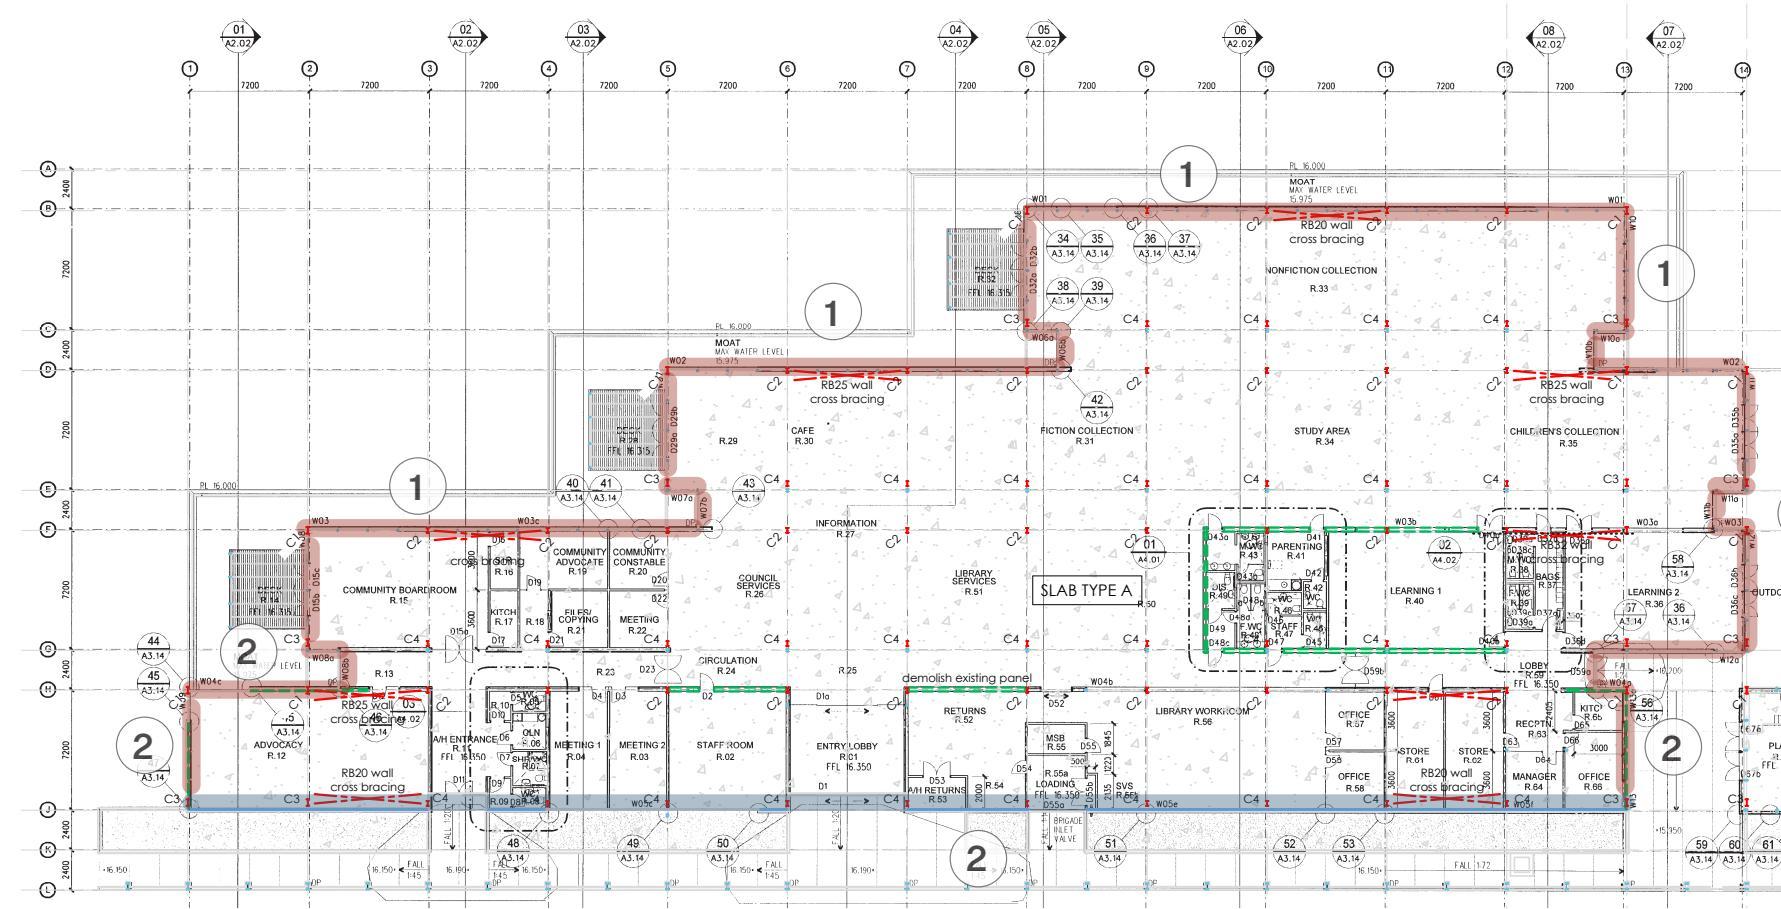
Each envelope element is highlighted with the corresponding colour to demonstrate visually the extent of what will need to be replaced vs what can potentially stay intact under the current structural repair scheme.

Structural repair - Demolish

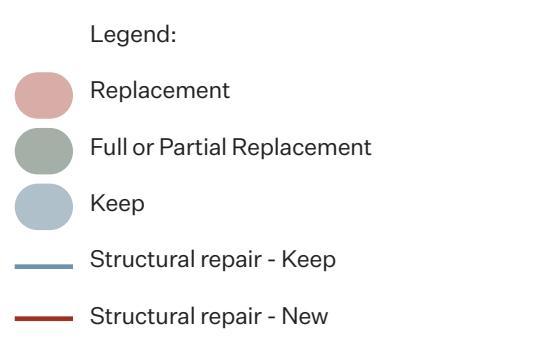
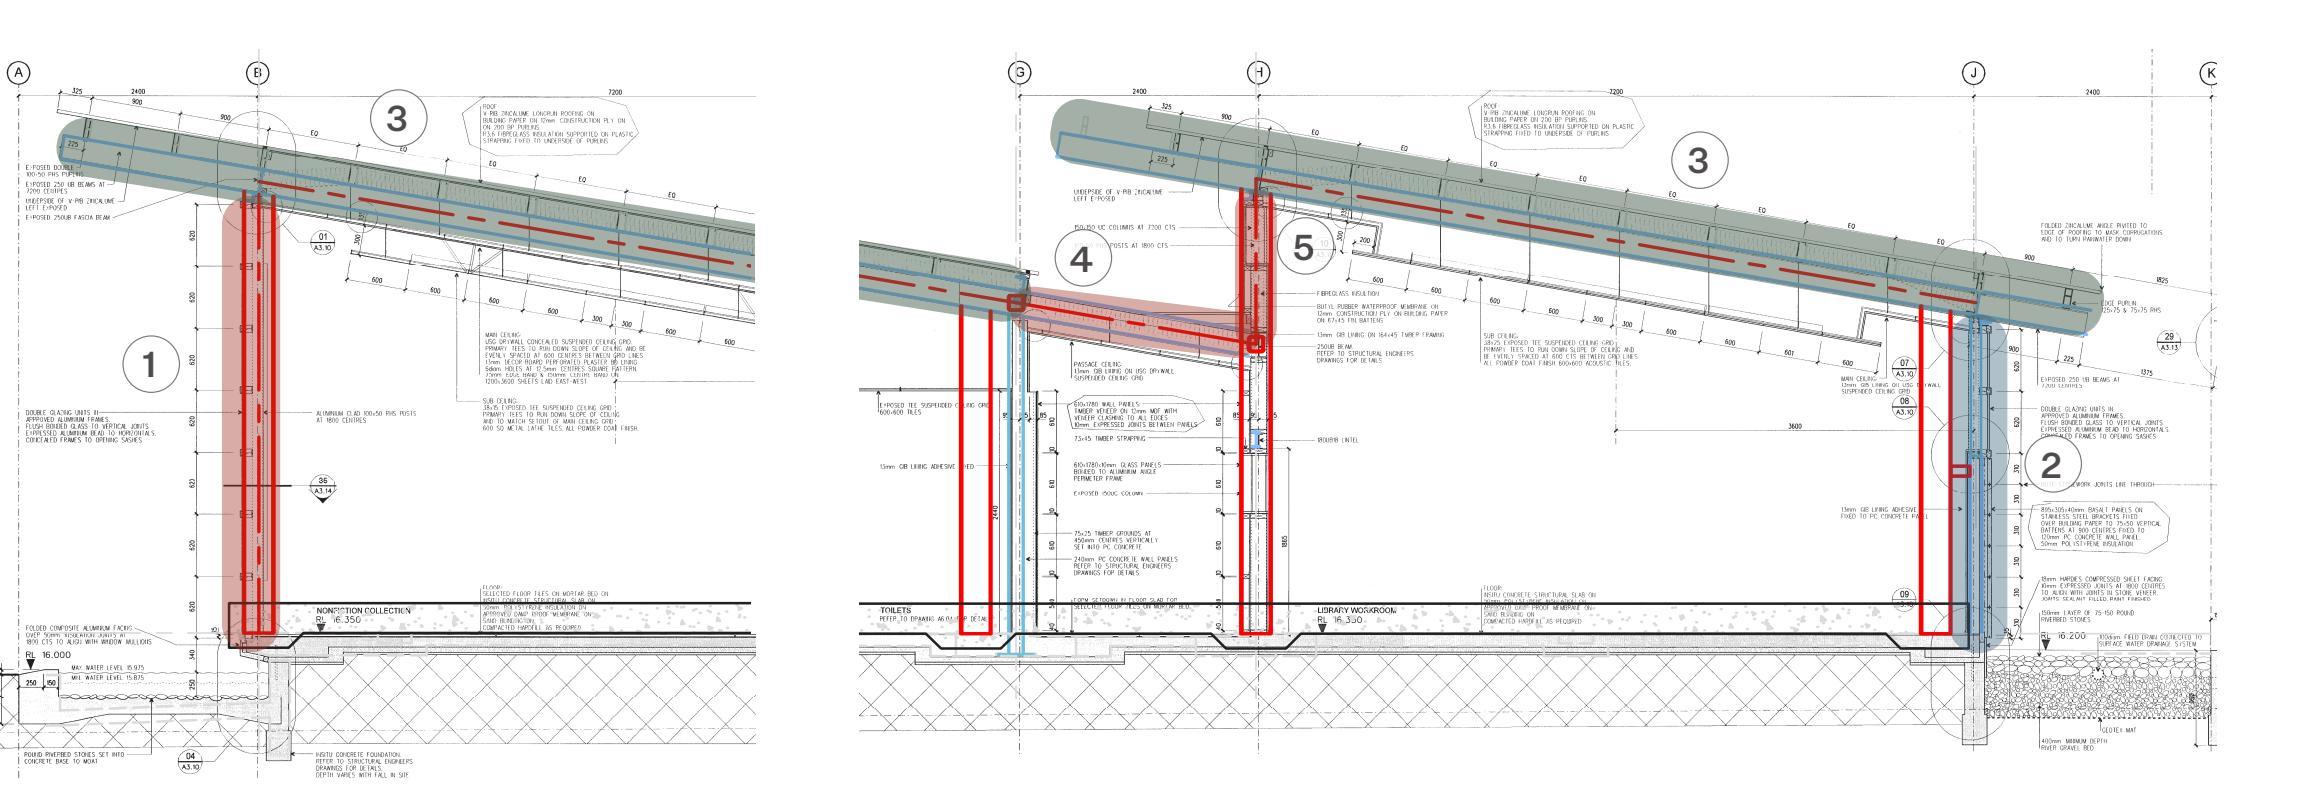
# **Option A - Section Analysis**

Each envelope element is highlighted with the corresponding colour to demonstrate visually the extent of what will need to be replaced vs what can potentially stay intact under the current structural repair scheme.

Structural repair - Demolish

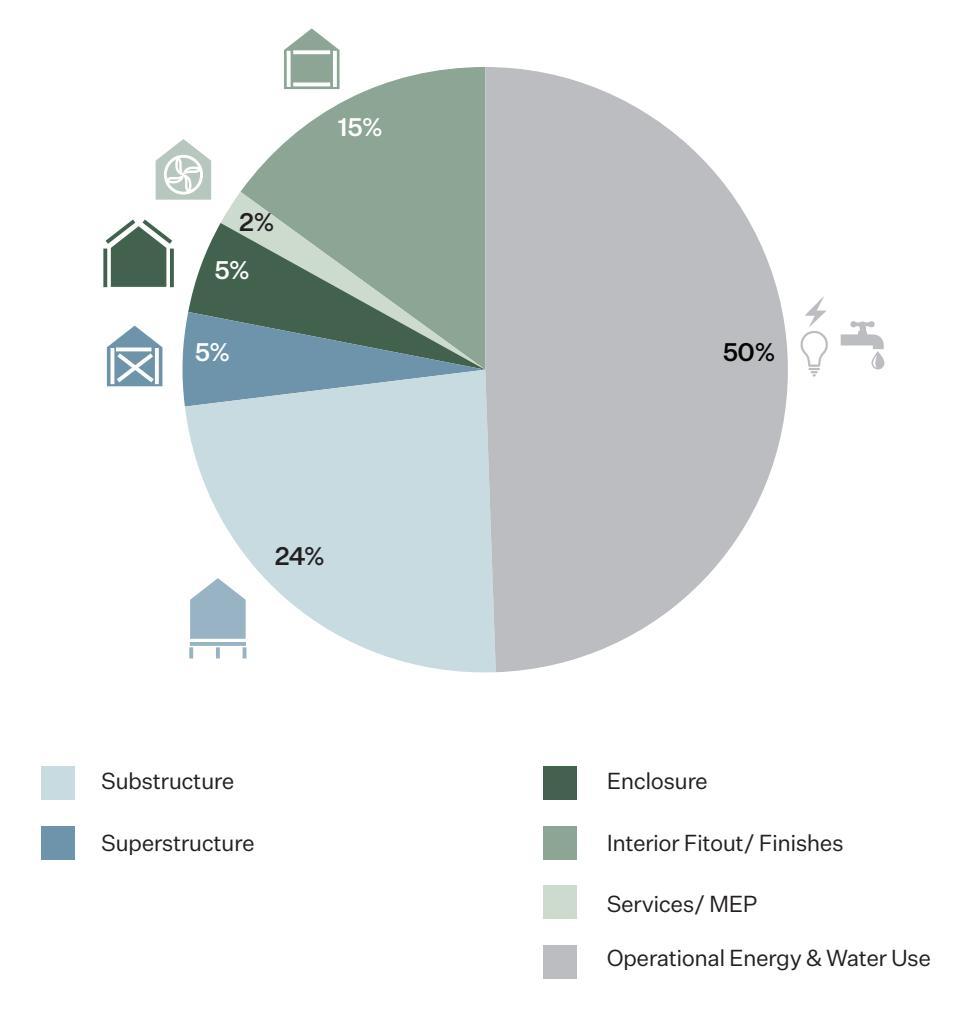
### **Carbon Distribution Across Building Element Categories**

The pie charts to follow illustrate the breakdown of life cycle carbon use when considered across building element categories, life cycle modules and building materials. They all show the same total life cycle carbon but each allows the carbon components to be interrogated differently in order to identify carbon hot-spots, where improvements can then be optioneered against project criteria.

Building Category								
Substructure	Superstructure	Enclosure	Interior Fitout/ Finishes	Services/ MEP	Operational Energy & Water Use	kgCO₂e/m²		
323.84	66.79	67.39	196.18	27.76	670.91	1,352.87

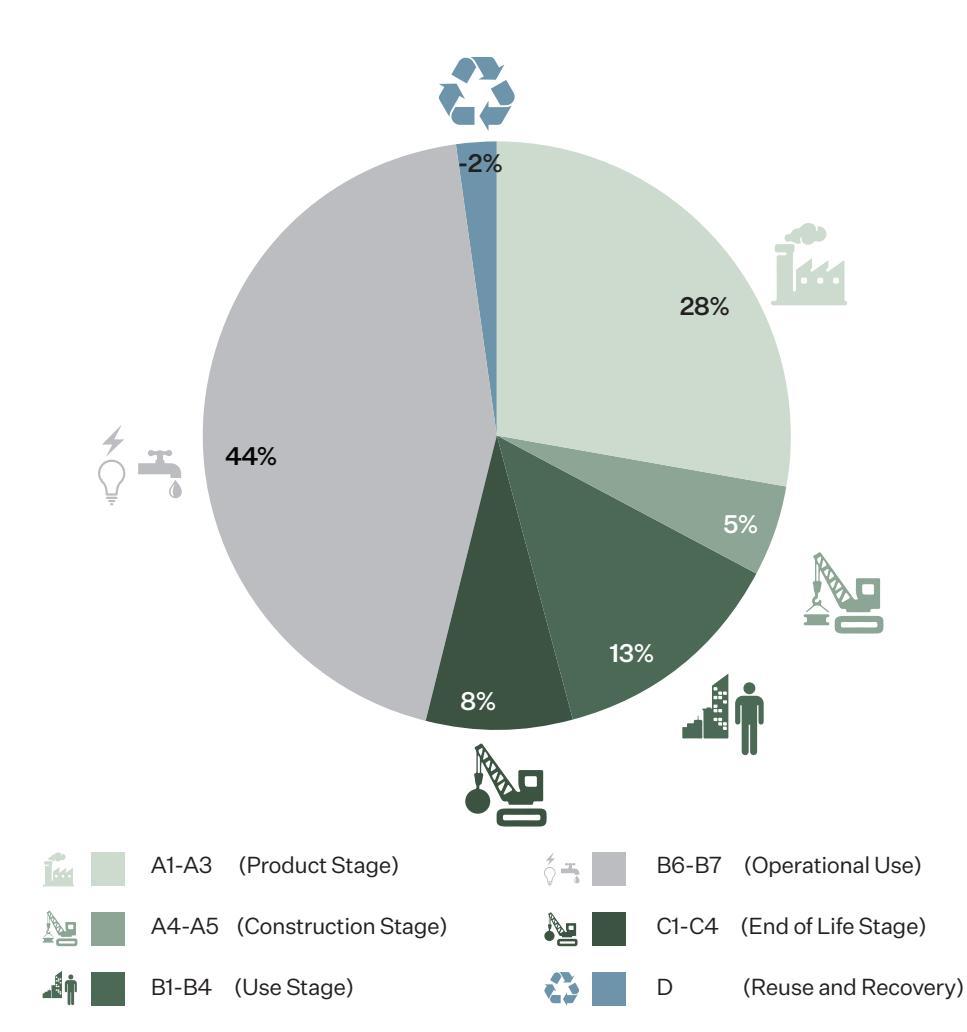
Option B - Green Rebuild

Embodied Carbon (Global Warming potential [kgCO <sub>2</sub> eq.]) per sq. metre (kgCO <sub>2</sub> e/m²)									Operational Carbon (kgCO₂e/m²)					
Materials and Construction Use Stage End of Life Stage		e	Benefits beyond L.C	Embodied Carbon Total	Operational Carbon		Operational Carbon Total							
A1-A3	A4	A5	B1	B2	B4	C1	C2	C3	C4	D	A, B1-B4, C, D	B6	B7	B6, B7
Product Stage	Transport	Construction	In Use	Maintenance	Replacement	Deconstruction and Demo	Transport	Waste processing	Disposal	Reuse	kgCO₂e/m²	Operational Energy Use	Operational Water Use	kgCO₂e/m²
320	58.	30		143.46		94.99		-18.10	598.70	497	.50	497.50

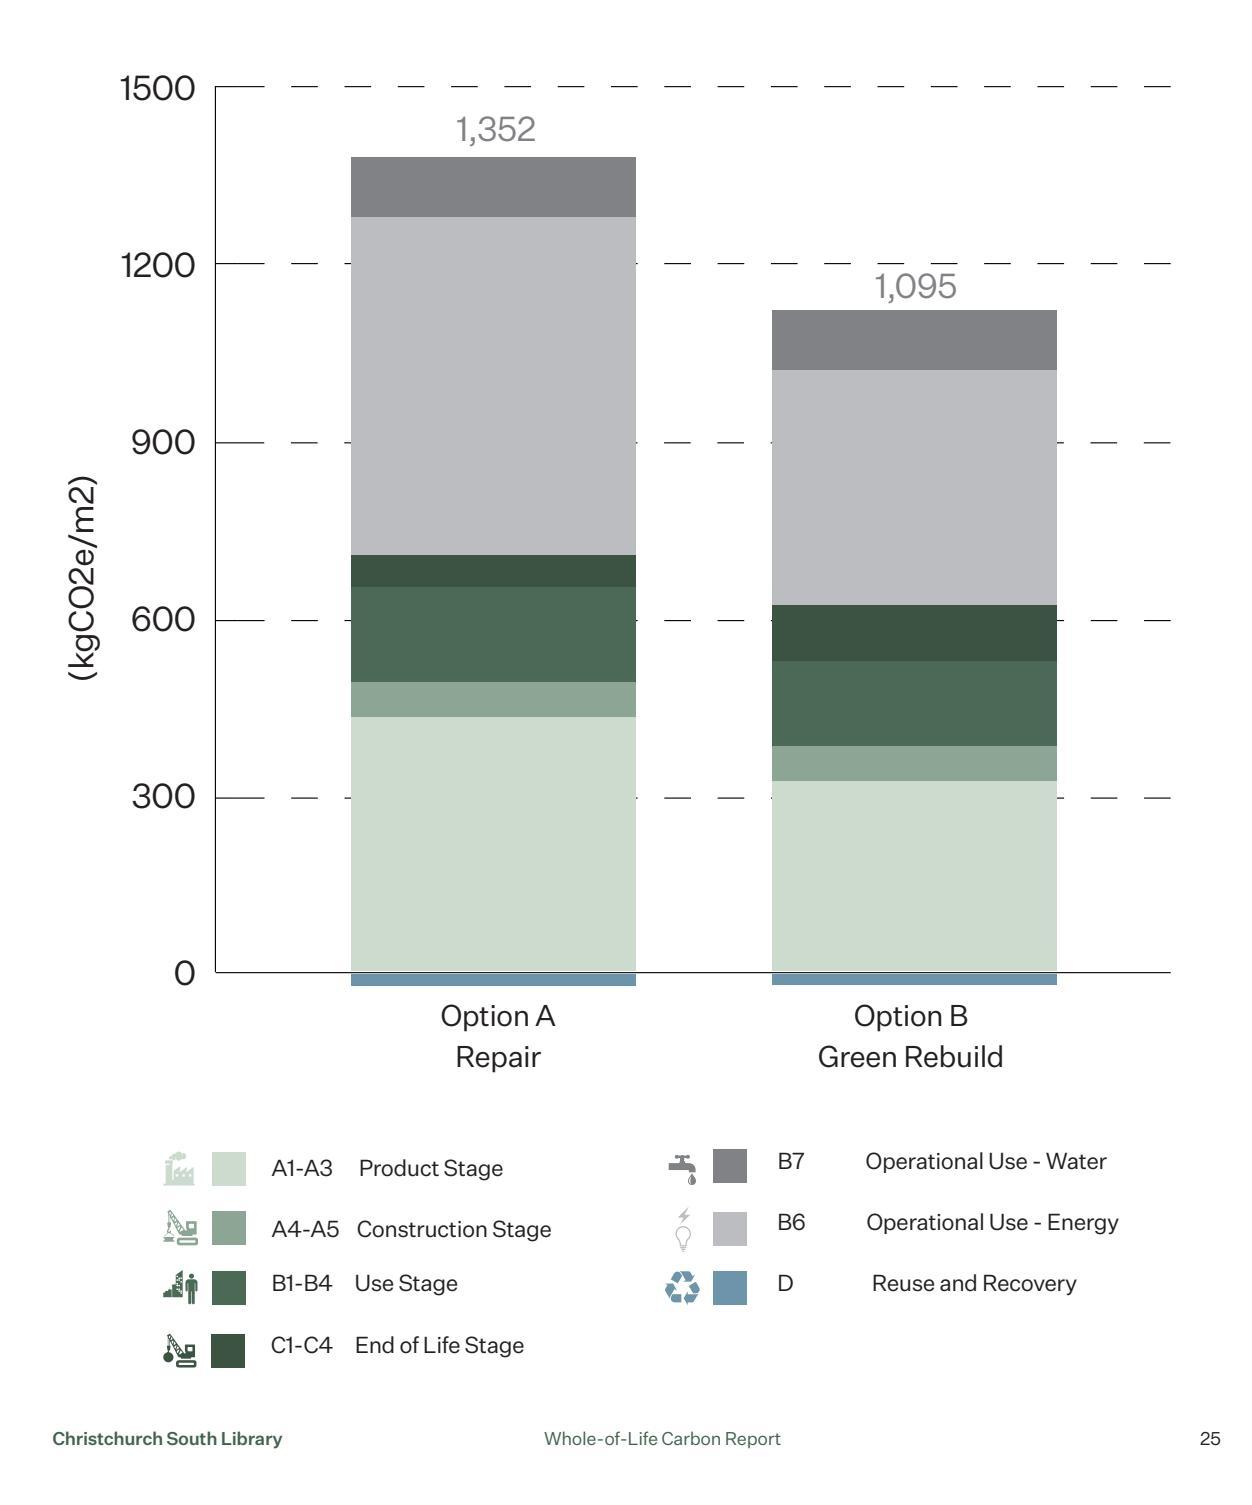
The bar chart below compares the total expected life cycle carbon for each option as well as breakdown by life cycle module. Option B Green Rebuild performs better across all categories except C1-C4 End of Life as the assessment assumes the worse case scenario of all sequestered carbon in the timber being released at this stage.

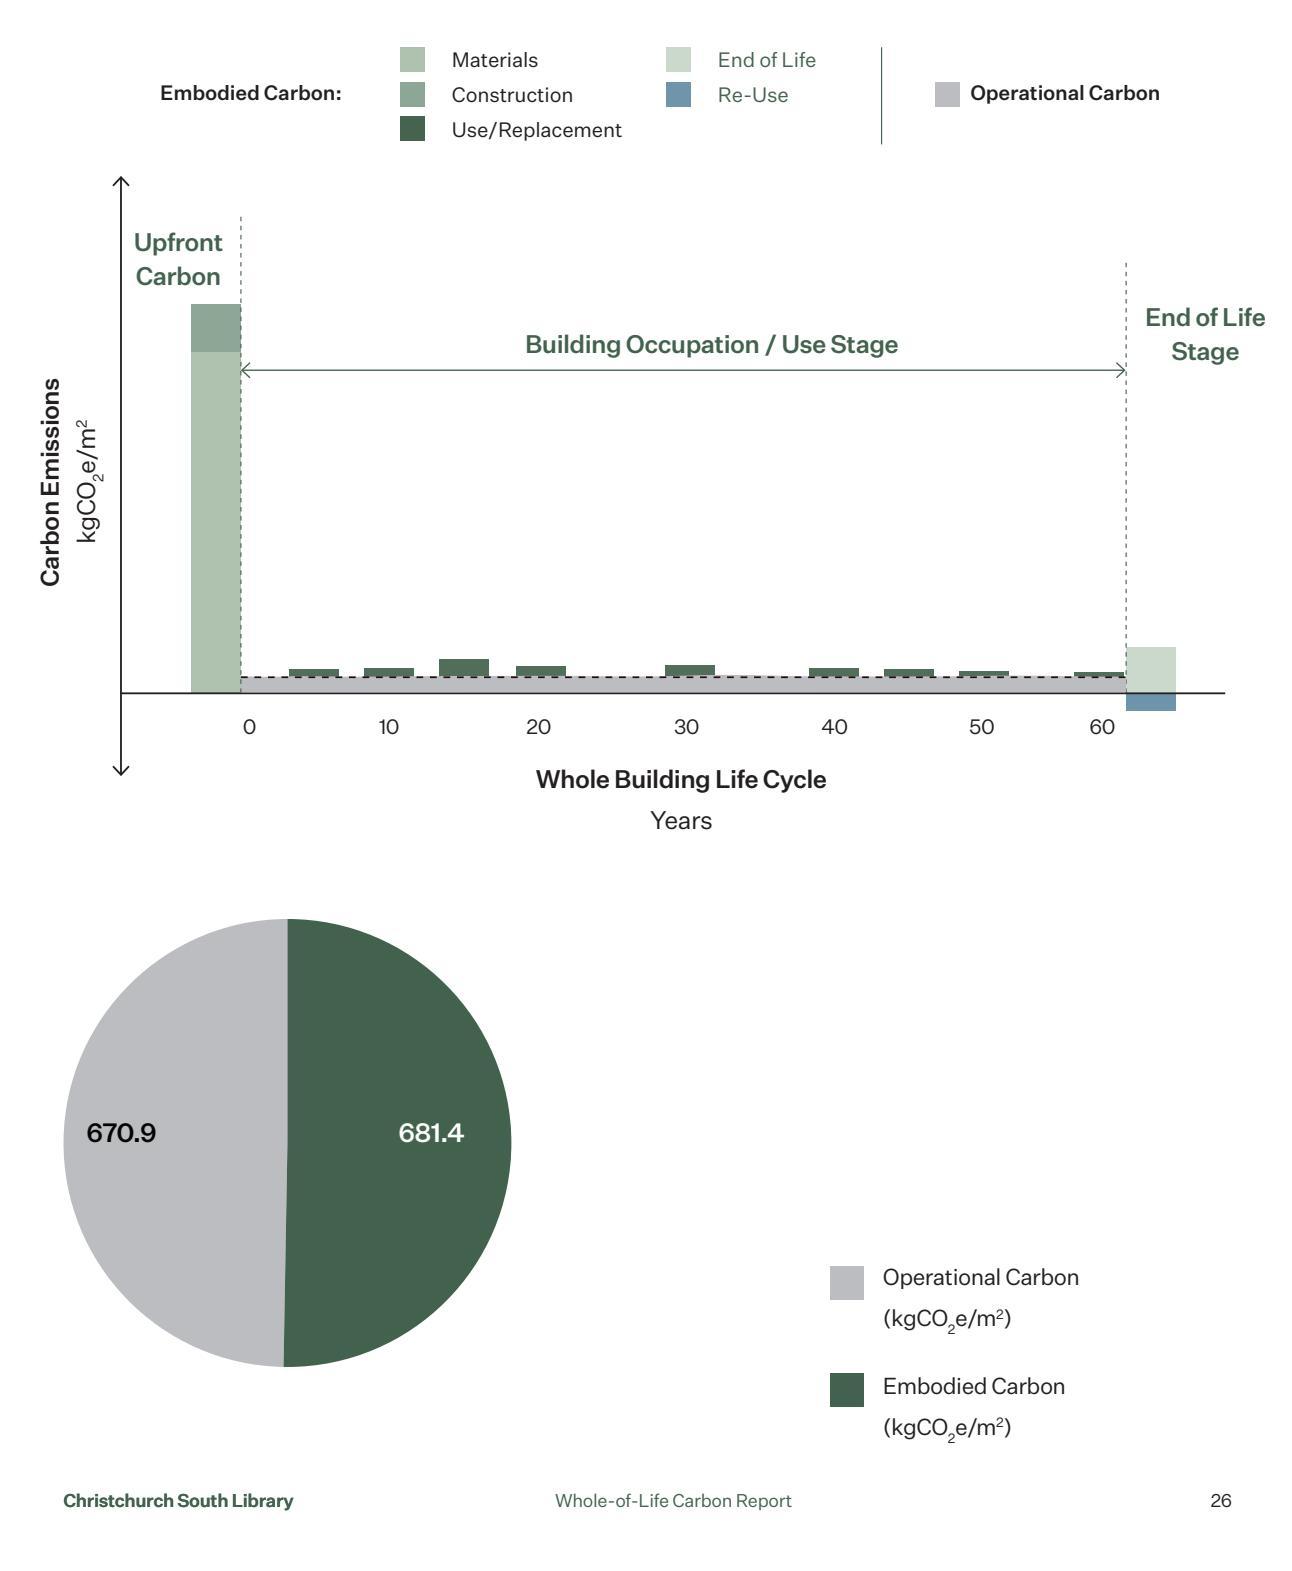
# Whole-of-life Carbon Across Building Life Cycle

The following charts show the amount of carbon released at each building life cycle stage. Climate change occurs as a result of accumulated greenhouse gases in the atmosphere so limiting upfront carbon is an important strategy to delaying emissions and resulting climate impacts.
