Slip Lane Project Tree Assessment

This tree assessment provides information relating to the proposed removal of one (1) street tree and replacement planting to enable the construction the Linwood Avenue School slip lane upgrade.

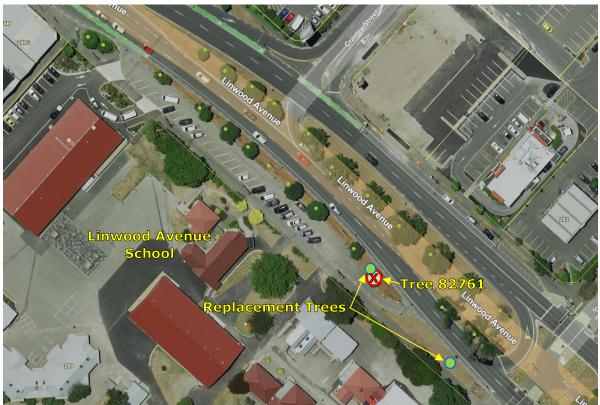
Figure 1: Site Map.

The tree to be removed is located outside Linwood Avenue School at 260 Linwood Avenue, within the landscape strip between the road and the slip lane.

Two (2) Upright Hornbeam (*Carpinus betulus* Fastigiata) replacement trees will be planted within the near vicinity of the tree to be removed as shown in Figure 1. The replacement species was chosen due to compatibility with the site conditions and existing trees within the vicinity, and the upright canopy shape will minimise future maintenance requirements such as power line and road clearance.
