Park Terrace changes - 2023

Background information

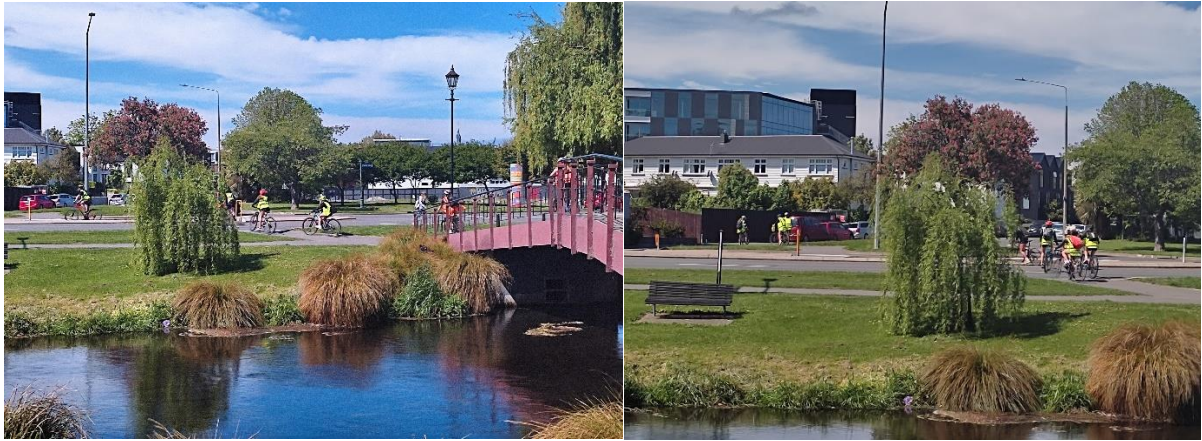
School children using the Salisbury Street crossing on bicycles

One of the safety issues identified was at the Park Terrace/Salisbury Street intersection for people crossing the road due to the two northbound lanes of faster traffic and the island being unable to accommodate demands at peak times, also groups of school children were observed riding their bicycles through this crossing.

Crossing count data (June 2023) shows that there are 79 people crossing during the morning peak (38 people on bicycles and 41 people walking). The staggered arrangement makes it difficult for people on bikes and with assisted devices or pushchairs to use, particularly when there is an oncoming user.

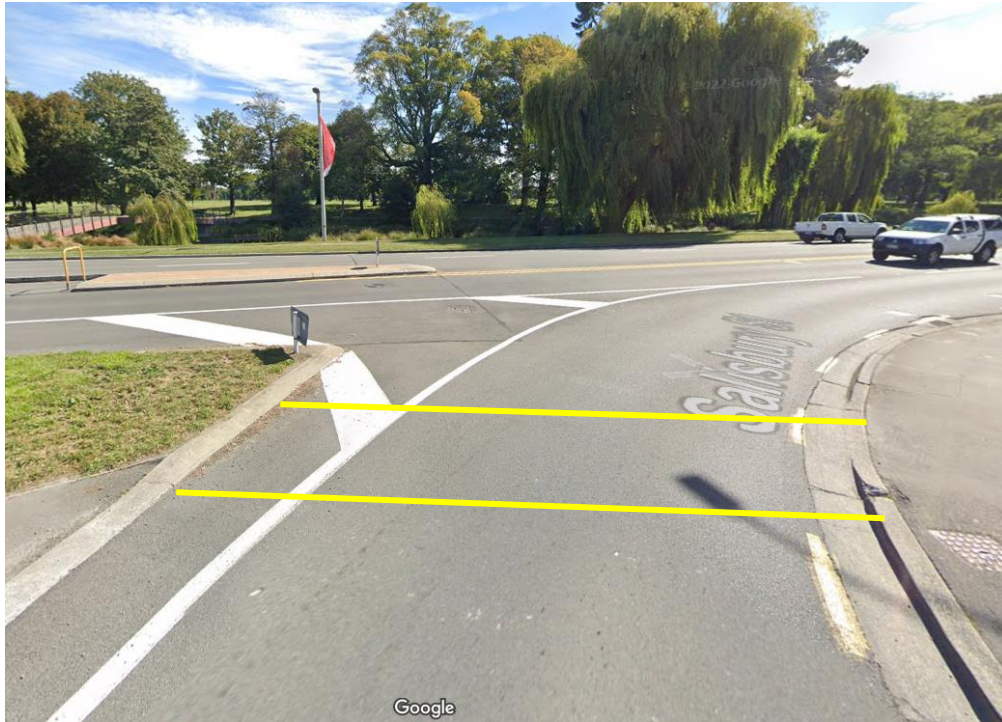
Pedestrian crosswalks not aligning at Salisbury Street

For people walking southbound on Park Terrace, trying to cross the slip lane on Salisbury Street to access the central island is difficult because visibility is restricted to the north so a person crossing is undertaking the movement without fully being able to see what traffic is heading south to make the turn. Further the cut-down does not align with the pedestrian crossing point, instead it guides you towards the full kerb and grass area of the island.

This turn is often completed at high speed so there is a risk of a collision that could result in a serious injury to a person walking.

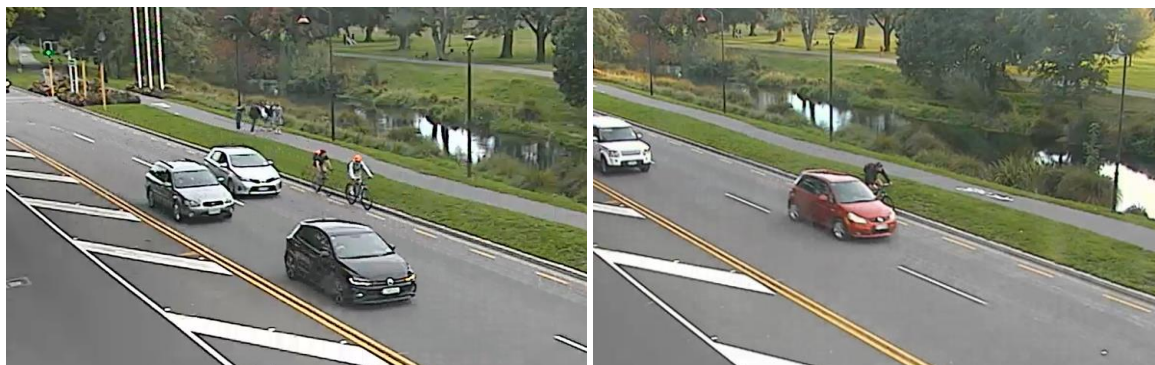
People riding bicycles on the road (traffic lanes do not meet best practice guidance)

While a shared path is provided along the riverside, people are choosing to ride bicycles along this section of Park Terrace on the road. This is an area with faster vehicle speeds and the bus also travels in the kerbside lane. The current lane widths do not align with best practice provided by Waka Kotahi NZ Transport Agency in the Cycling Network Guidance for shared (cycles and vehicles) kerbside lanes where the posted speed limit is 50Km/h and particularly where the operational speeds are higher.
