## HMNZS STEADFAST – LANDSCAPE HISTORY & CONSERVATION REPORT

PREPARED FOR CHRISTCHURCH CITY COUNCIL

JANUARY 2022

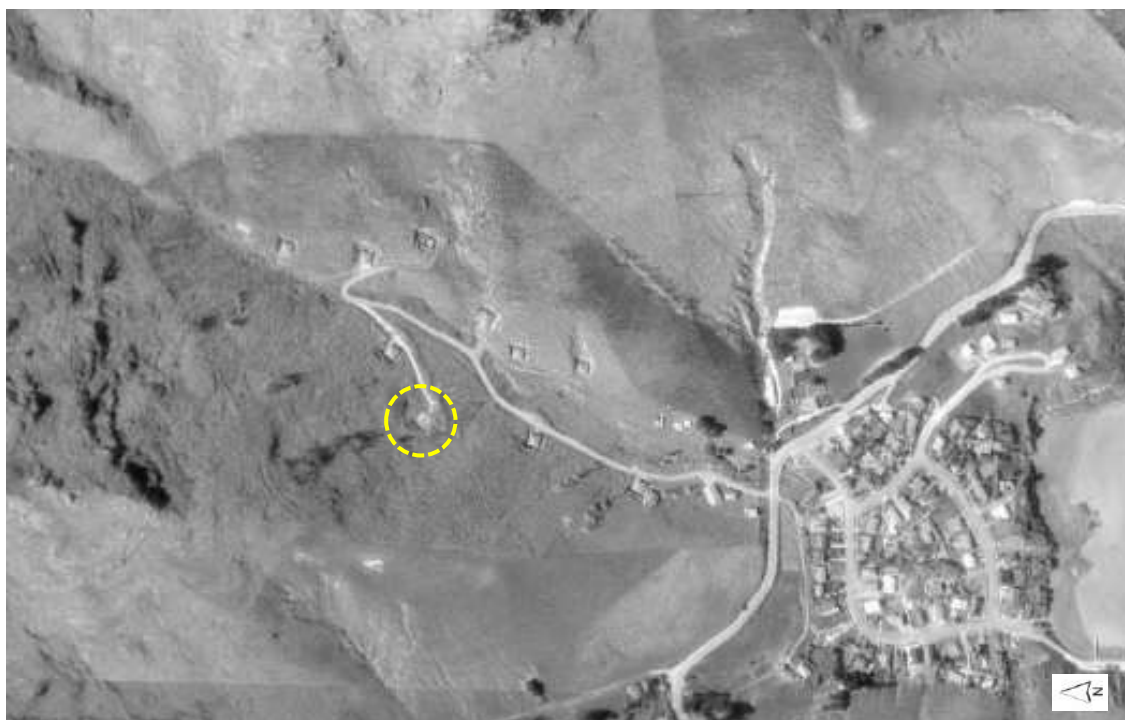
Figure 72: Motukauatirahi-Cass Bay and the naval armament depot 1980-84. After the explosion of ammunition store #8 (indicated).  
Source: Canterbury Maps, 2021.

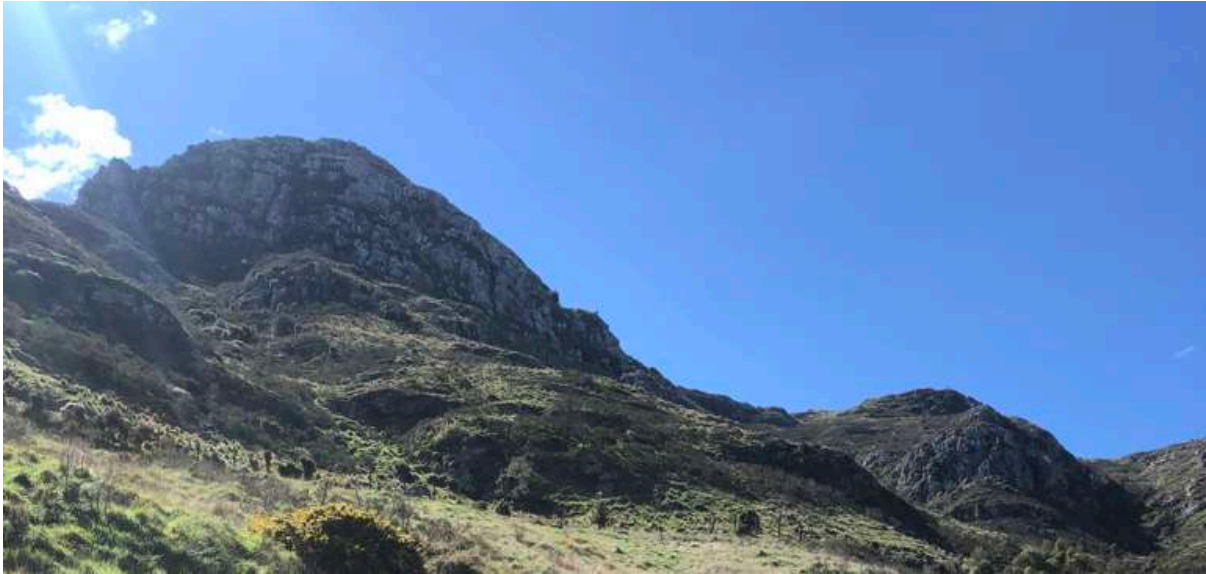
*Figure 85: The rockfall source areas located immediately above Steadfast pose an ongoing risk for people using the upper parts of the site.*

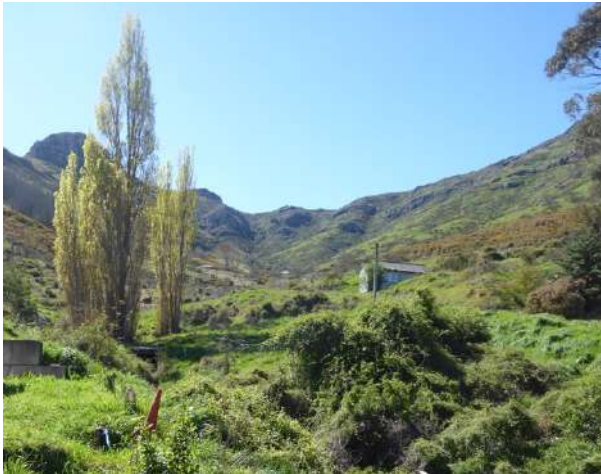
*Figure 93: Large poplar trees, blackberry and other weed species have encroached on the waterway.*

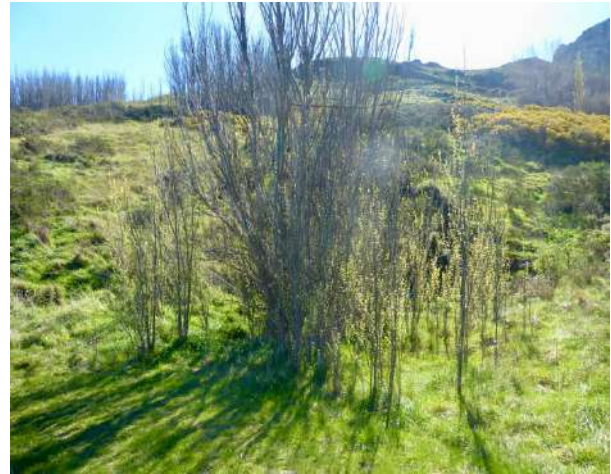
*Figure 94: Suckering poplars have spread throughout the site.*

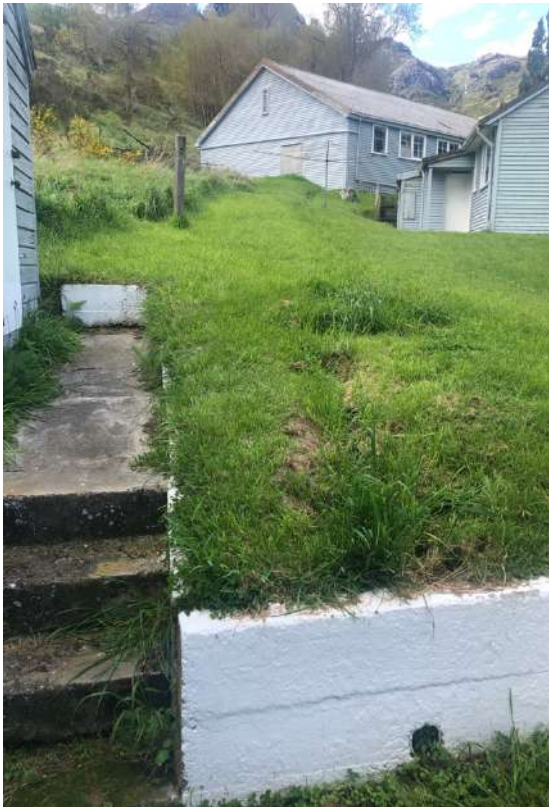
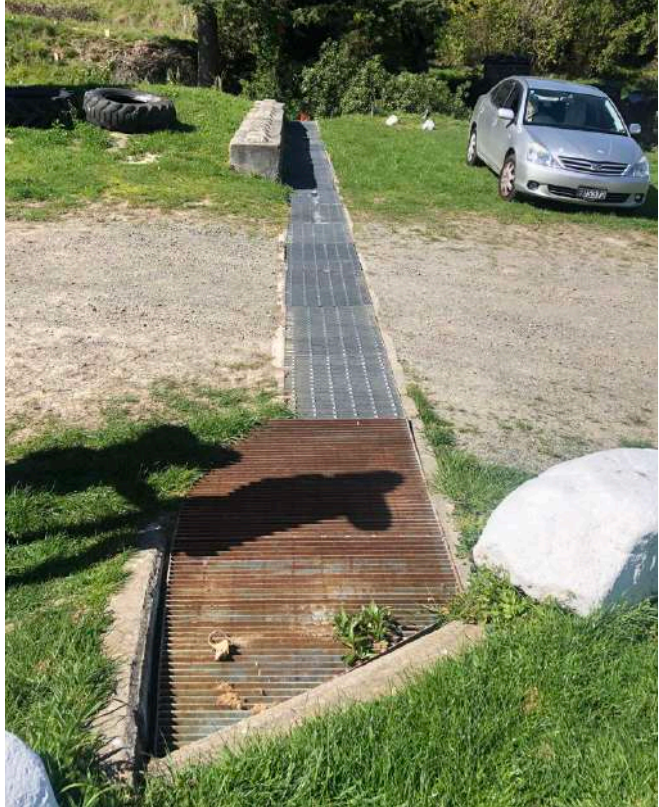
*Figure 95: Drainage issues are evident with historic and recent drainage channels constructed on the site.*

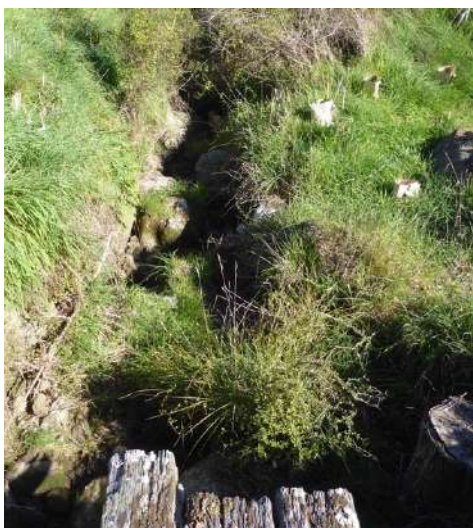
Figure 96: Eroded stream bank.

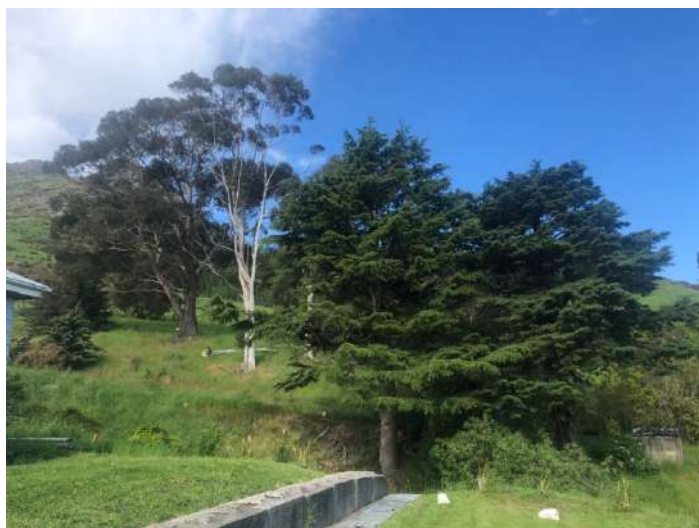
Figure 97: Mature pine and eucalyptus species may pose an issue with limb failure over time.

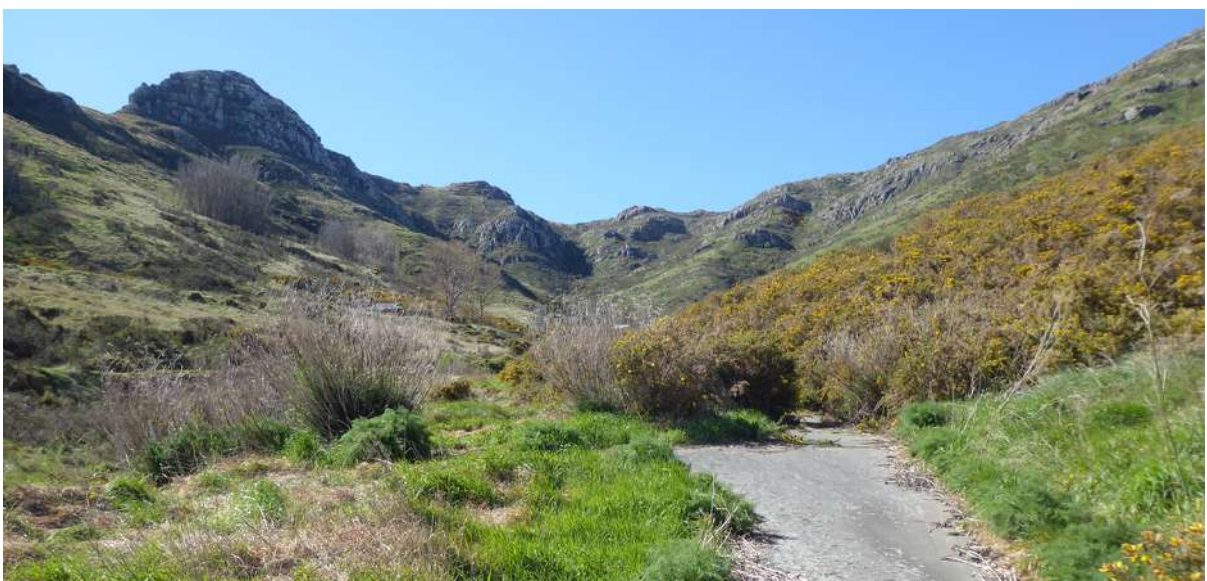
*Figure 113: Gorse and weed species encroach on access roads.*

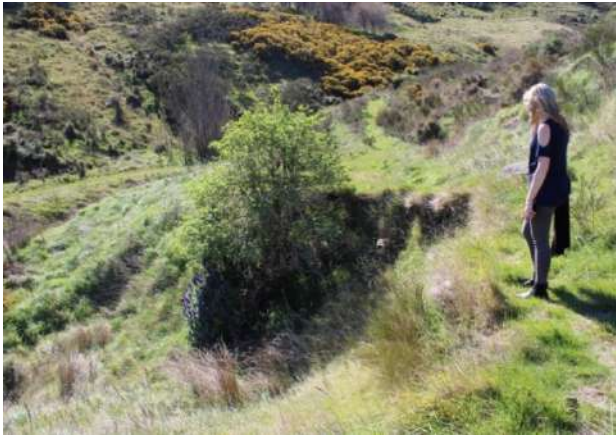
Figure 114: A section of the upper valley roads has been lost to erosion.

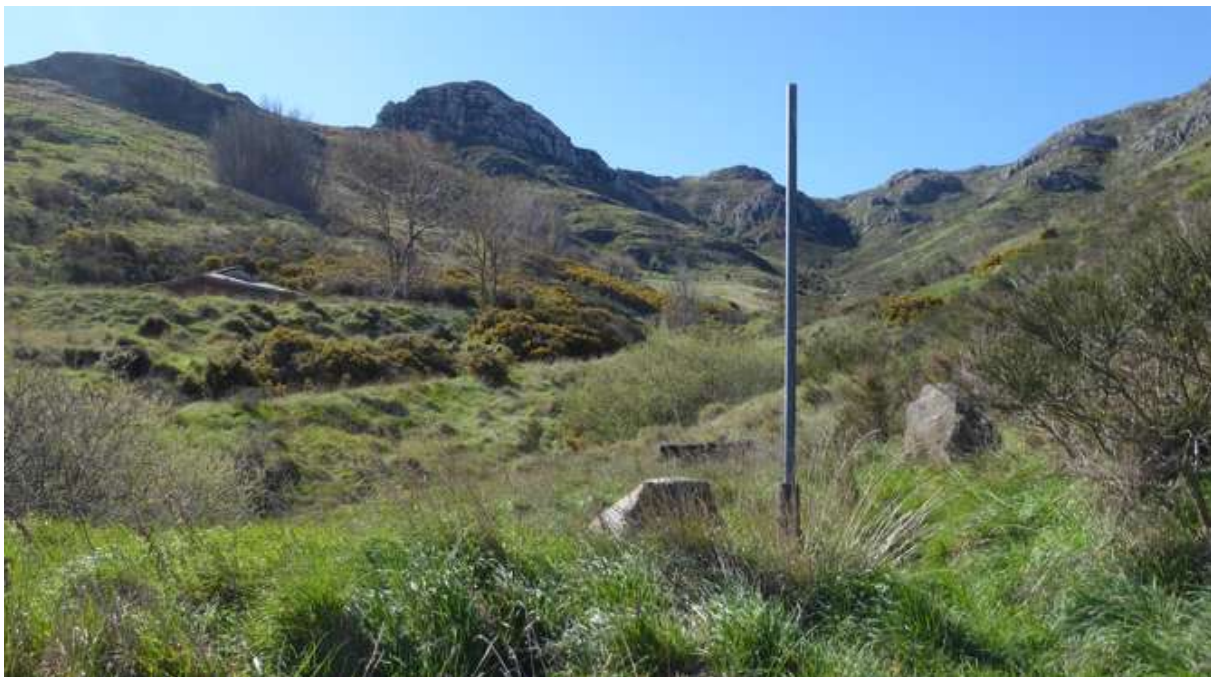
*Figure 126: TS Steadfast firing range and flagpole. The range hasn't been used since the February 2011 earthquakes when boulders rolled into and blocked visibility on the site.*

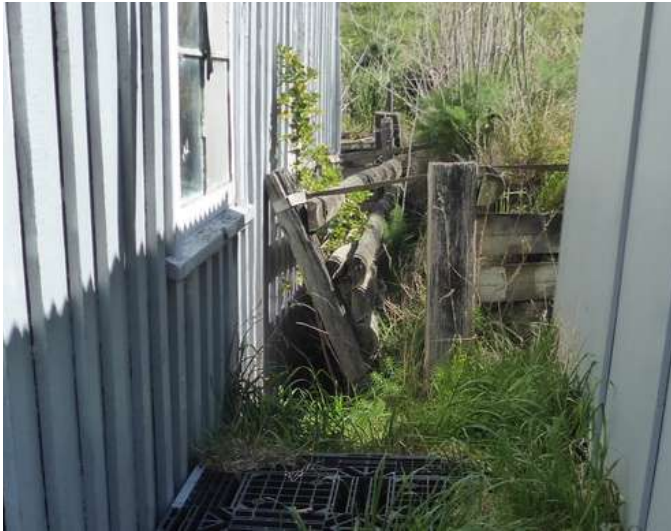
Several retaining walls associated with the buildings on site are in various states of deterioration. Timber retaining walls behind the Store (previously the Garage) and the Drill Hall are broken and have collapsed in places and are in urgent need of repair. Concrete and brick retaining behind the Ward Room is in better shape and appears stable although inspection is required to ensure safety. Low concrete and stone retaining walls (painted white) can be found across other parts of the lower site. The concrete wall forms the edge to what was once the entrance of the original Garage (Figure 132).

Figure 129: Timber retaining walls behind the Store, previously the Garage.

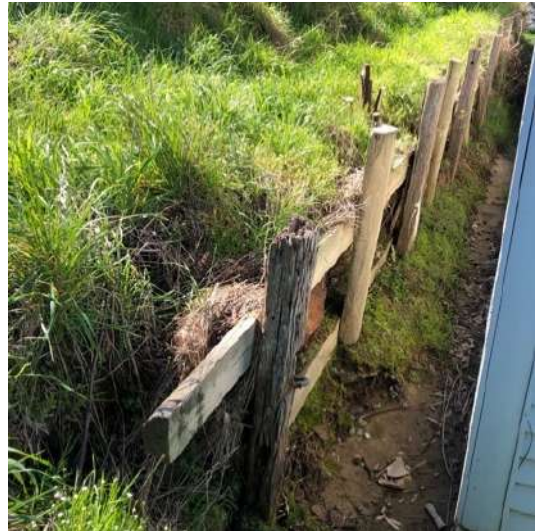
Figure 130: Timber retaining wall behind the Drill Hall.

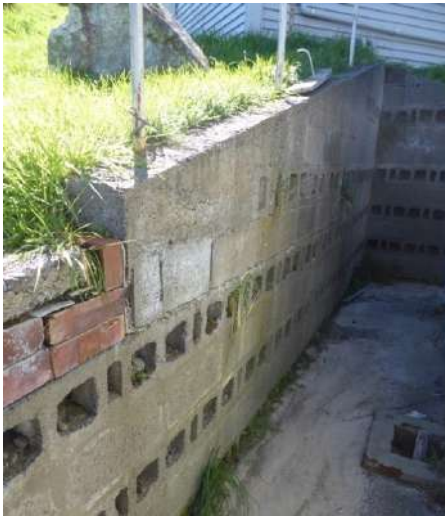
Figure 131: Concrete block and brick retaining wall behind the Ward Room requires inspection..

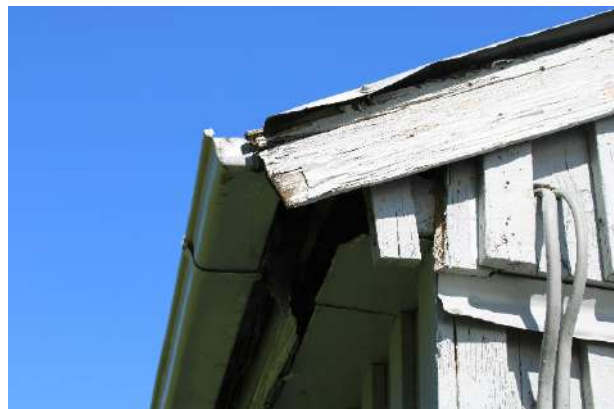
**The overall condition of the Girls' Accommodation Block is poor.** Exterior paint is badly worn and there is rot in the timber bargeboards and fascias, and in some of the wall cladding. Windows are failing and/or have been temporarily repaired. There is cracking to the concrete slab, and microbiological growth indicating damp conditions. Wall and ceiling linings are failing, with ceilings linings bowing and showing signs of water damage; and all are uninsulated. Asbestos has been identified in the soffit lining, and is presumed to be present in the interior wall plastering, switchboard, and in the roofspace. The building does not meet the accessibility requirements of the NZ Building Code.

*Figure 142: Rotten bargeboards and other roofing elements.*

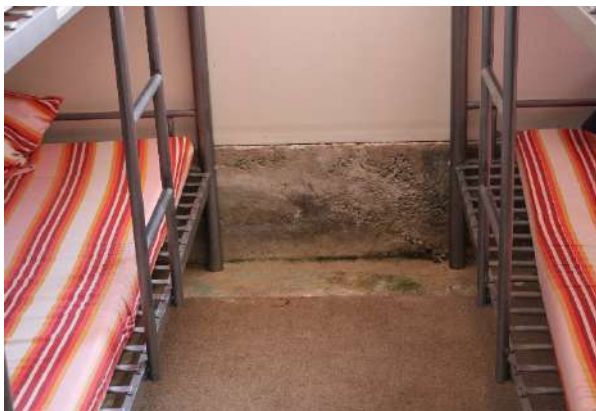
Figure 145: Exposed concrete walls and floor with evidence of some microbiological growth.

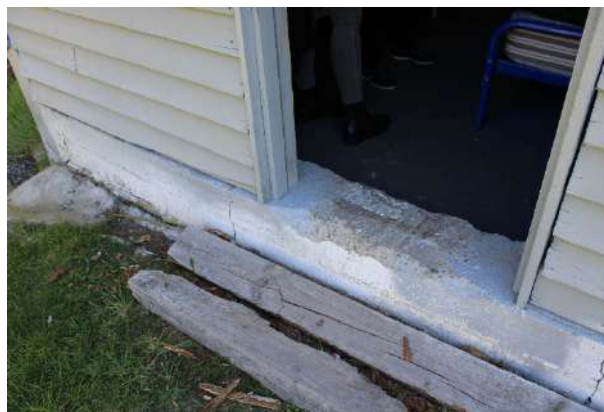
Figure 148: Entranceway with timber planks in the place of stairs.

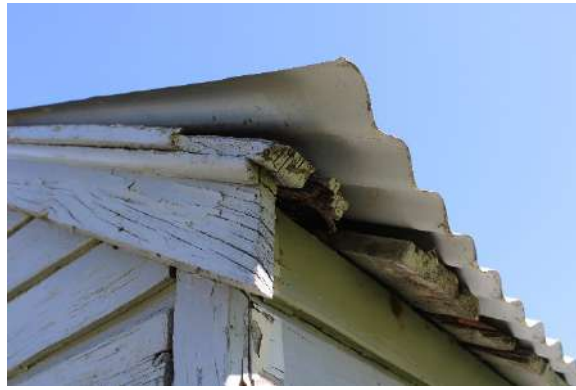
**The overall condition of the Store Hut is very poor.** There is widespread deterioration of the cladding, there is no spouting or flashing at the building barges or fascias, and there is evidence of leaking inside. The wall and ceiling linings are deteriorating, and there are holes.

Figure 150: Condition of the store hut barge and fascia

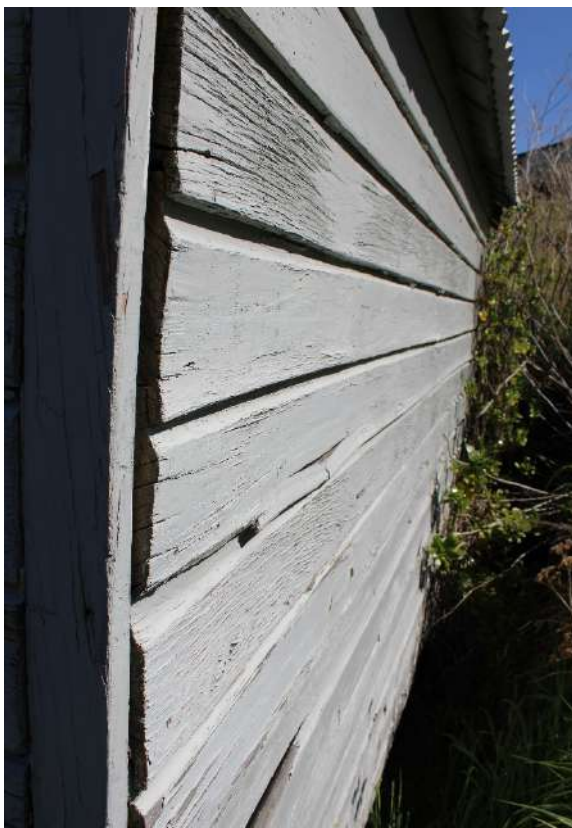
Figure 151: Condition of the store hut cladding

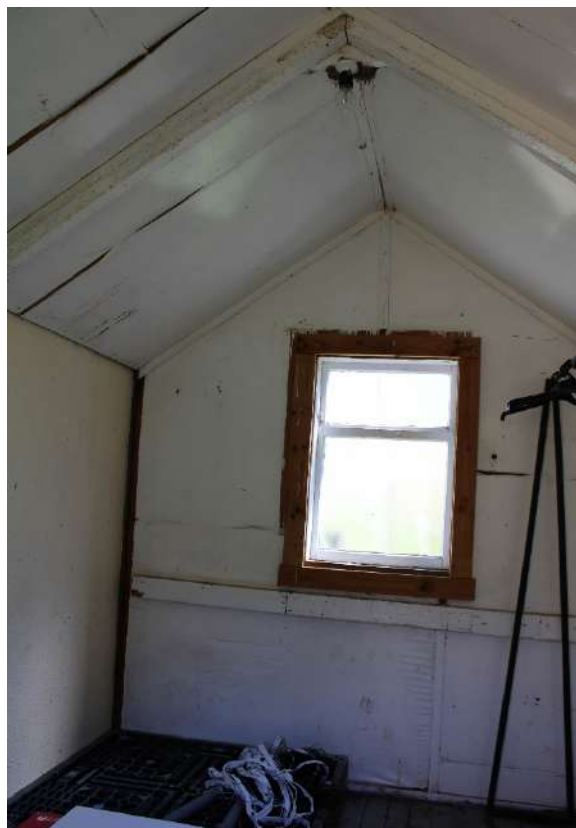
Figure 152: Condition of the store hut interior

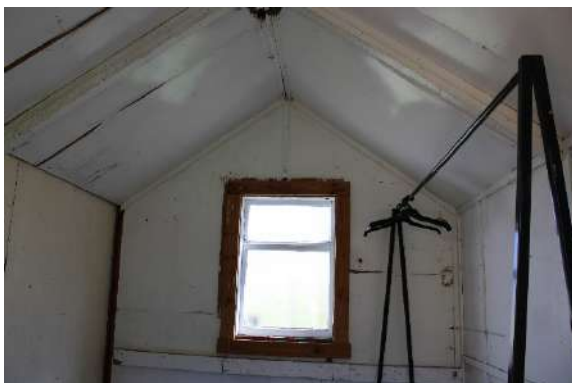
Figure 153: Condition of the store hut interior

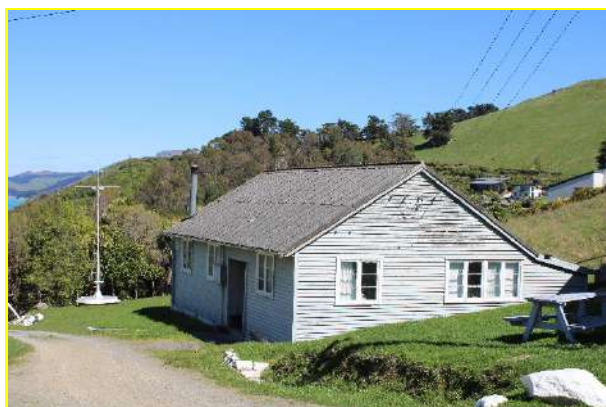
Figure 155: The office/ward room

**The overall condition of the Office/Ward Room is poor.** Roofing sheets are deteriorated and some have broken at the edges. The guttering has failed. Exterior paintwork has worn away and there is evidence of rot in some places. There are broken and deteriorated windows and hardware. Floor levels are uneven and the floor, wall and ceiling linings are failing. It is unclear what impact the removal of walls may have had on the overall building structure. Asbestos has been identified in the roofing (including flashings), rainwater goods, soffits, and vinyl floor tiles; and is presumed to be present in the switchboards, electrical wiring, and potentially some wall linings.

It is understood that HNZMS Steadfast wish to refurbish this building and continue to use it for officer accommodation, with bedrooms and bathrooms, kitchen and living area. This work would include repiling; stripping out and replacing internal linings and finishes, fixtures and fittings; and rearranging the existing external-access bathroom so that it can be accessed without the need to go outside.

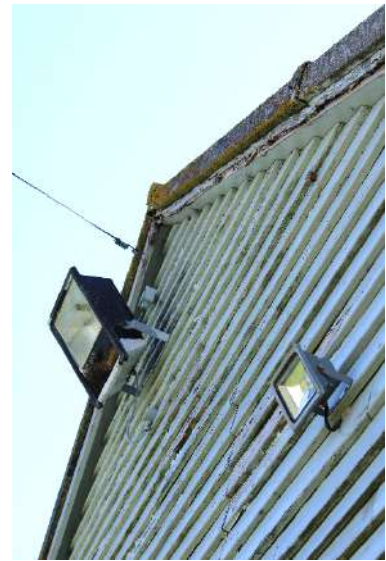
Figure 160: Paint flaking exposing timber underneath to elements.

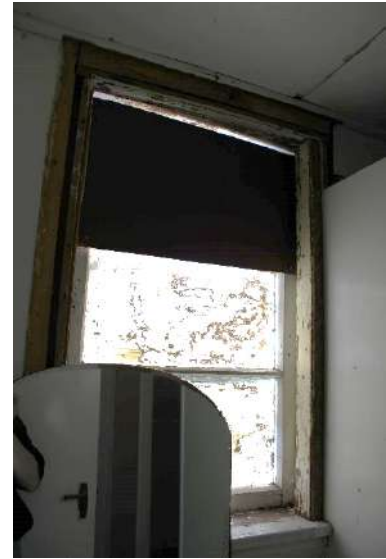
Figure 166: Damaged windows.

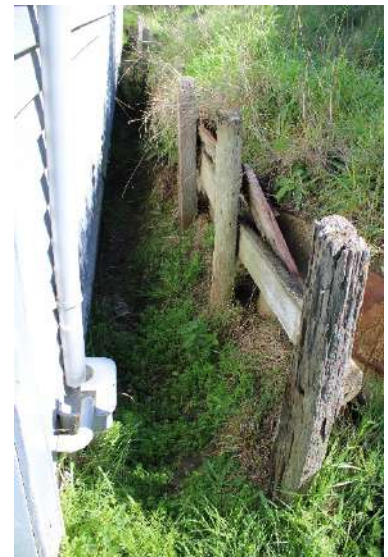
Figure 181: Failing retaining wall.

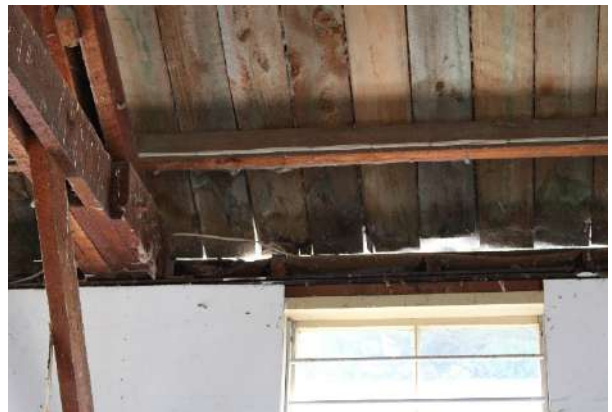
Figure 183: Lack of weathertightness to roof edges.

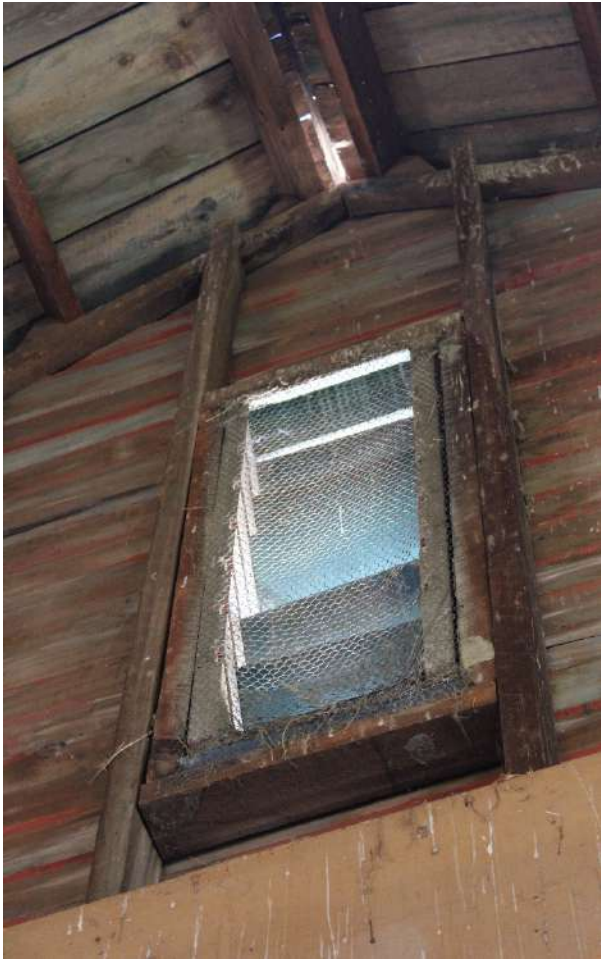
Figure 184: Evidence of pigeon infestation to gable end external grilles.

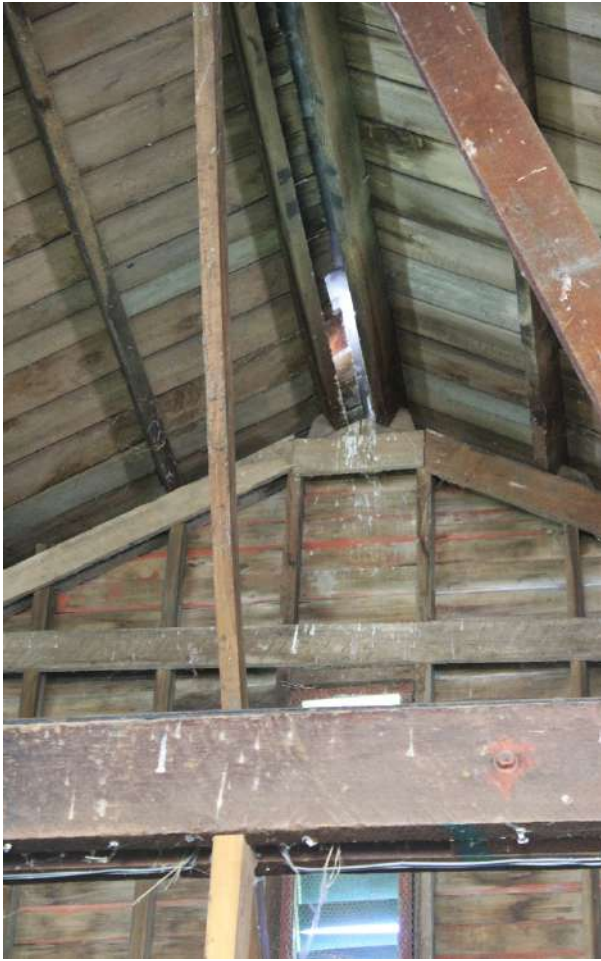
Figure 186: Evidence of pigeon infestation to roof and lack of weathertightness.

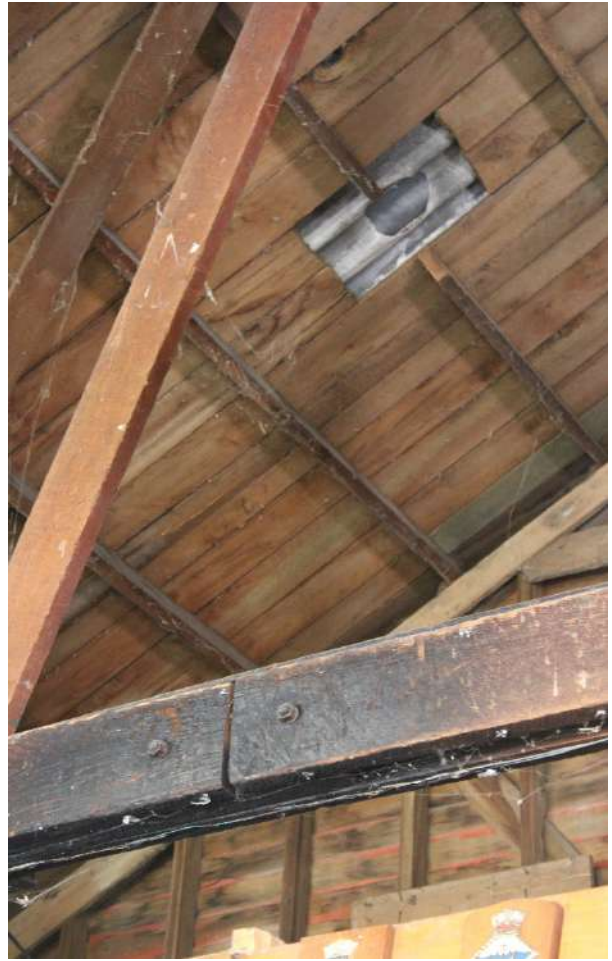
Figure 187: Charred beam from historic fire, and covered hole in the ceiling where chimney originally existed.

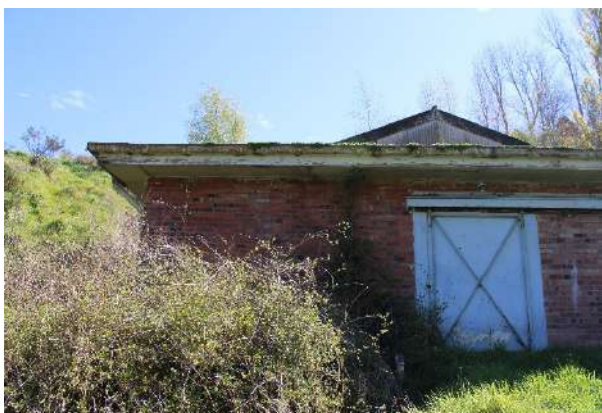
Figure 200: Microbiological growth to guttering.

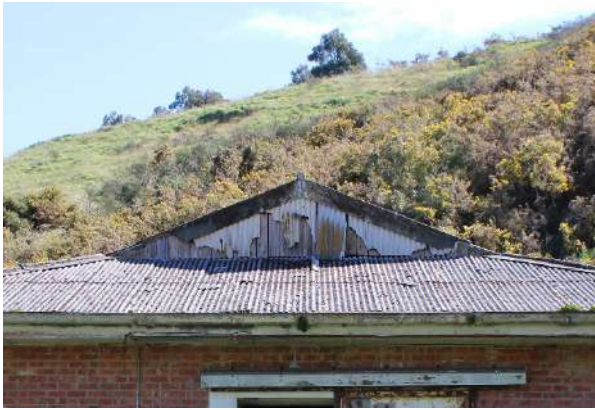
Figure 204: Severely deteriorated roof cladding

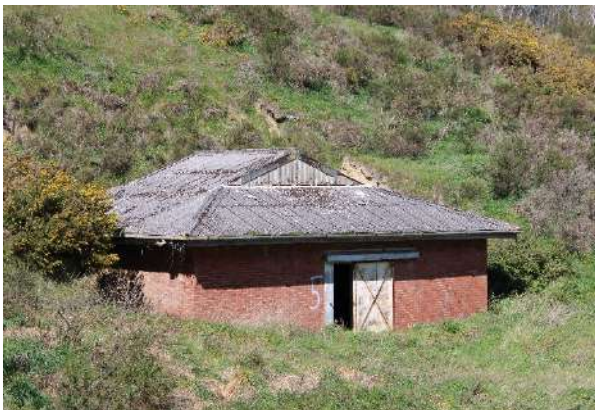
Figure 206: Severely deteriorated roof cladding

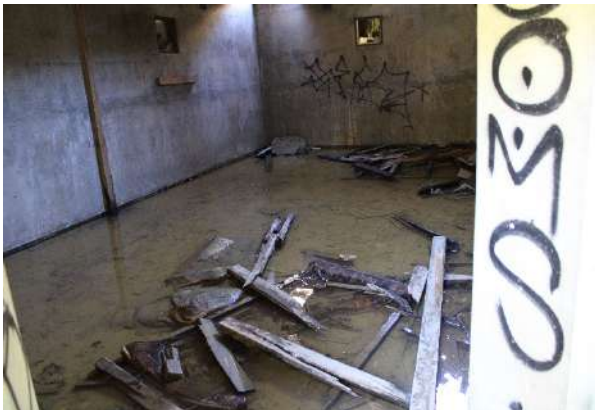
Figure 208: Flooding caused by roof penetration.

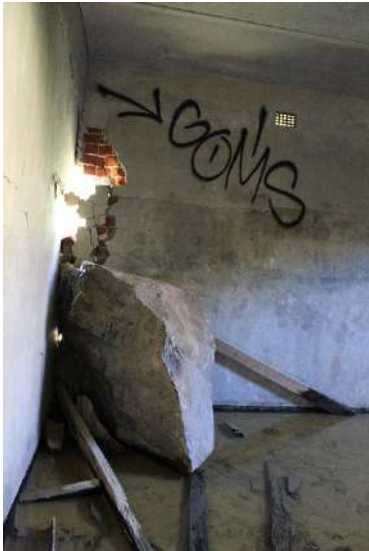
Several of the magazines were damaged by rockfall during the Canterbury Earthquakes, leaving gaping holes in the walls and roofs. Even where they are intact, the magazine roofs and gables are deteriorating, with brittle sheet cladding breaking or falling away. Gutters are blocked with living or dead plant material, or have failed. Steel doors are corroding and many have seized. Microbiological growth is prevalent on both the exteriors and interiors, and many have also been graffitied. Some are waterlogged and are unable to drain. Ceiling linings are broken or have holes. Many show signs of pest infestation. Asbestos has been identified in the roofing, flashings, gutters, downpipes and soffits. Contamination of the ground around magazines 4 and 8 is strongly suspected. We understand that HMNZS Steadfast intend to continue using magazine 10 for storage.

Figure 210: Rock which caused damage to structure

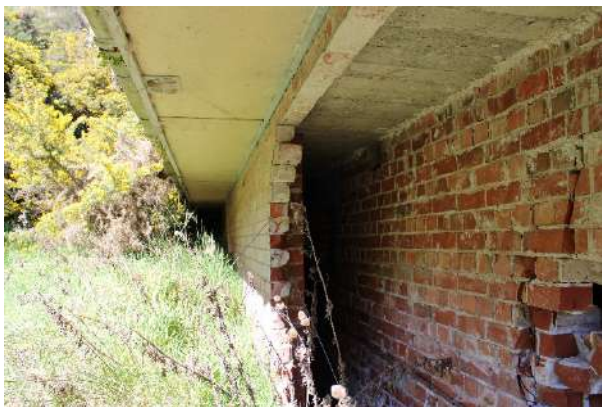
Figure 214: Damage to one of the magazine stores caused by a rockfall, exposing the separated double brick wall structure.

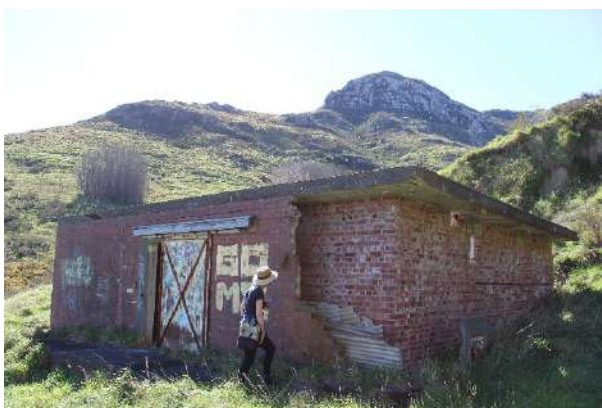
Number 8, which “exploded” in 1980 (see Figure 48), has been almost completely destroyed save for the concrete foundations and door frame (Figure 218 and Figure 219). The inner walls and some of the outer walls of number 5 are still standing, but the roof has been destroyed (Figure 216 and Figure 217). The reasons behind its destruction are unknown.

Figure 216: Magazine store number 5, with no roof.

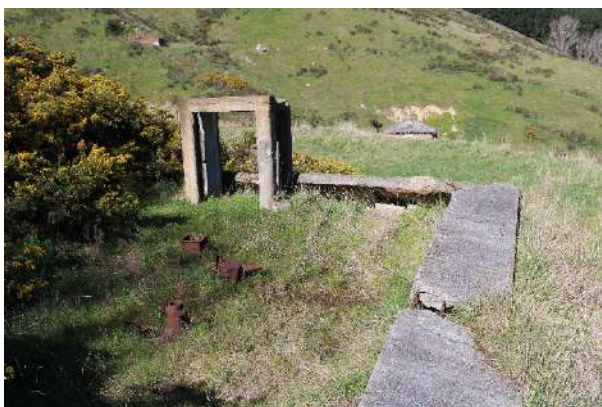
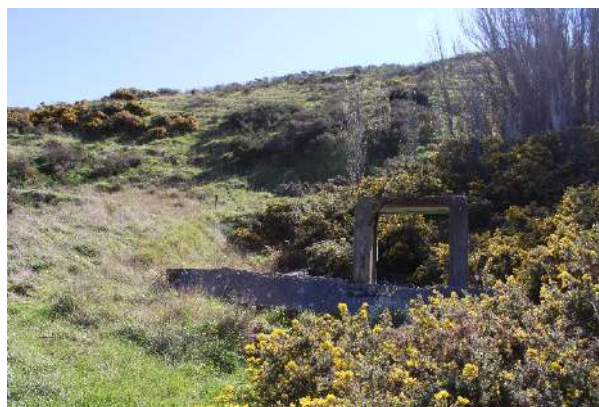
Figure 218: The remains of magazine store 8, which exploded in 1980.

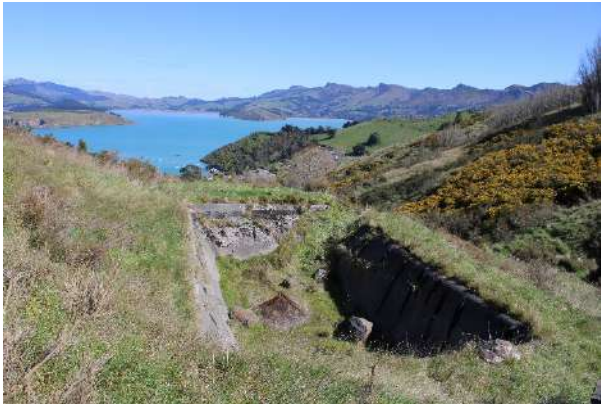
Figure 220: The larger of the two water reservoirs.

**The reservoirs are in very poor condition**, and it is not expected that they will ever be repaired or reused.

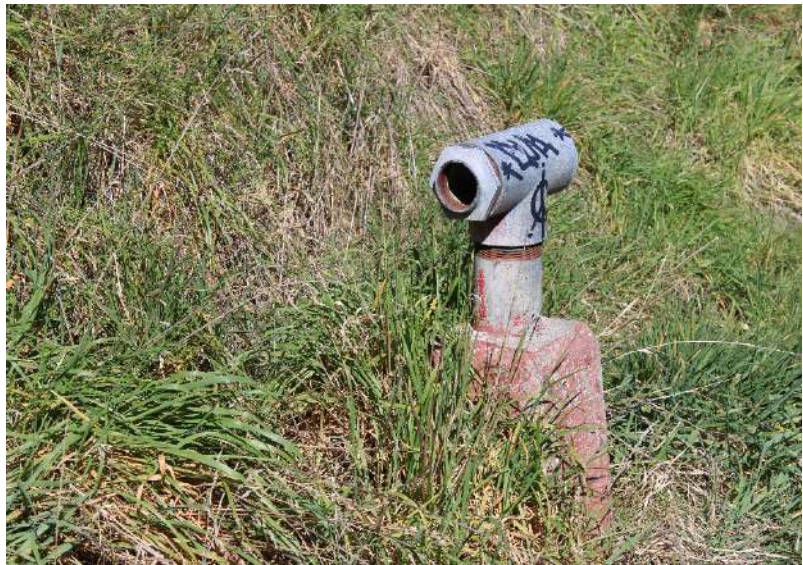
Figure 223: One of the hose feed/hydrant connection points along the military road east of the stream.

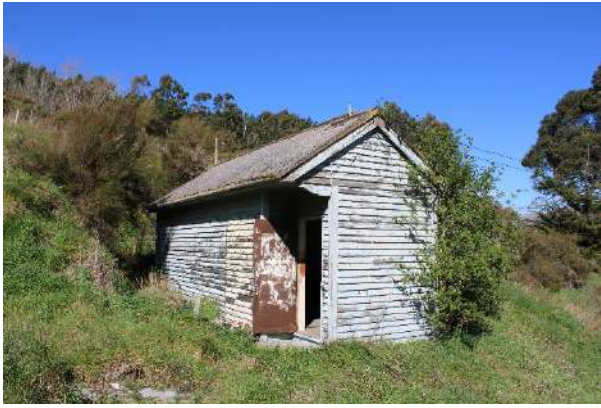
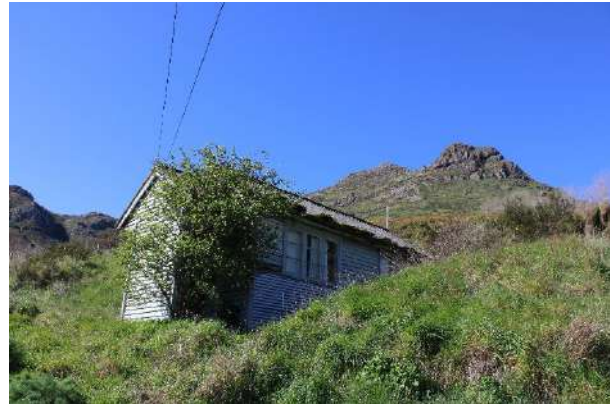
*Figure 224: The laboratory.*

**The former laboratory is in very poor condition.** There is vegetation growing directly next to the building that has penetrated the wall cladding. Weatherboards are unpainted and rotting. The roof sheets, which contain asbestos, are brittle and breaking, and there are no gutters. Windows are broken or badly damaged, wall linings are cracked and ceiling linings are bowing. Pest infestation (bird and rodent) is widespread.

Laboratory	Very Poor	<ul style="list-style-type: none"> <li>• Rotten timber</li> <li>• Pigeon infestation</li> <li>• Wall cracking</li> <li>• Window damage</li> <li>• Failing asbestos roof cladding</li> </ul>	Detailed condition and structural assessments of these buildings should be carried out to determine the extent to which they can be repaired.
Quartermasters	Very Poor	<ul style="list-style-type: none"> <li>• Rotten timber</li> </ul>	Adaptive reuse of these buildings should be considered in

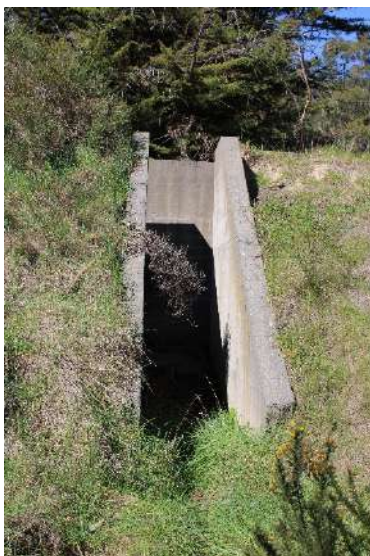
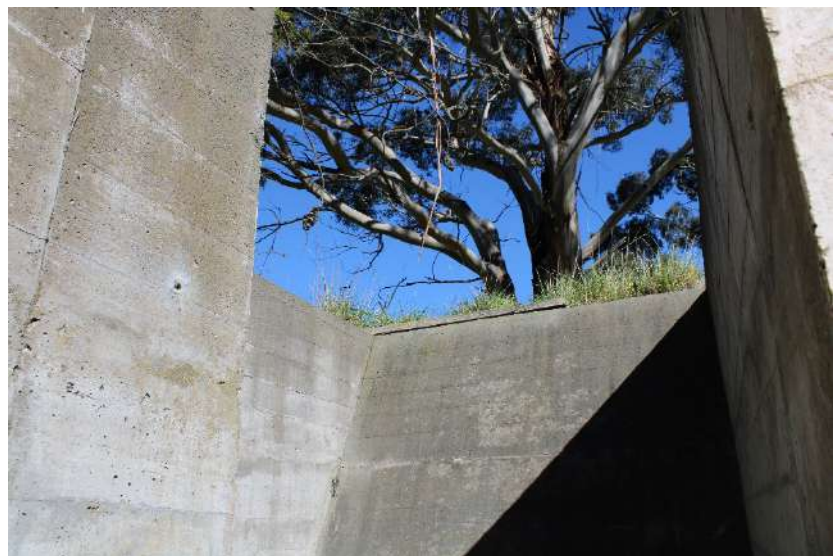
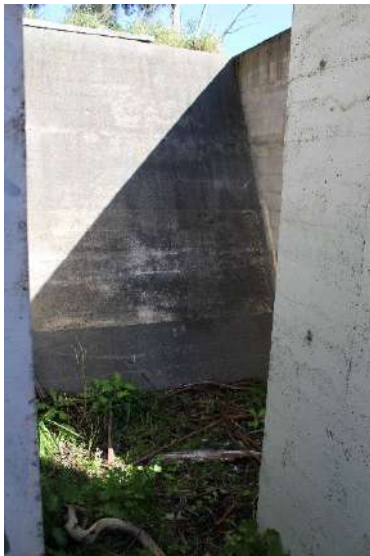
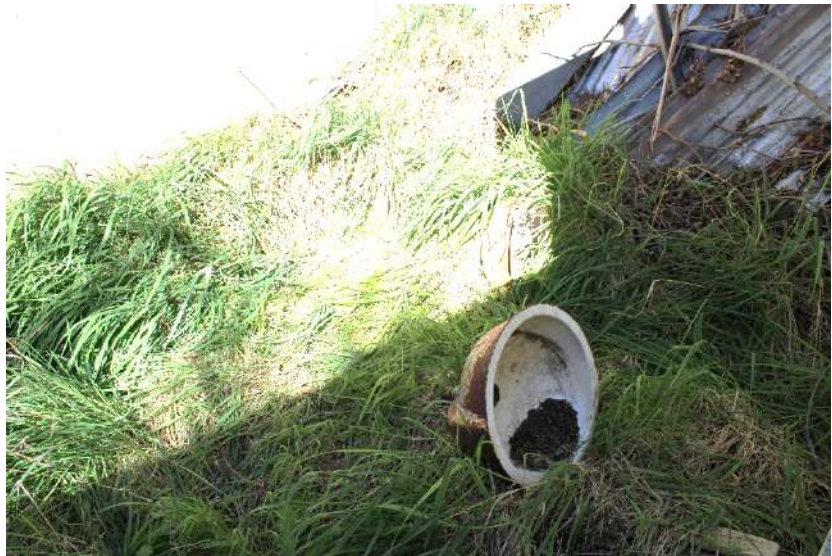
The detonation chamber was initially used for detonating ammunition during the site's time as an armament depot (Figure 30), but was converted into the ablutions block during TS Steadfast's occupation of the site. Showers were installed in the "wings" of the chamber, and toilets were built on top. **The structure is now a ruin and is not expected to be reused.**

Figure 230: The entrance to the detonation chamber.

Figure 231: The interior of the detonation chamber.

Figure 232: The interior of the detonation chamber.

Figure 233: Washbasins inside the detonation chamber.

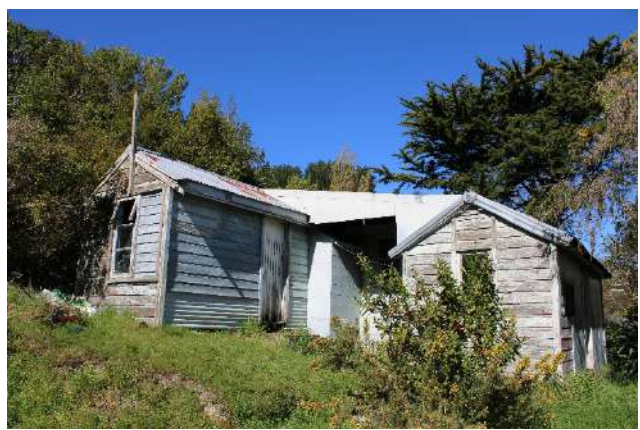
Figure 235: The quartermasters accommodation today, formerly the guardhouse.

**The quartermaster's accommodation building is in very poor condition.** Weatherboards are unpainted and rot is widespread. The roof sheets, which contain asbestos, are brittle and breaking, and gutters are failing. Windows are broken or badly damaged. Wall and ceiling linings are decaying in places, and the floor levels and stairs are uneven. Pest infestation (bird and rodent) is widespread.

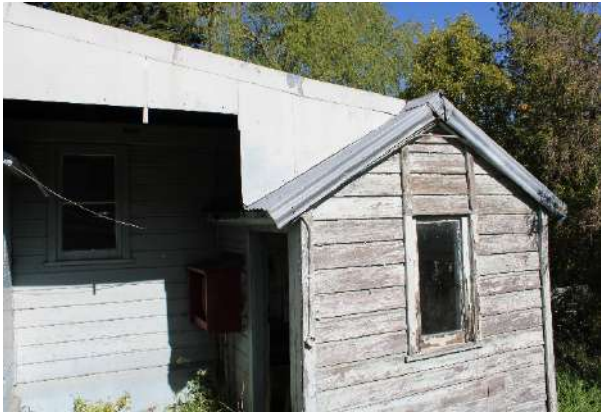
*Figure 236: Gable end of the building showing flaking paint and rotten timber.*

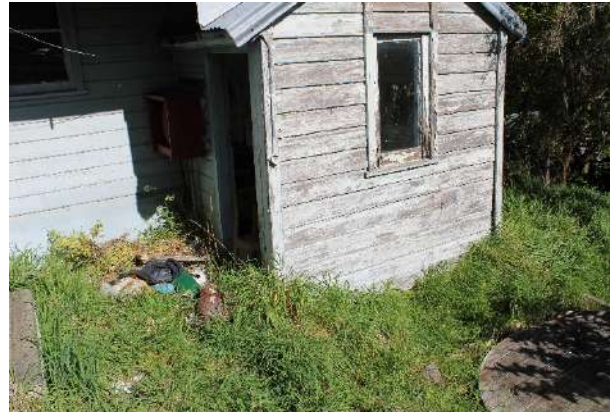
*Figure 237: Gable end of the building showing flaking paint and rotten timber.*

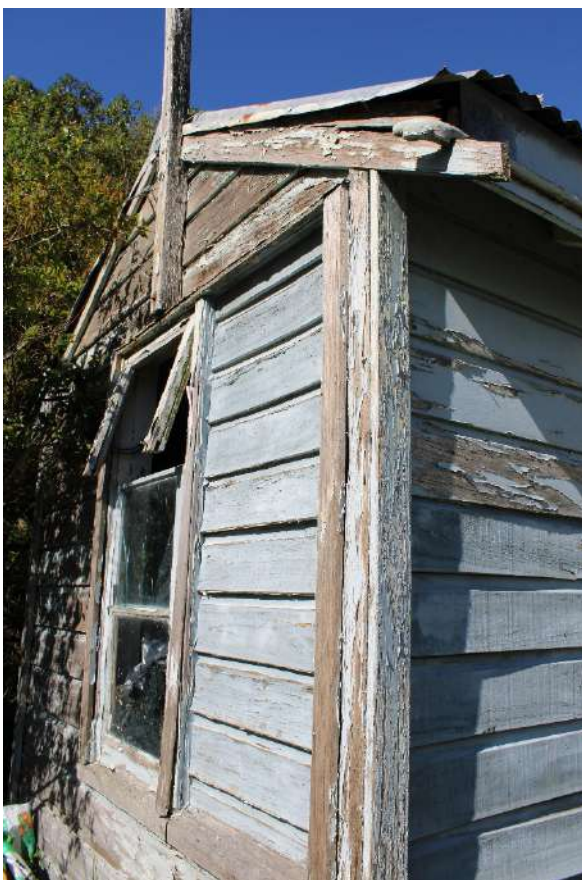
*Figure 238: Rotten timber cladding and window framing to the exterior of the building.*
